**Biological Overview of the
Malibu Creek Watershed Proposed Channel Clearing Sites**

**Prepared by the Resource Conservation District of the Santa Monica Mountains
Kathleen Bullard, Executive Officer, and Sean Manion, Conservation Biologist**

October 20, 1997

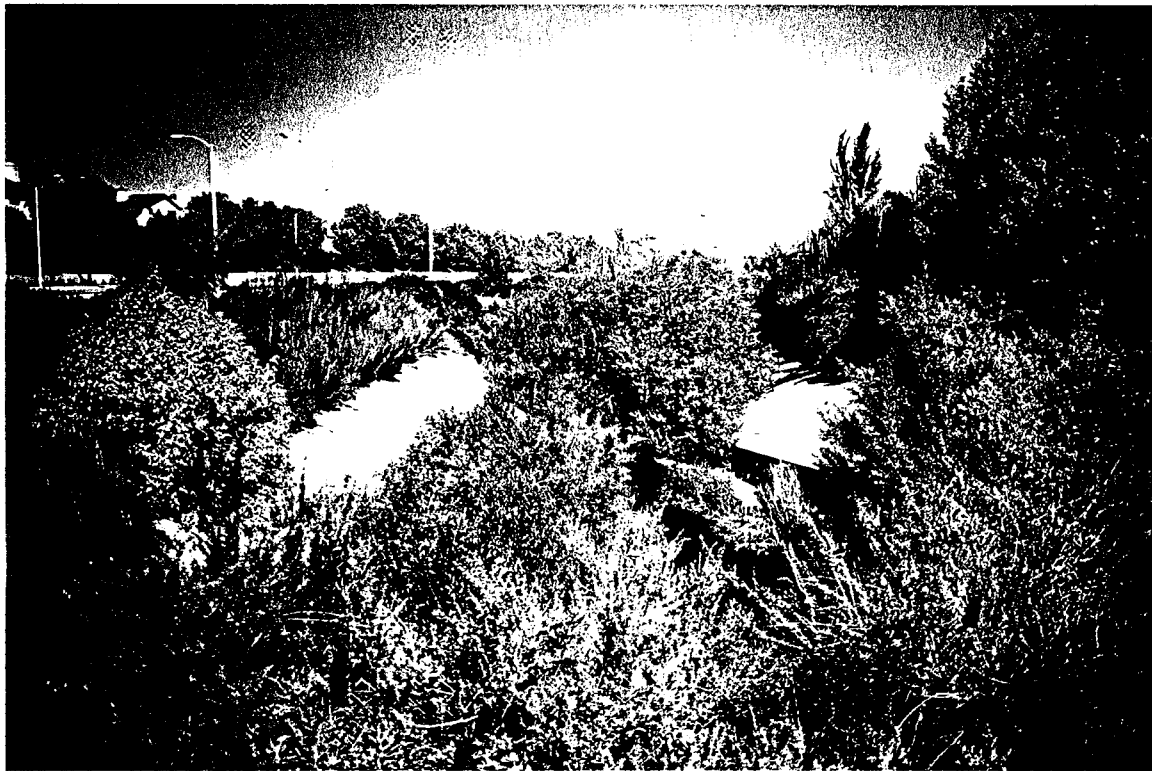
Site # 31 Las Virgenes Creek: 475' upstream of Meadow Creek Lane to 222' upstream of Meadow Creek Lane.

The site has a tree canopy of approximately 75% or greater and many willows are over 4" DBH or greater (approximately 200). This habitat is part of a critical wildlife corridor between the Simi Hills and the State Park system. The substrate of the creek is silts and fine clays forming a thick veneer over the original cobbles and gravels. When we observed the site on October 11, we observed numerous lizards (sideblotched, alligator and western fence) as well as mourning doves, and red-tail hawk. A thorough biological assessment through three seasons was performed in part, for fulfillment of California Department of Fish and Game Streambed Alteration Permit requirements. The site is best described as Southern Willow Scrub (Long 1995). The site has been utilized by two sensitive species, the white-tailed kite and yellow warblers. Mammals using this site include ground squirrel, Audubon's cottontail, raccoon, skunk, and mule deer. Tree frogs were observed at the Meadow Creek Street undercrossing. Please see Appendix A for the complete biological assessment report by biologist Michael C. Long which covers both the Las Virgenes Creek streambank restoration site and the area proposed for channel clearing.

Because the stream's carrying capacity will be increased upstream of the proposed site for clearing, we recommend that site #31 referenced above be removed from the list of creek stretches proposed for clearing and be allowed to remain in its current condition. If the hydrology indicates that thinning is still deemed necessary to increase channel capacity, then this should consist of selective vegetation removal by hand with the roots allowed to remain for slope stability.

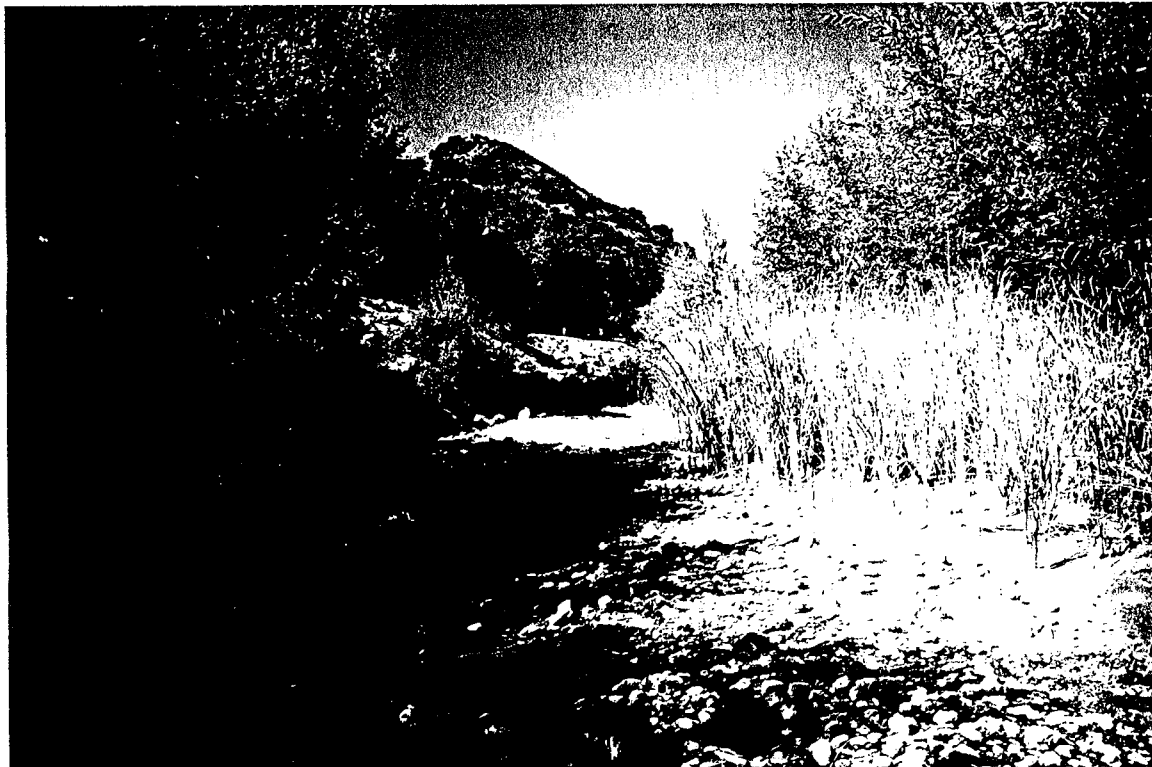
Site #28 Triunfo Creek: 384' upstream of Mullholland Highway to the downstream edge of Mullholland Highway.

This particular reach is adjacent to Peter Strauss Ranch, a National Park Service Site. The creek bottom, although dry, consisted of medium to large cobbles and two pools of standing water that were observed being utilized by ducks and a great blue heron. The pools may serve as southwestern pond turtle habitat and for tree frogs. In the main channel small willows and cattails were growing. On the western bank we observed larger willows and significant understory habitat, and near the Mulholland overcrossing several significant sycamores are providing bank protection. Many mourning doves were observed at the site and just upstream of the sycamore, an owl roost site was noted due to the numerous pellets. One of the sycamores just on the downstream side of Mullholland has exposed roots. A large California live oak was observed downstream of Mulholland. Tree canopy was estimated at 10-15% with approximately 50 willows at 4" DBH or greater.

If clearing must be done, it should be done in a way that does not impact the two large pools of water upstream of Mulholland, and does not degrade the cobble bottom of the creek. If necessary, only the vegetation in the center of the channel should be removed by hand and the vegetation on the banks should remain for slope stability and habitat value. Roots of the sycamores holding up the banks of the bridge should be protected from compaction and fencing placed around the perimeter of the roots if mechanical clearing is utilized.

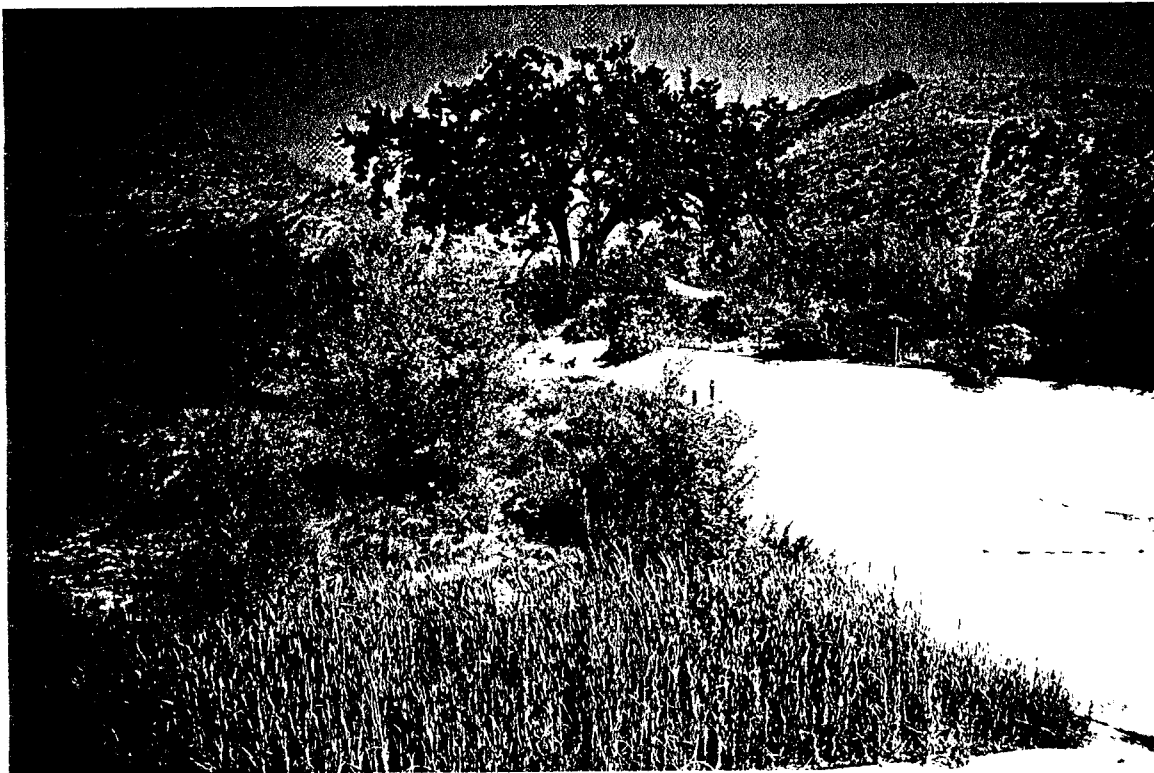
Site #29 Las Virgenes Creek at the Ventura County Line to 3006' upstream of Thousand Oaks Blvd.

Las Virgenes Creek flows out of Ventura County at Ahmanson Ranch, and eventually into a box culvert behind apartment buildings. Until it reaches the box culvert, the stream is natural. The stream reach proposed for clearing is the natural part of the stream from the Ventura County line to the culvert. The canopy is estimated at 10% and there are approximately 30 willows 4" DBH or greater. Numerous cattails line the channel. Tree frog tadpoles have been observed previously at this site. Similar to Las Virgenes Creek further downstream, the biological assessment by Michael C. Long in Appendix A would apply here as well. There is also a large Valley Oak in need of protection on the upper streambank.

Selective hand thinning of willows only near the Ventura County Line should reduce any threat of flooding to the nearby apartment buildings, since the creek drops in elevation rather quickly and the canopy naturally thins out. If the site cannot be taken off the list completely, at a minimum the scope should be significantly decreased.

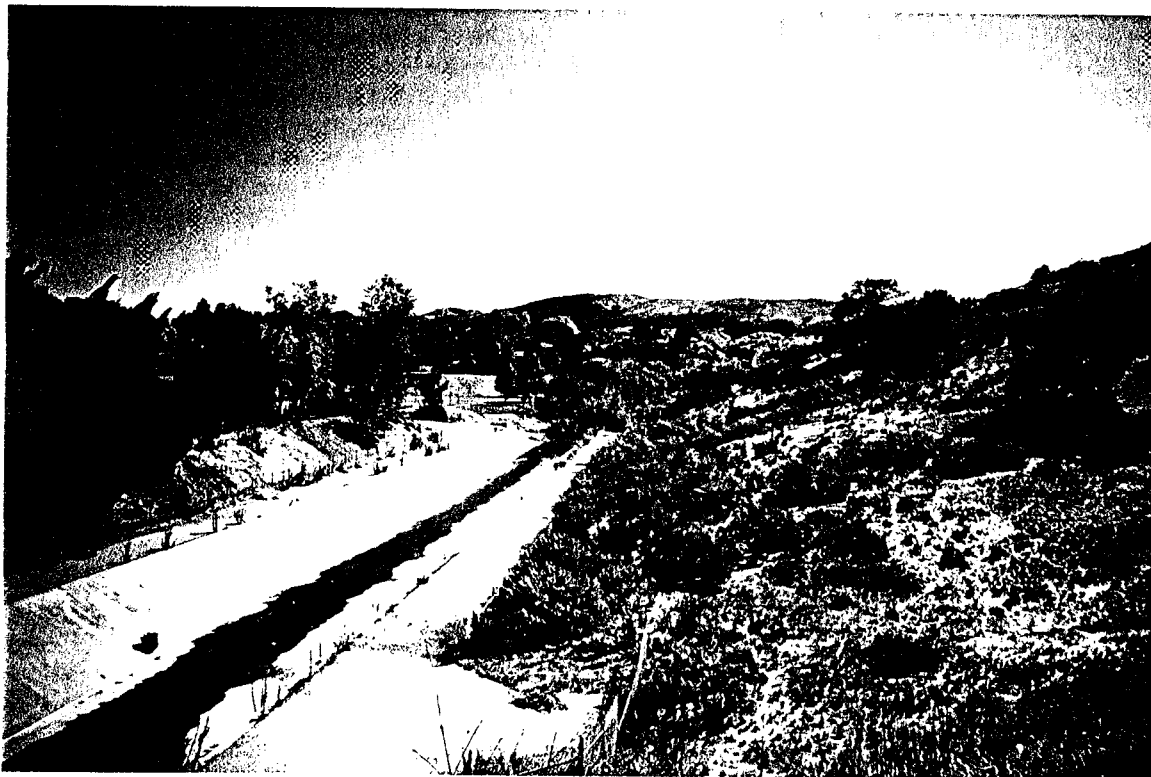
Site #34 Medea Creek 535' downstream of Kanan to 940' downstream of Kanan.

A mature riparian habitat, this site connects to site #35 under the 101 freeway. The canopy is 75% or greater, and in addition to mature willows (at least 100 greater than 4" DBH), the site also contains sycamores, cottonwoods, significant oak trees, and understory habitat. While there is considerable development upstream and the stream is channelized, at this location the creek is natural and surrounded by open space. Similar to Las Virgenes Creek at Lost Hills Road but more mature, Michael C. Long's biological assessment in Appendix A applies here as well. This site is certainly serving as an important riparian habitat to the surrounding hills as well as an important wildlife corridor.

Unless it can be shown specifically where the flood damage may threaten improved property, no clearing should take place and if necessary, allow the area to flood into the surrounding open space.

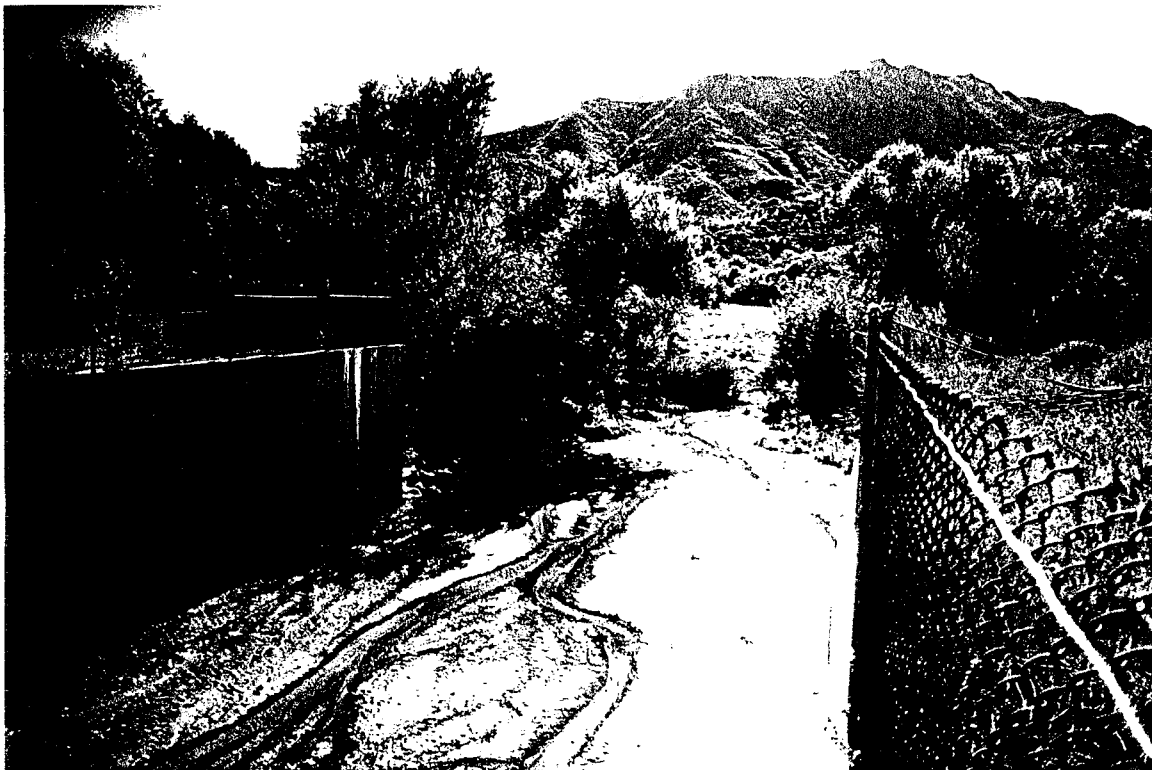
Site #37 Medea Creek/Cheseboro Creek Outlet: 614' downstream of Agoura Road to 784' downstream of Agoura Road.

The confluence of Medea Creek and Cheseboro Creek are two box channels coming into a larger box channel. Downstream of this, the creek becomes natural again, and this is the site proposed for clearing. While not directly accessible, it was easily observed to be a mature riparian habitat with at least 20 willows 4" DBH or greater, and at least 2 significant Valley Oaks. Canopy cover is estimated at 50%. This would make excellent bird breeding habitat in spring.

Selective thinning to open the stream where the flow from the box culverts enters may be necessary to avoid flooding upstream, but ultimate care should be taken to preserve as much as the habitat as necessary. Due to the mature nature of the habitat, and the significance the roots play in streambank stability, roots of the mature trees should be protected from compaction, and fenced off. Similar to Las Virgenes Creek, Michael C. Long's biological assessment applies.

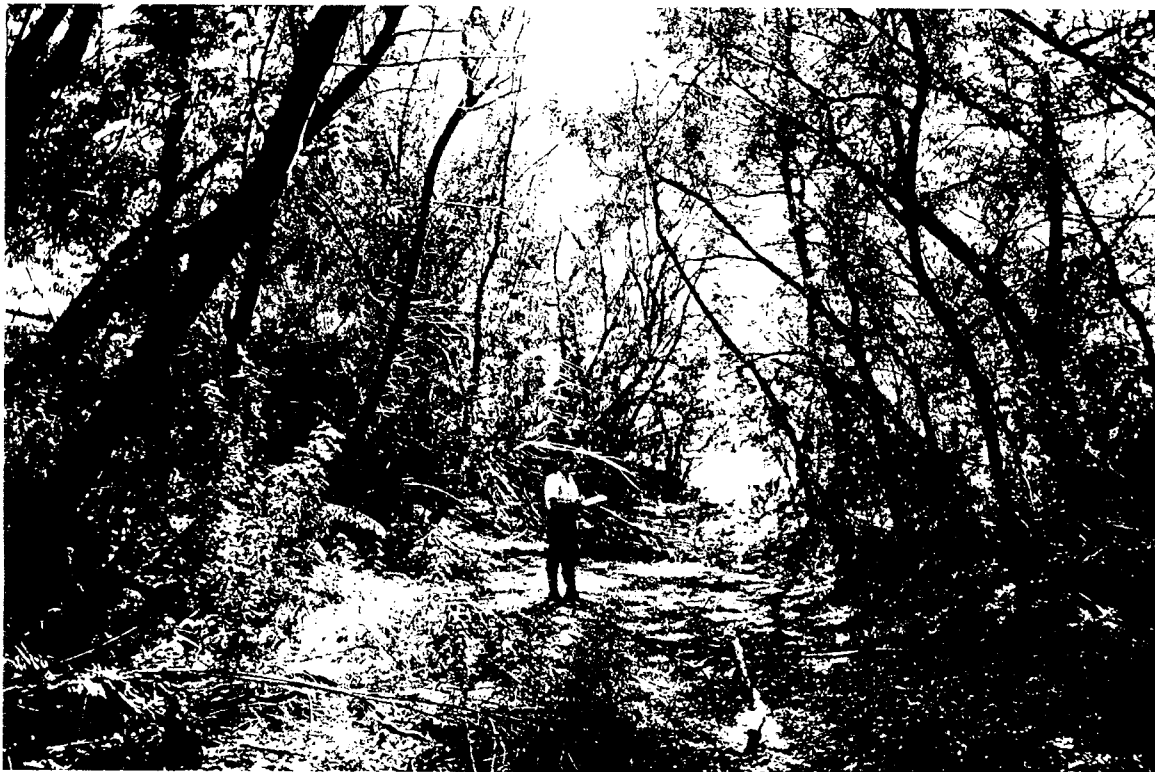
Site #36 Cheseboro Main Channel Inlet: 100' upstream of Driver Ave. to 44' upstream of Driver Ave.

The creek here is natural before it flows under Driver Ave. and into a box channel. While not as mature a habitat and not as diverse as some of the other locations listed above, the site nonetheless contains approximately 40 willows of 4" DBH or greater and small Valley Oaks were observed. It has a canopy cover of 60%. The willows perform another very important function at this site. Surrounding the creek, and further upstream are numerous equestrian facilities that contribute significant amounts of nutrients and coliform bacteria from horse manure. Water quality testing in November 1994 and January 1995 confirms this. The willows are undoubtedly performing as filter strips in both holding back the waste from entering the creek, and taking up the nitrogen once it does enter. The main part of the channel on the day we observed it was dry, and little or no vegetation was actually in the center of the channel.

We do not see the need for any clearing at this site since the main channel is open, and the area immediately surrounding the space is an equestrian park. Due to the importance of nutrient uptake, removal of the vegetation could seriously degrade the water quality at the site and downstream.

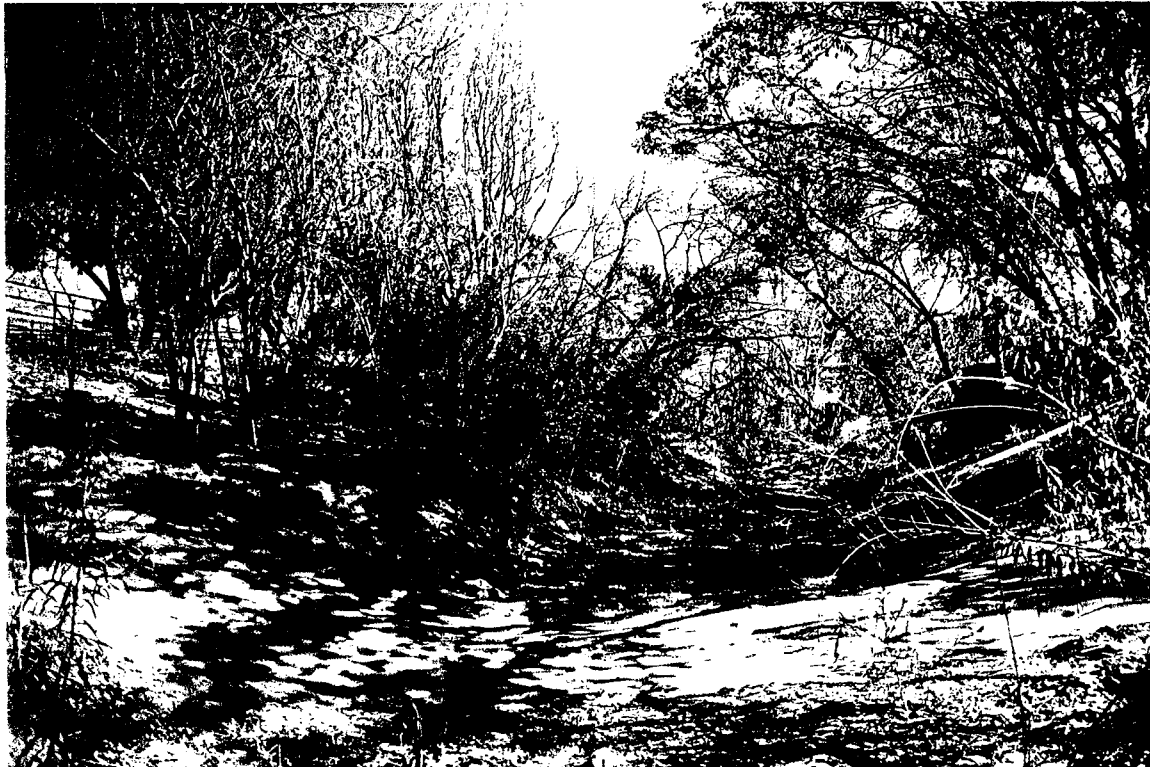
Site #32 Stokes Canyon: Intersection of Quad Sheet blue line with the eastern boundary of Section 6, Township 1S, Range 17W to 1600' upstream of the intersection of Mulholland Highway.

Arundo donax was observed only at this location. This stream has been reinforced with gabions, and many willows hold up the banks. The number of willows 4" DBH or greater is estimated at 50, and the canopy cover is approximately 20%. Much of this habitat burned in the Calabasas fire last year, and many willows were killed as a result. Nonetheless, the willow roots are still performing bank stability. Numerous coyote and rabbit tracks were observed on the day we visited. The substrate here consists of mixed cobbles, sands, and finer sediments. The creek is surrounded by larger homes, many containing equestrian facilities.

There seems to be no need for clearing at this time since the fire last year reduced so much vegetation anyway. In many places the banks appear unstable, and removing vegetation here could serve to de-stabilize the banks further, and create even more significant problems to property owners. Removal of only the *arundo* is recommended.

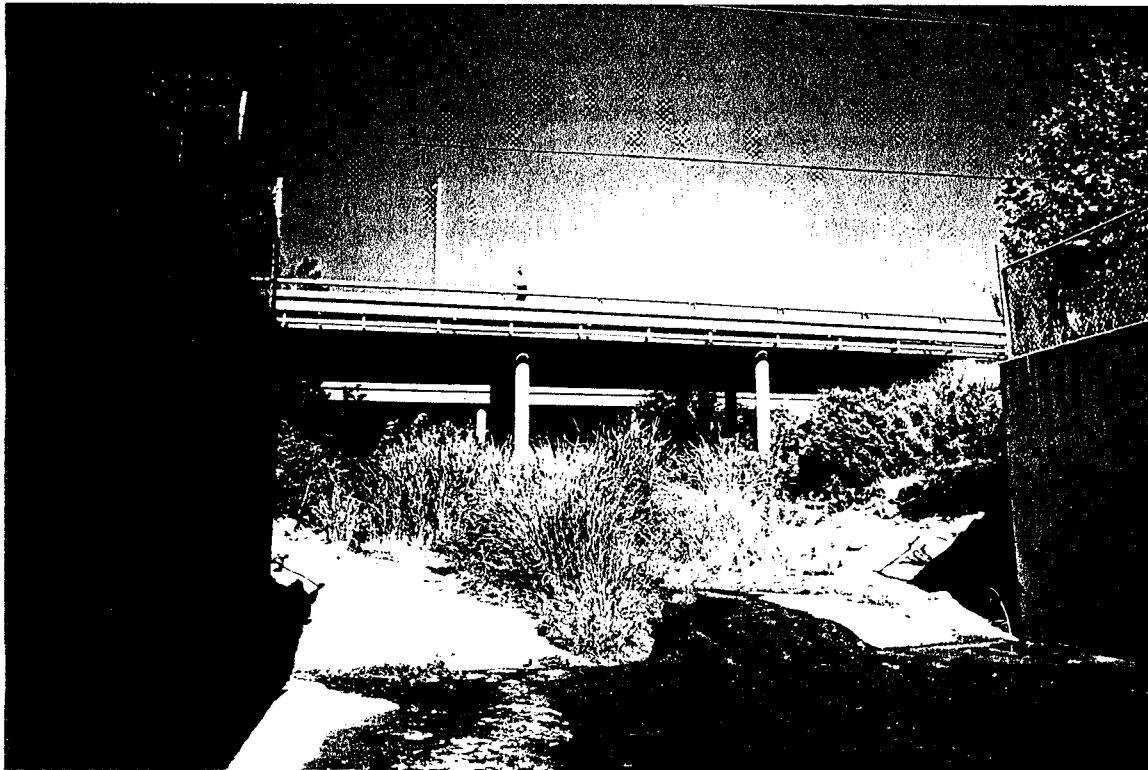
Site # 35 Medea Creek Main Channel Inlet Under 101: 98' upstream of the upstream side of Roadside Drive to 13' upstream of the upstream side of Roadside Drive.

This site runs under the 101 freeway from frontage roads on either side of the 101 freeway. Percent cover is not applicable due to the freeway. Numerous cattails and willows are in the creek. On the north side of Roadside Drive a mature riparian habitat exists (see site # 34) and there are several deep pools that could be southwestern pond turtle habitat or tree frog breeding habitat. On the far south side, there is a Valley Oak on one side and a Coast Live Oak on the other side of the crossing that are holding up the stream bank.

Mechanical clearing is acceptable if confined to under the freeway. At the frontage roads, trees are performing bank stability and their roots should be protected from compaction and fenced off for protection during clearing activities. Due to the deep pools and mature habitat, we do not recommend clearing upstream of the upstream side of Roadside Drive.

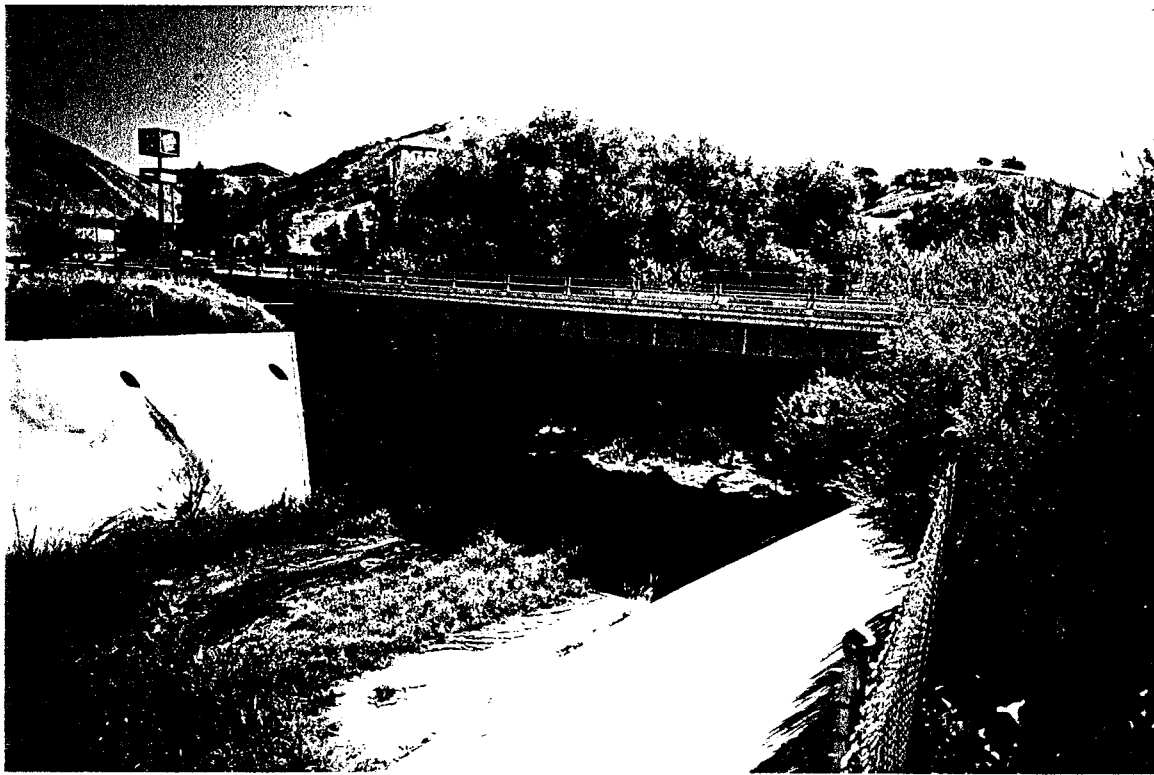
Site #30 Las Virgenes Creek under Agoura Road

A trapezoidal channel is upstream of Agoura Road; under the road the channel contains rip-rap. The channel is then natural, with a canopy of approximately 60%. Under the road however, no trees are performing bank stability, and there is very little habitat of any value. Cattails and watercress are in the stream.

This site could be mechanically cleared with very little impact, as long as the clearing is confined to only under the road. Once past the road however, it significantly changes and is part of Michael C. Long's biological assessment study area (see appendix A).

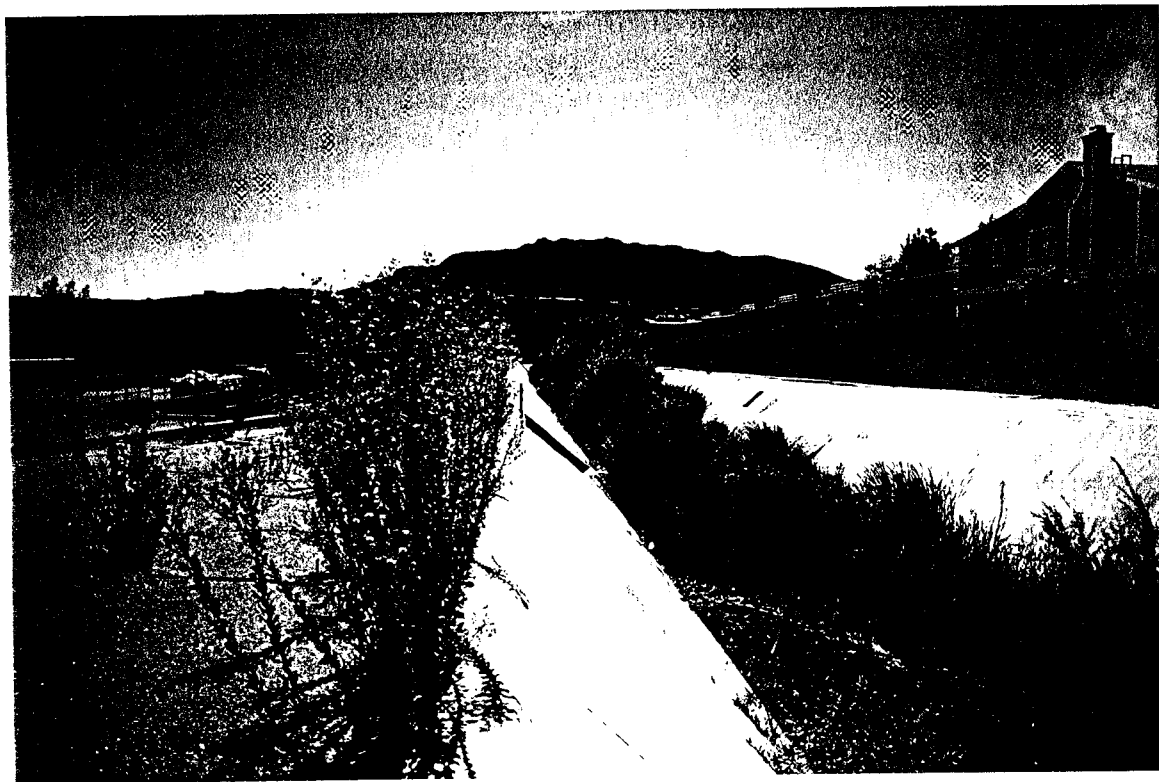
Site #33 Medea Creek: 731' upstream of Thousand Oaks Blvd. to 215' upstream of Thousand Oaks Blvd.

Bounded by concrete walls on both sides, vegetation only occurs in the bottom of the channel. On the upstream half of the area, there is no canopy, on the bottom half, canopy is estimated at 20% with approximately 6 willows 4" DBH or greater. Most of the vegetation consists of cattails. The substrate consists of fine sediments. Many non-native mosquitofish were observed in the stream. This site is the one pictured in the L.A. Times article on channel clearing. Habitat value here is low.

Mechanical clearing would have very little impact on habitat since it is already so depauperate in biodiversity. Development bounds both sides of the channel, increasing the need for flood protection.
