1 **Malibu Creek Ecosystem Restoration Study**
2
3 **Los Angeles and Ventura Counties, California**

4
5 **Appendix D**

6
7 **Geotechnical Engineering**
8

9
10
11
12 **U.S. Army Corps of Engineers**
13 **Los Angeles District**
14

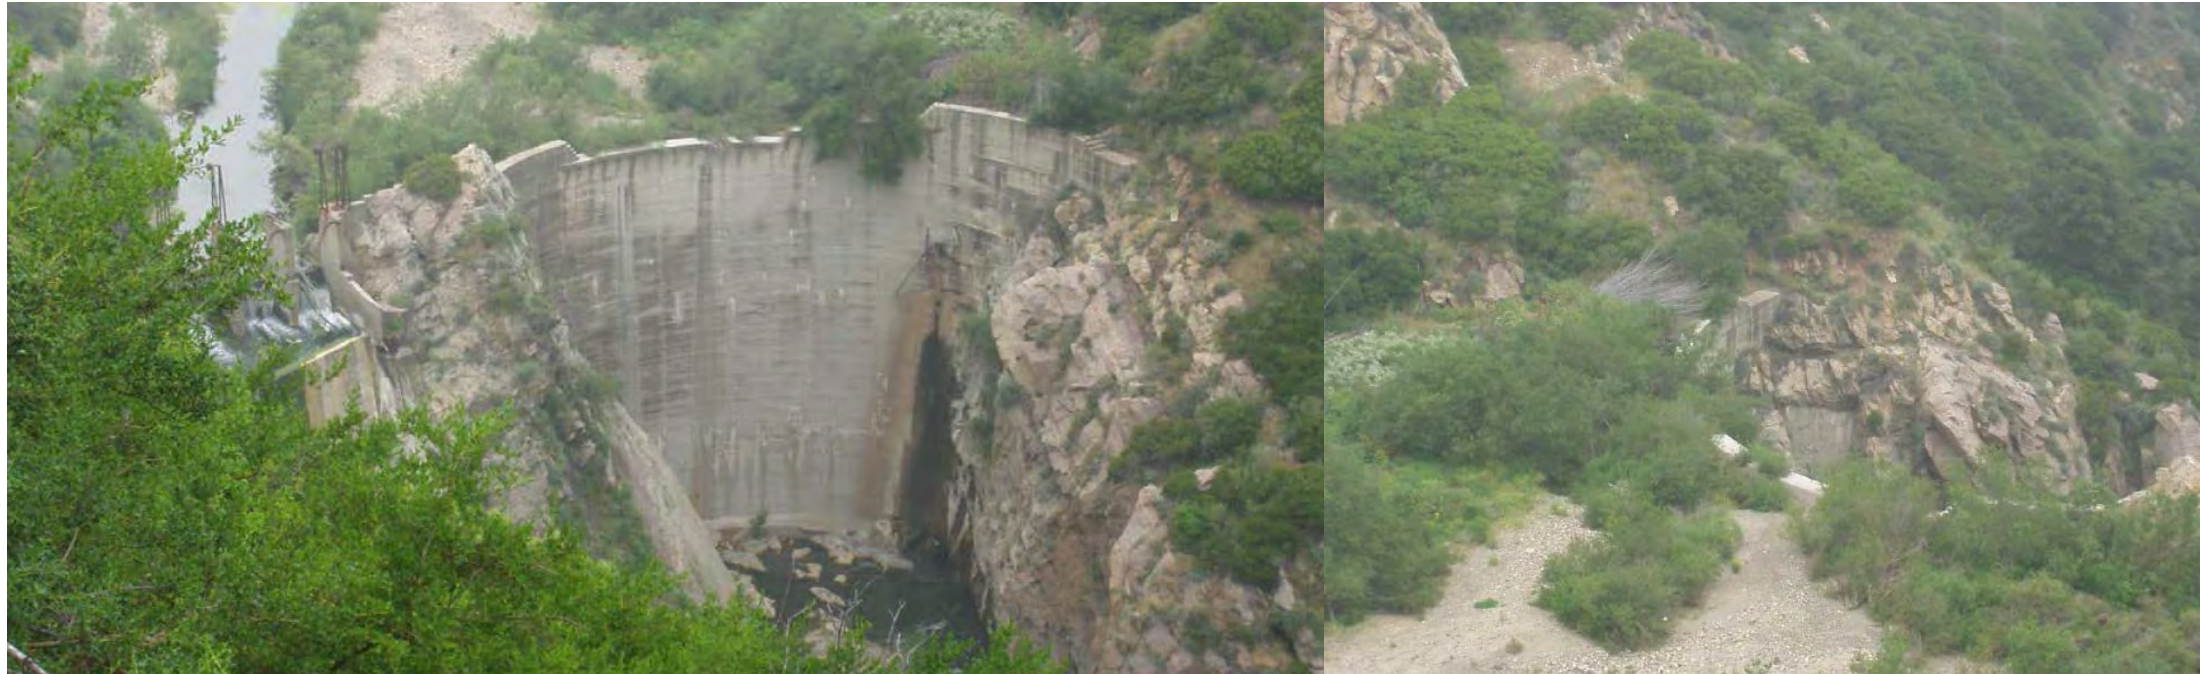
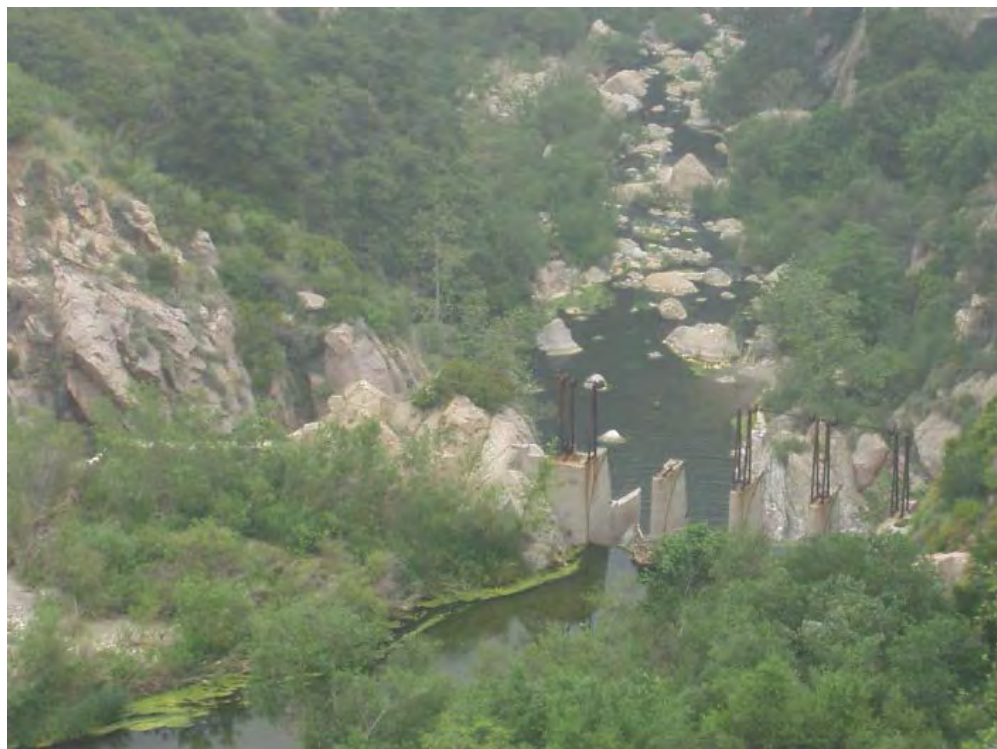
Clockwise from left: View of the downstream face of the dam, left and right abutments, and spillway. View of the upstream face and crest of the dam. Sediment has deposited on the upstream face almost to the top. View of the upstream side of the spillway.

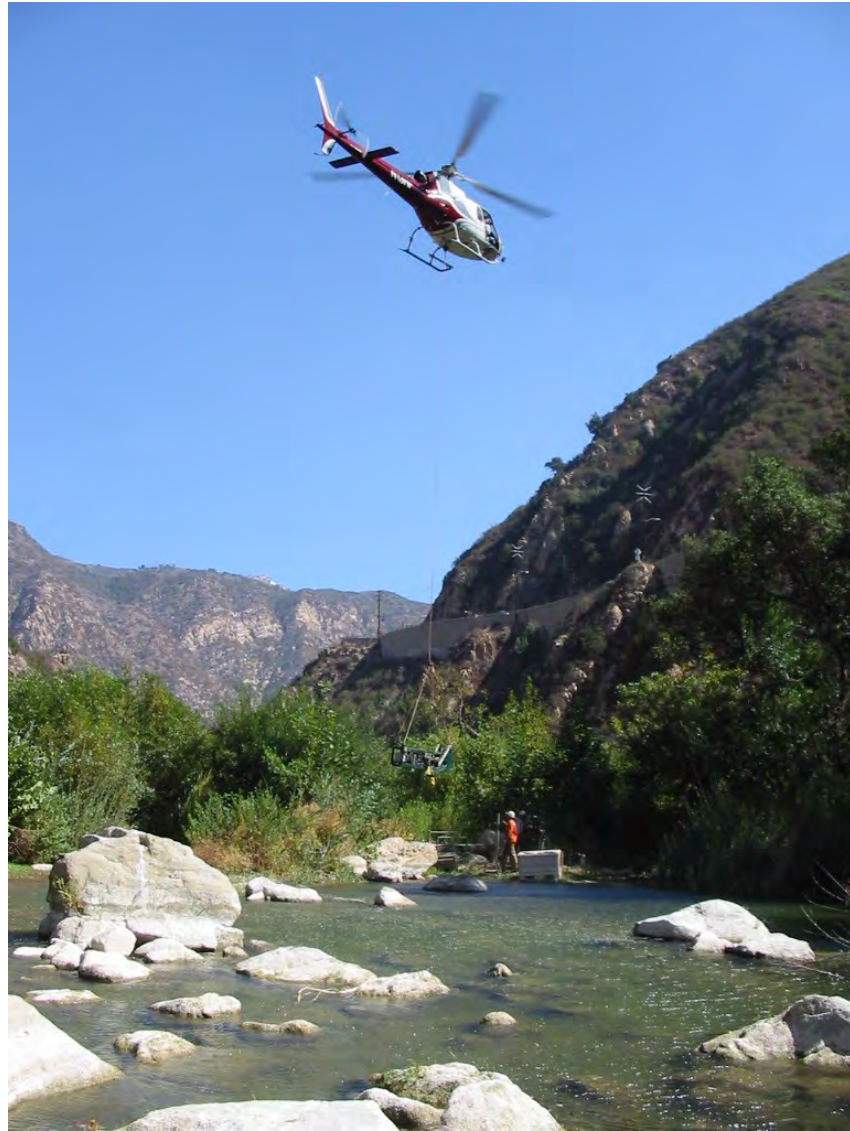
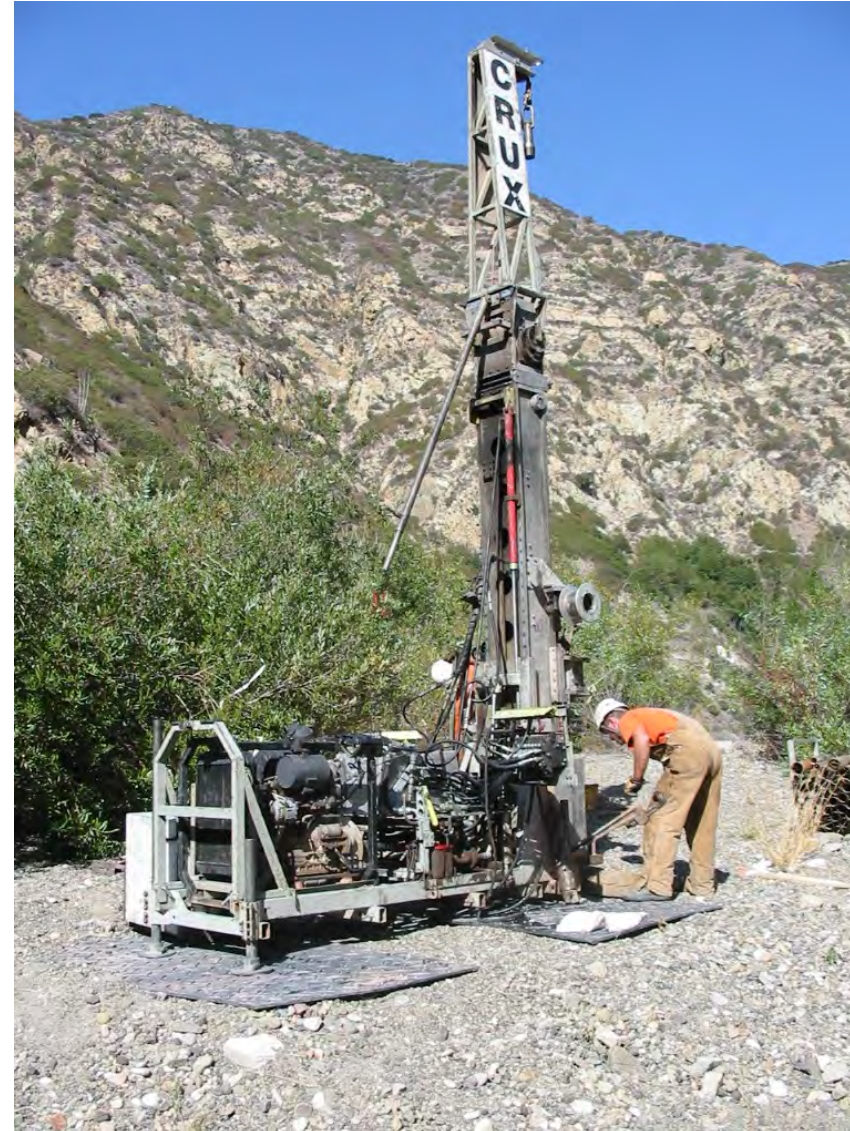
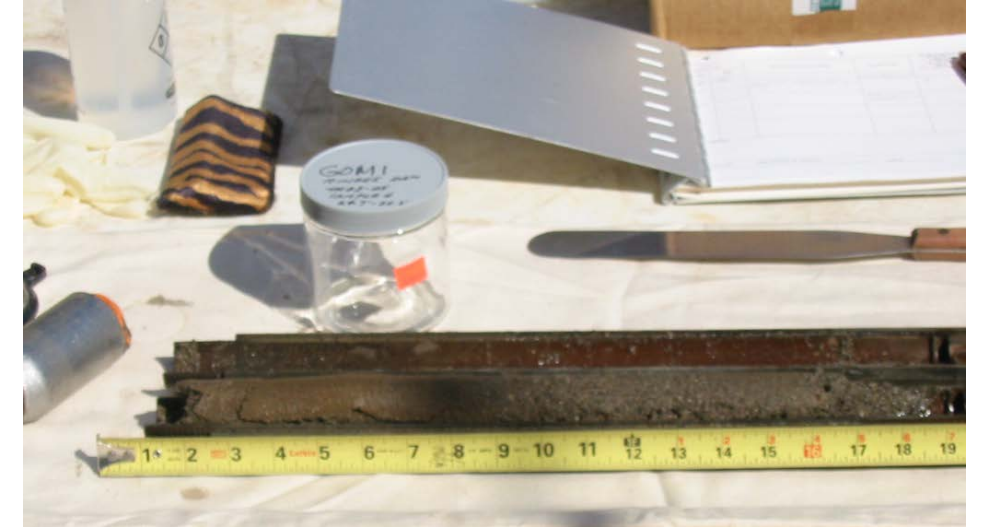
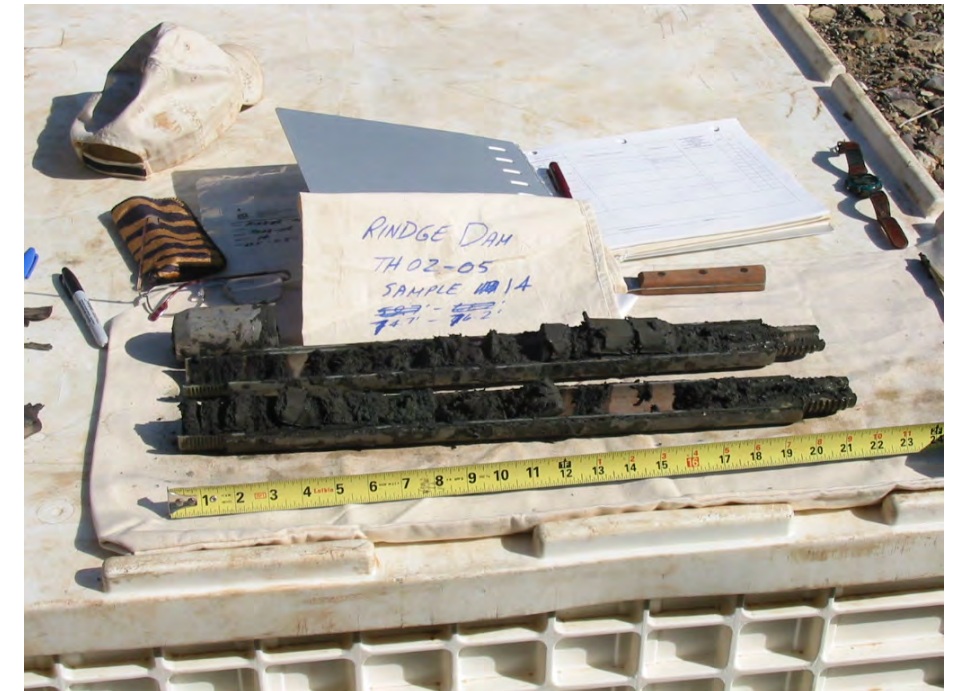
USACE subsurface exploration program.

- Structural field study of Rindge Dam including in-situ testing of the concrete through use of the Schmidt hammer.
- Excavation of eight borings.
- Evaluation of groundwater conditions.

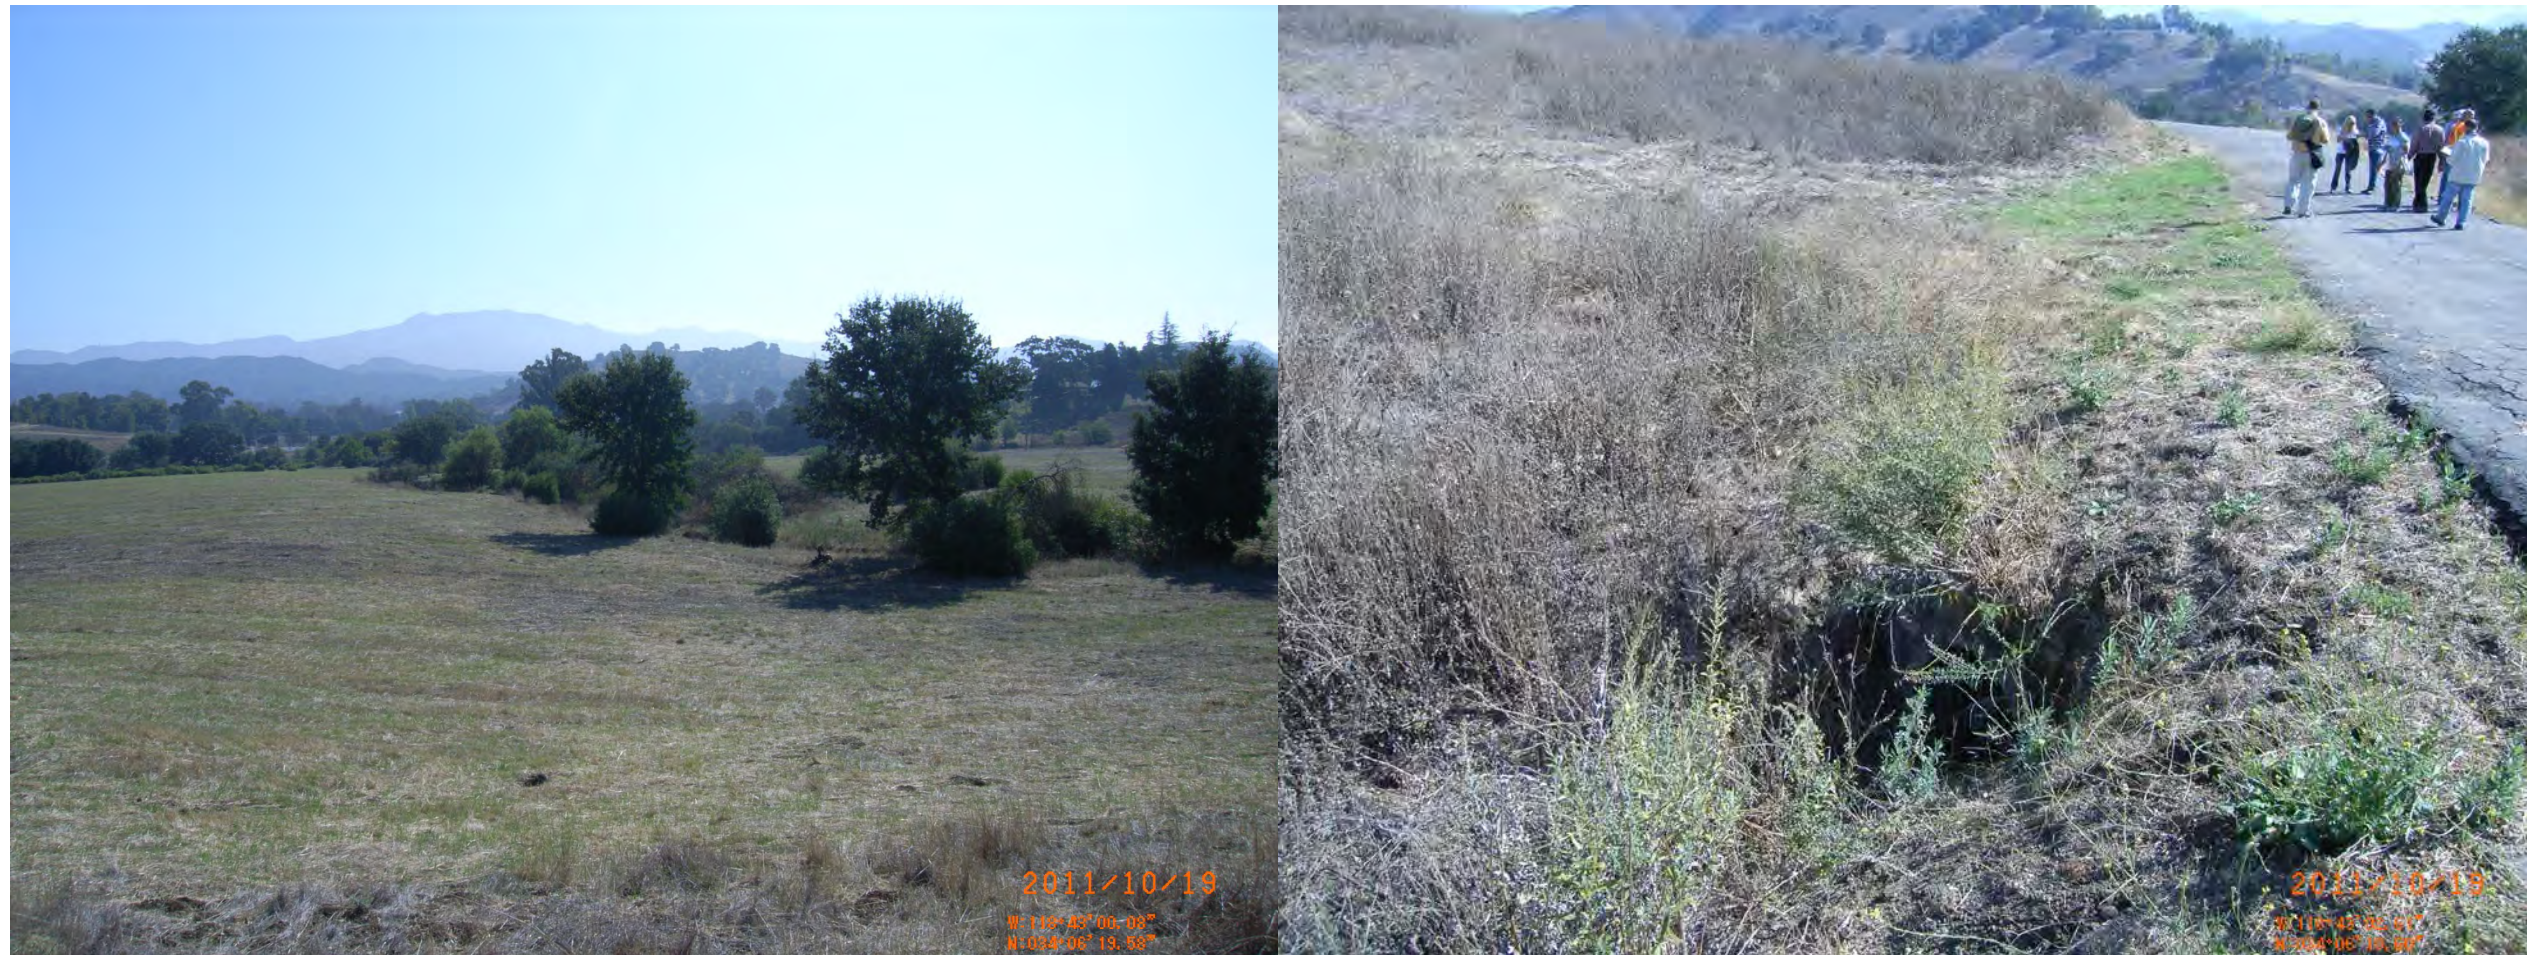
Proposed storage Site F.

In particular, a geotechnical assessment of the foundation of Site F must be undertaken prior to its use for this purpose, as it is the only such site that appears likely to be carried forward as an alternative. The assessment must consist of the site foundation being drilled, logged, and sampled to verify subsurface and soils properties conditions prior to the onset of construction, something beyond the budgets available for this feasibility study. Site F is the only site currently under consideration as a temporary storage site. No permanent, in-canyon, upland disposal sites are under consideration, currently, other than a commercial landfill, which will not require additional study.
