Malibu Creek Ecosystem Restoration Study
Los Angeles and Ventura Counties, California
Appendix J
Habitat Evaluation

U.S. Army Corps of Engineers
Los Angeles District

January 2017

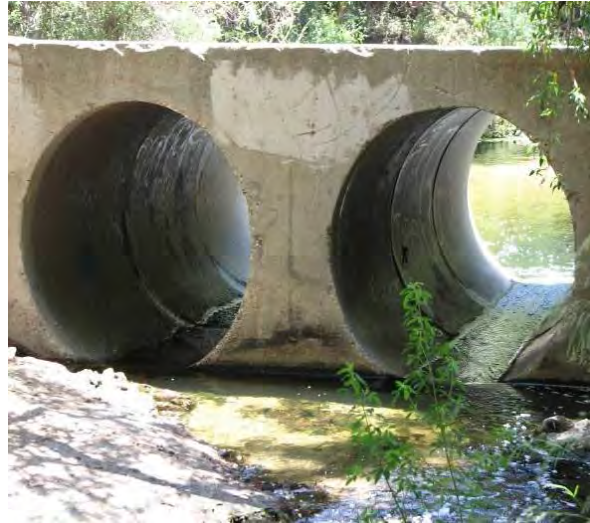
**BARRIER- LV1
Craggs Road Culvert Crossing**

Stream: Las Virgenes Creek
 Severity: Passable at high flows
 Type: Dam
 Number of downstream barriers: 4
 Downstream habitat quality (wPHQ): Good
 Upstream habitat quality (wPHQ): Excellent
 Description: 6 ft high, 87 ft wide, 6 ft long diversion dam with notch
 Material: Concrete
 Land ownership: Public (Malibu Creek State Park)
 Lat./Long – NAD '27:
 34.11211457530 / -118.71128380300

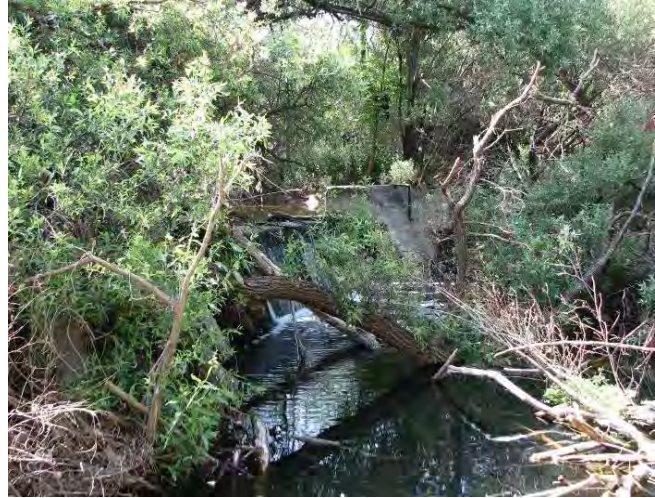
**BARRIER – LV2
White Oak Farm Dam**

Stream: Las Virgenes Creek
 Severity: Passable at high flows
 Type: Dam
 Number of downstream barriers: 4
 Downstream habitat quality (wPHQ): Good
 Upstream habitat quality (wPHQ): Excellent
 Description: 6 ft high, 87 ft wide, 6 ft long diversion dam with notch
 Material: Concrete
 Land ownership: Public (Malibu Creek State Park)
 Lat./Long – NAD '27:
 34.11211457530 / -118.71128380300

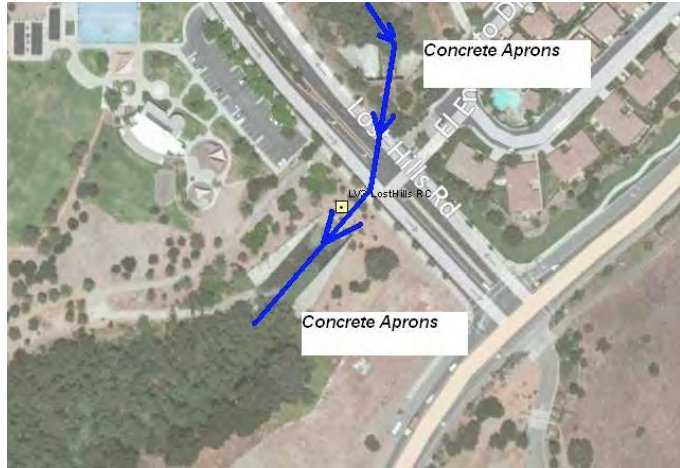
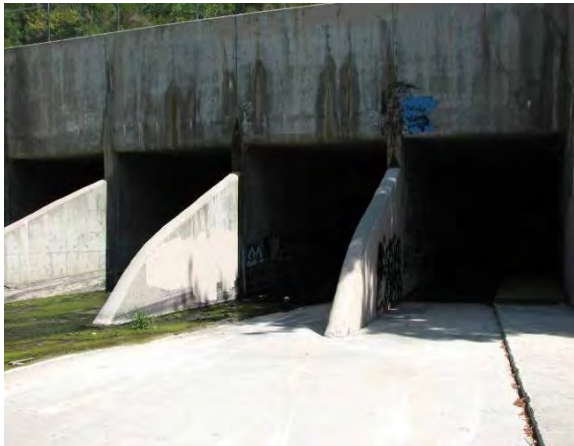
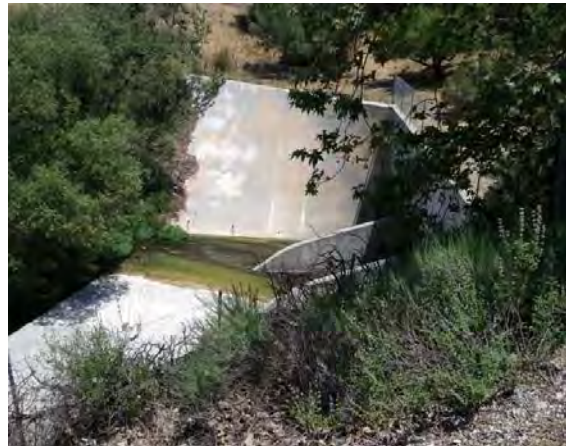
25 **Upstream culvert entrance looking towards**
26 **Lost Hills Rd**

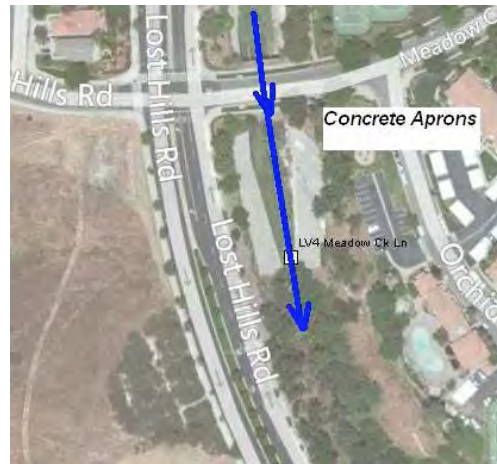
Entrance/intake upstream
