Malibu Lagoon Restoration and Enhancement Project

Comprehensive Monitoring Report (Year 5)

July 2018

Prepared by: The Bay Foundation (TBF)

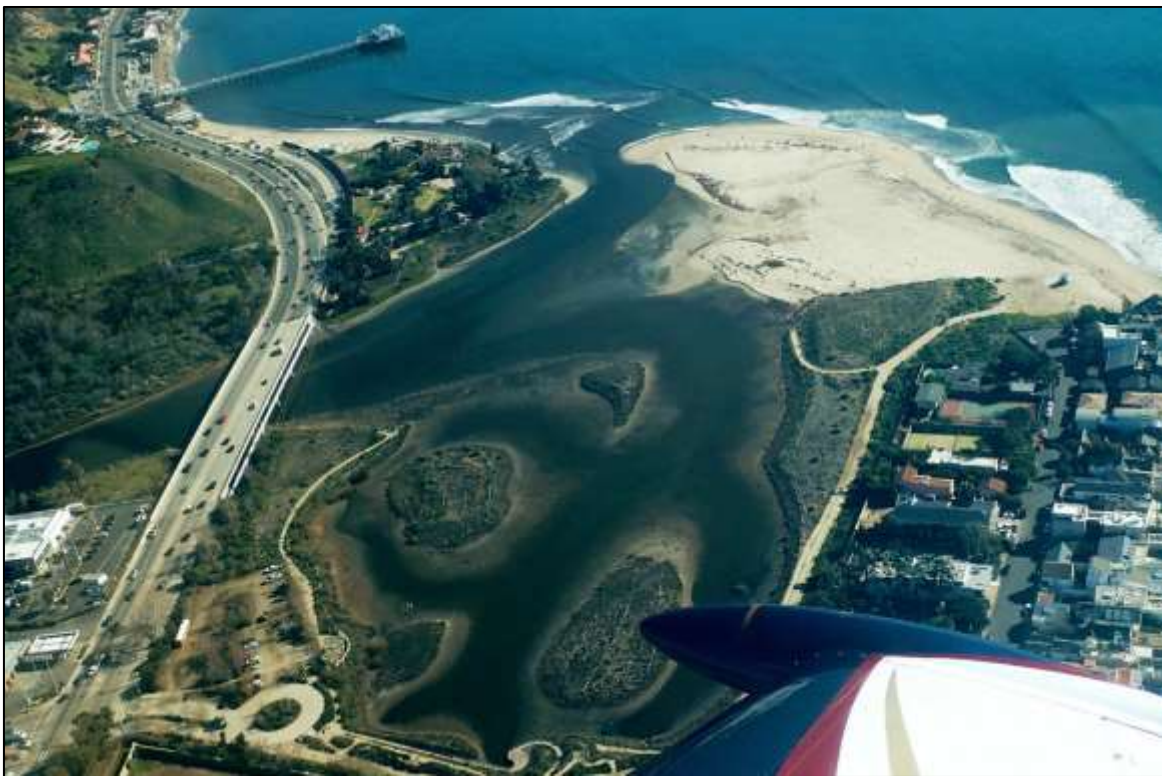
Figure 1. Aerial view of Malibu Lagoon from Lighthawk flight in January 2017 with an open berm condition (credit: P. House, The Bay Foundation).

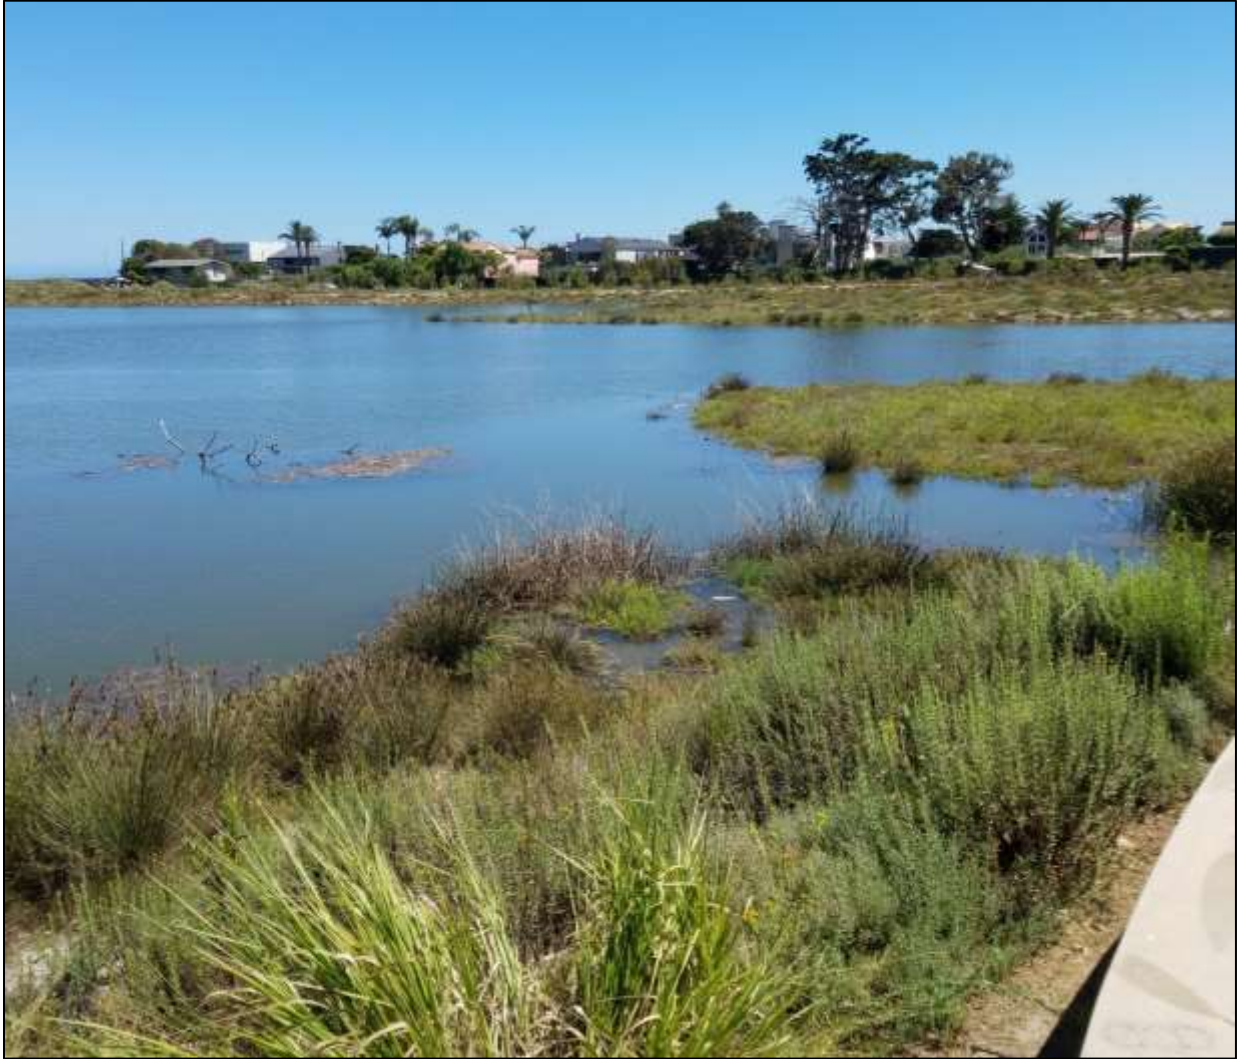
Figure 3. Landscape photo of a portion of the CRAM AA at Malibu on the most recent survey, 26 June 2017.

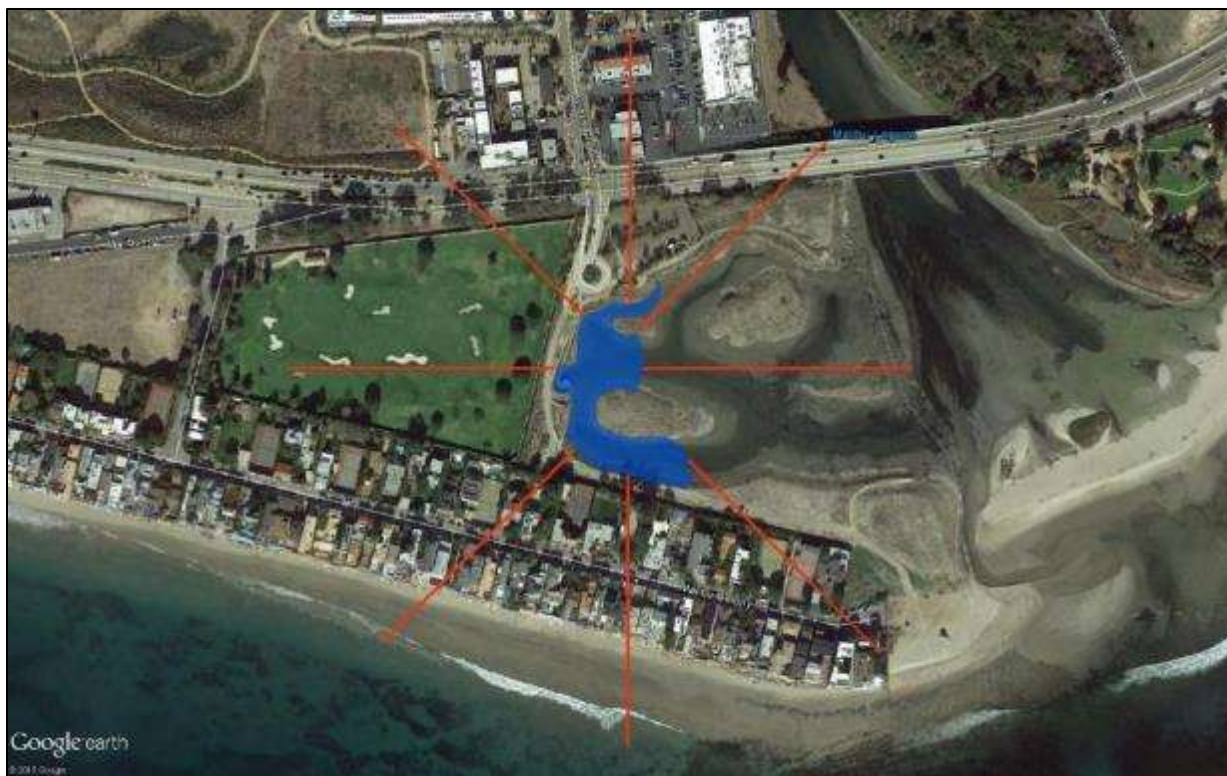
Figure 4. Post-restoration CRAM Assessment Area (blue polygon) at Malibu Lagoon. Red lines indicate radiating (potential) buffer lines.

Figure 4 displays the Assessment Area (AA) and buffer lines for the post-restoration CRAM survey. The AA is approximately one hectare, or two and a half acres of wetland habitats, following guidelines described in the User Manual. The AA location is approximately the same as the pre-restoration survey.

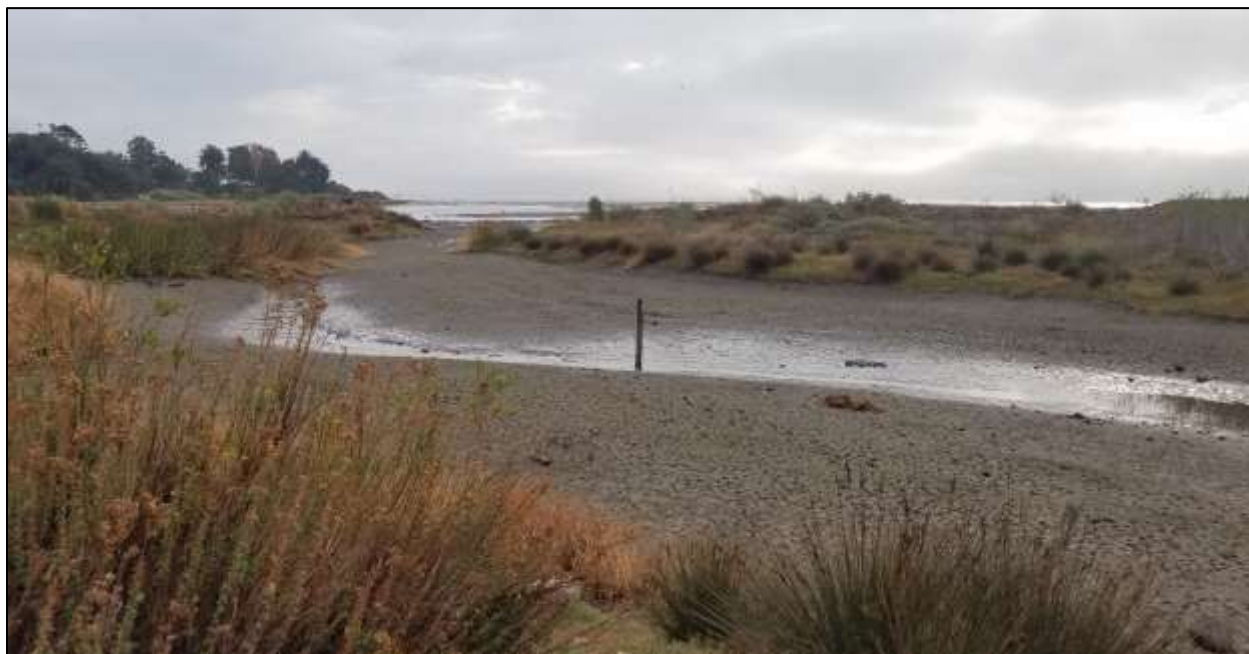
Figure 6. Cross-channel elevation survey location at Malibu Lagoon, 6 January 2017.

Five permanent and repeatable cross-section locations were monitored for five consecutive post-restoration years. Surveys were conducted on 14 February 2013, 18 December 2014, 19 January 2016, 21 and 27 December 2016, 20 February 2018, and 9 May 2018 (Figures 6 and 7). Two survey days, 20 February 2018 and 9 May 2018 were needed in Year 5 to complete the monitoring. Horizontal and vertical locations of cross-section end-points were fixed by permanent monuments; however, in Year 5, field technicians were unable to locate a few monuments which were accidentally removed along with irrigation pipes. Missing monuments were referenced in the field using recorded GPS locations and the monuments were replaced; however, slight variances in Year 5 surveys may be due to small-scale variability in the transect location. Sediment scour or deposition depths were calculated from the data based on area approximated using a Riemann sums method and compared across survey dates.

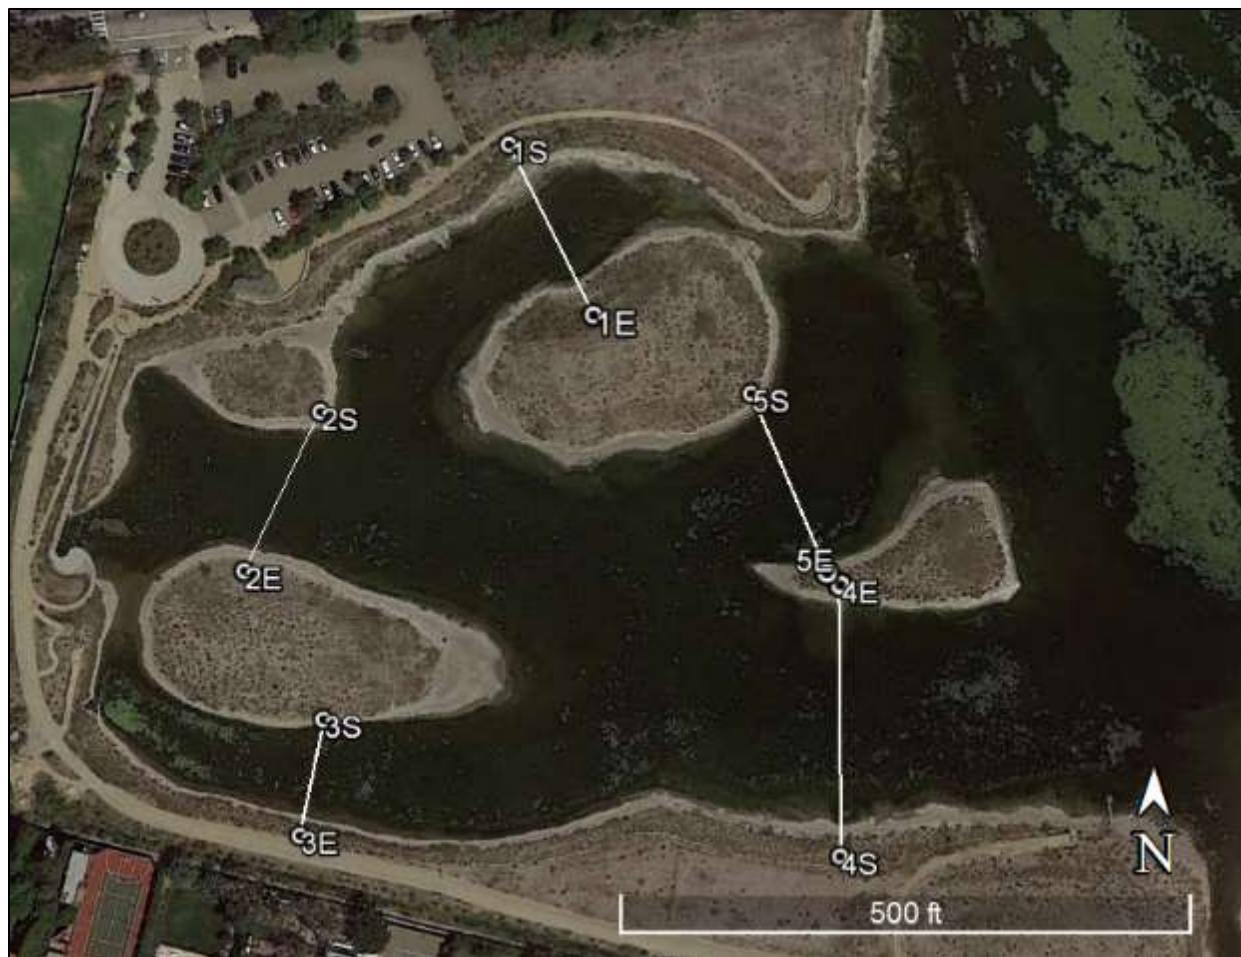
Figure 7. Map of cross-channel elevation transect locations.

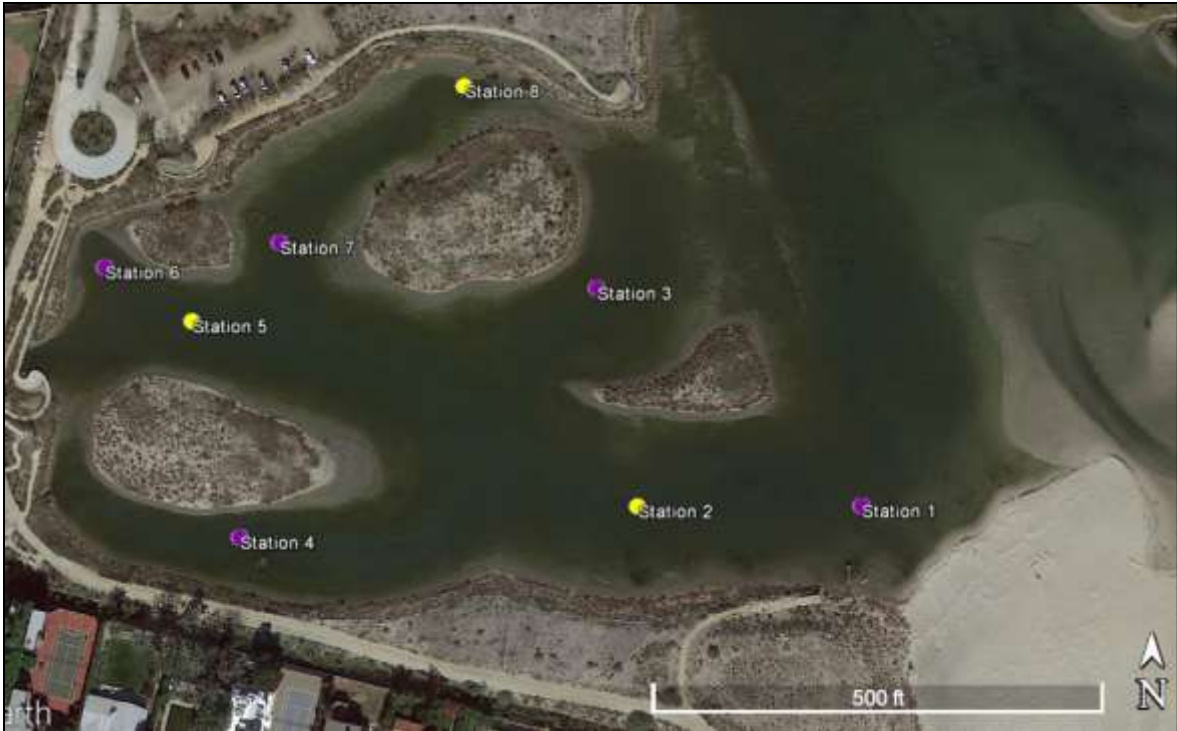
Figure 14. Map of post-restoration vertical profile, SAV/algae, surface and bottom water nutrient, and sediment survey stations. Stations 2, 5, and 8 are the locations of the three permanently-deployed Hydrolab data sondes (in yellow).

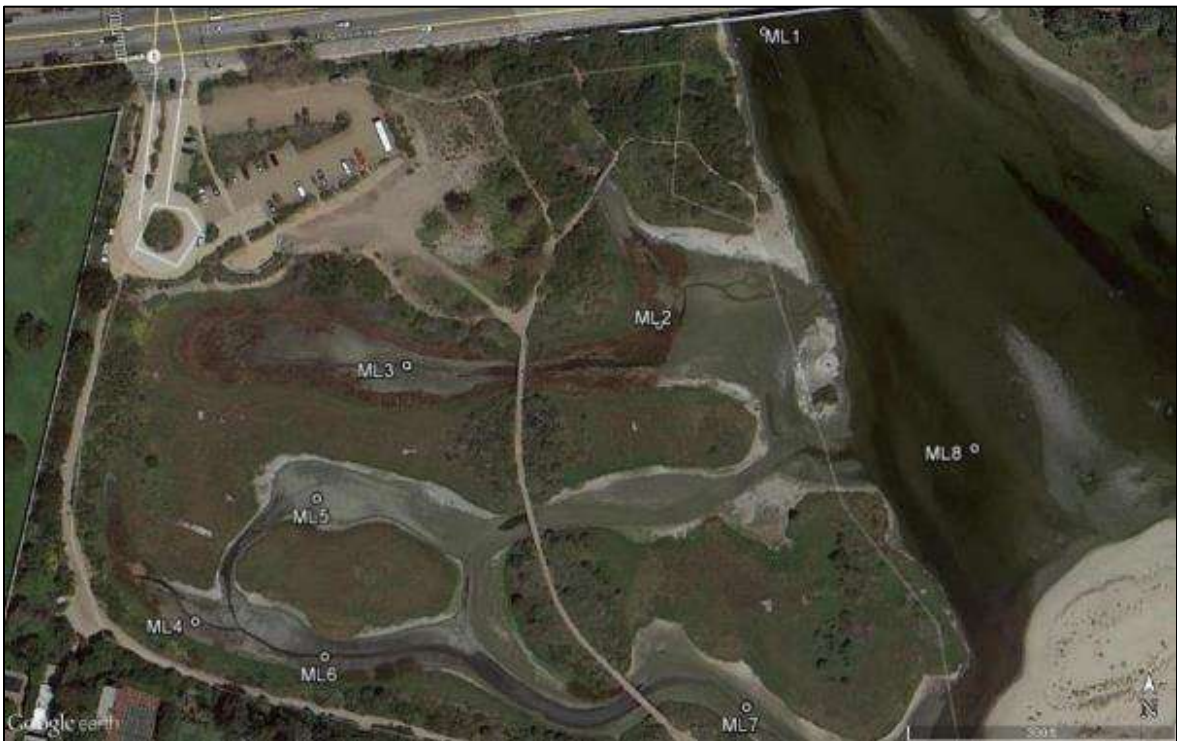
Figure 15. Map of pre-restoration water quality monitoring stations. ML2 and ML6 are the locations of the pre-restoration permanently-deployed YSI data sondes.

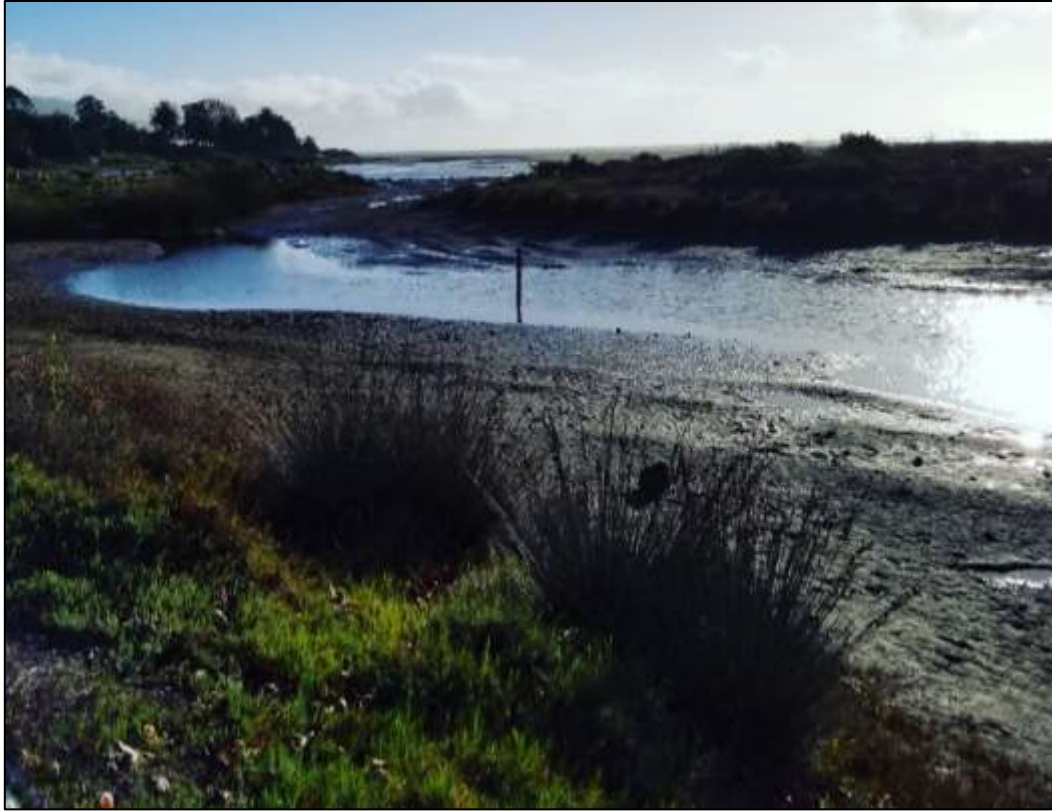
Figure 16. In-field sonde calibration following breach event; 19 December 2017.

Lastly, sonde probe failure and equipment malfunctions, primarily unexplained early shut-offs of the Hydrolab sondes, led to periods of missing data during the cooler closed bar conditions. To address problems with probe failure and equipment malfunctions, data continue to be QAQC'ed monthly to analyze issues as soon as possible and more frequent checks of sonde status in the field have been conducted. Additionally, failed sondes with unidentified problems were returned to the manufacturer and replaced. There are no comparative pre-restoration data to the back channel station due to the inability to install sonde equipment given the sedimentation, anoxia, and "muck" conditions that dominated the pre-restoration back channels.

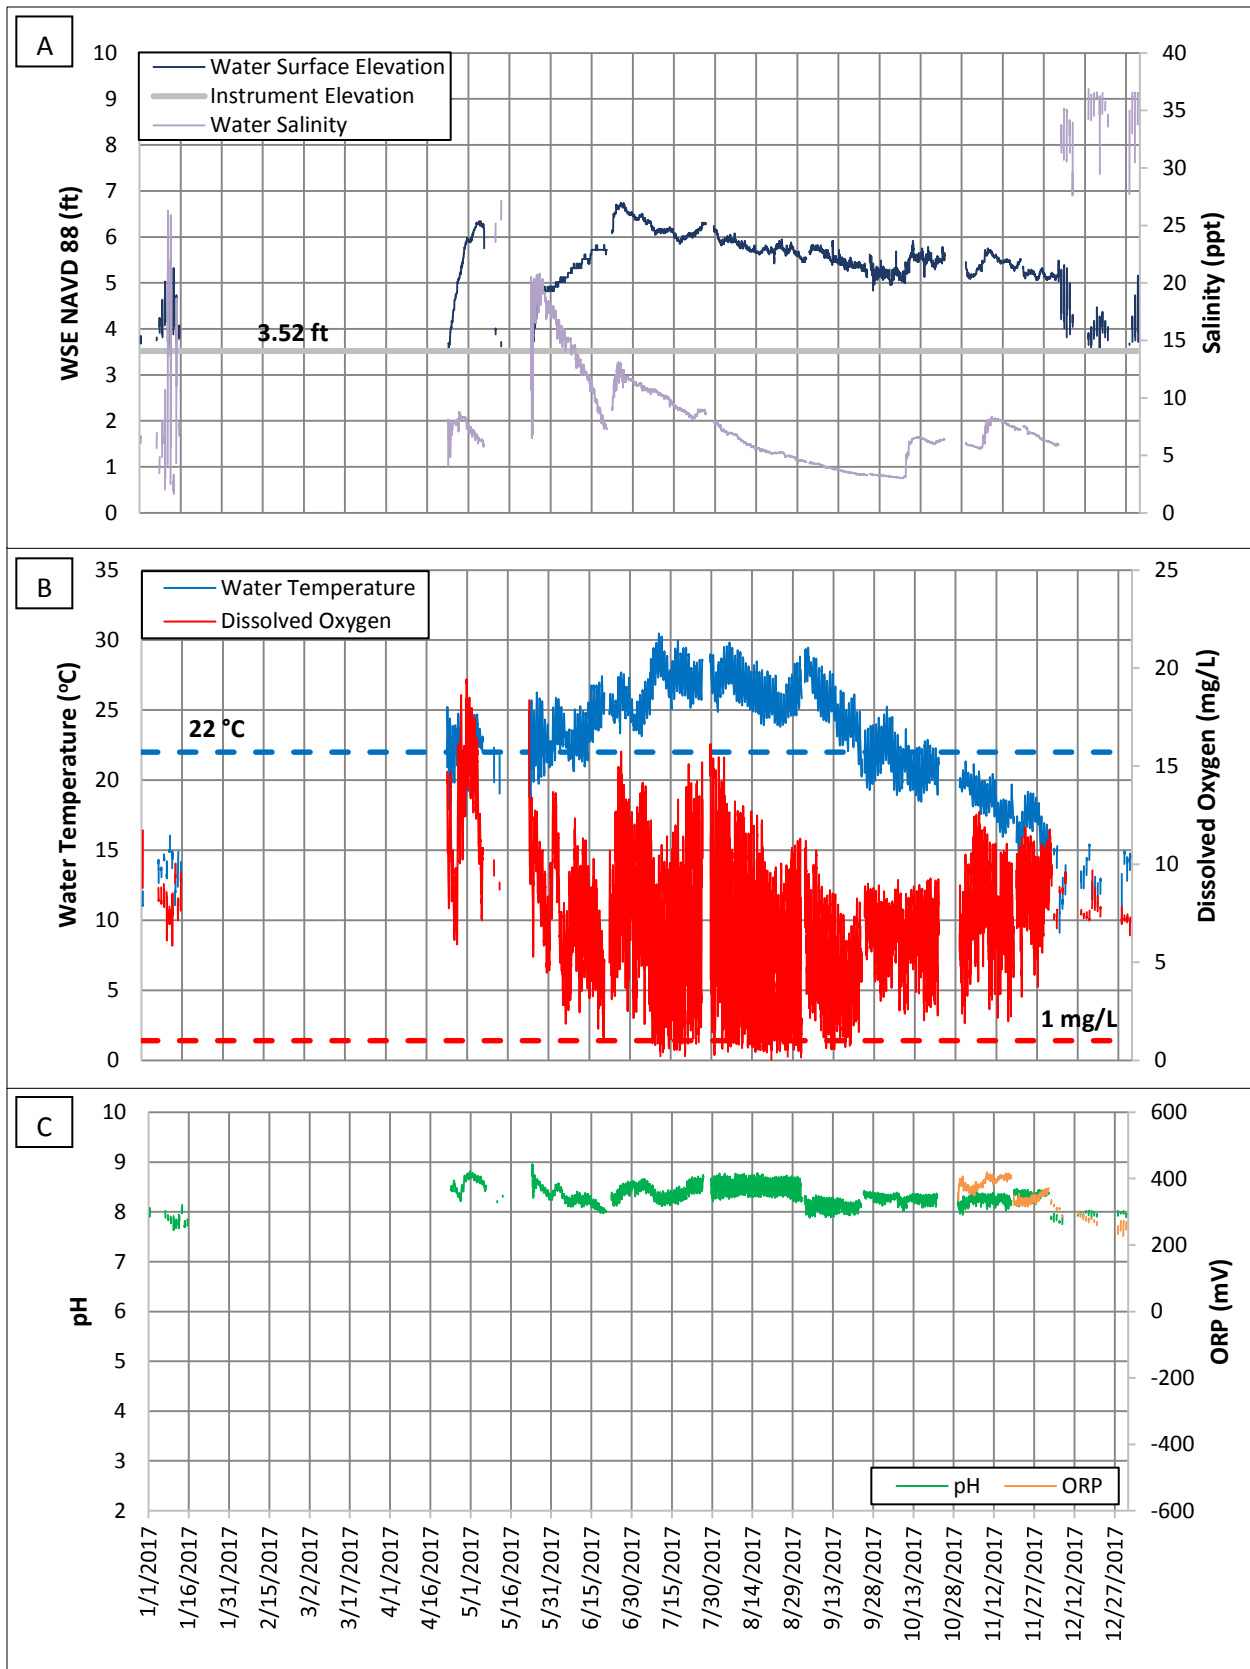
Figure 17. Graphs illustrating continuous water quality parameters from Station 8 (2017).

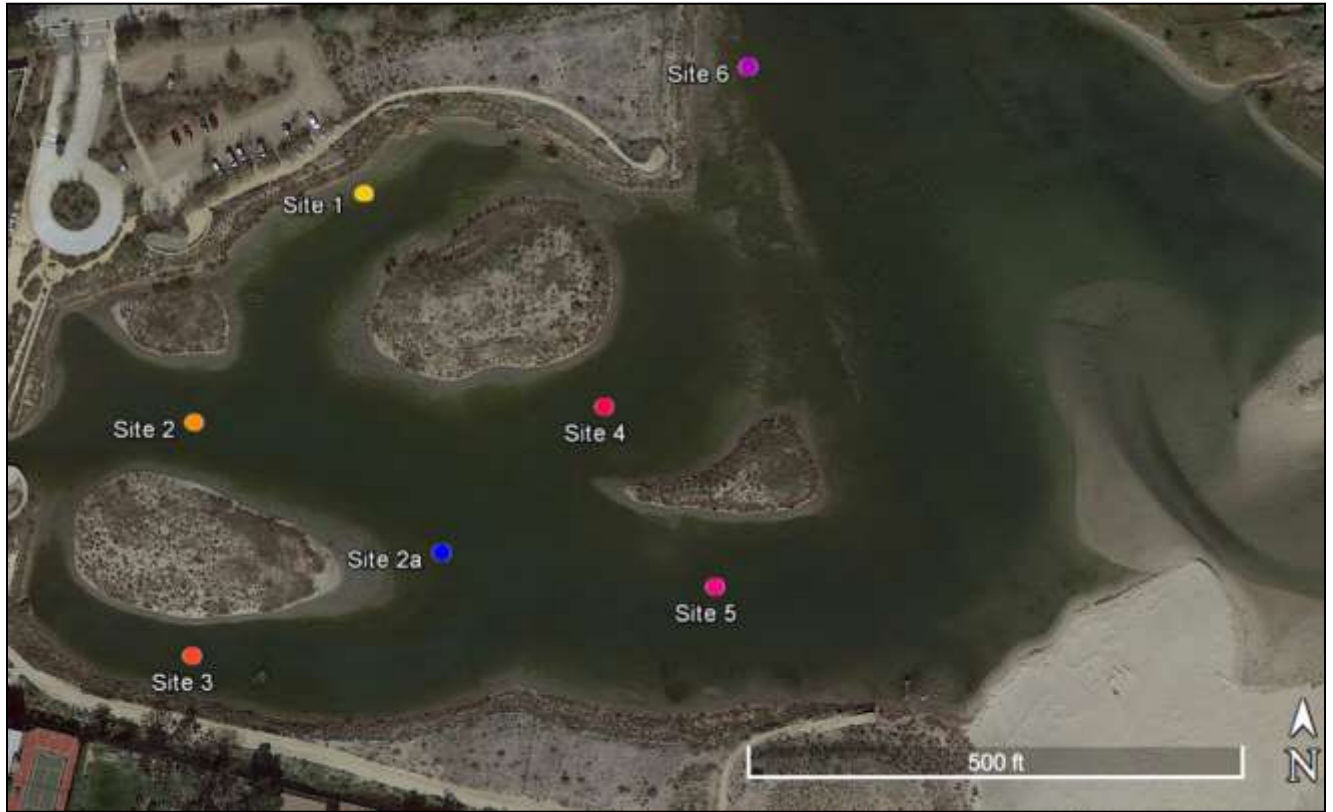
Figure 29. Map of the six permanent fish monitoring Sites.

Site 4 continued to be inaccessible; therefore, Site 2a was surveyed again for Year 5 surveys (similarly to previous surveys) to comply with monitoring plan requirements. The lagoon (berm) was closed to the ocean for the July 2017 survey, but it was open for the January 2018 survey.

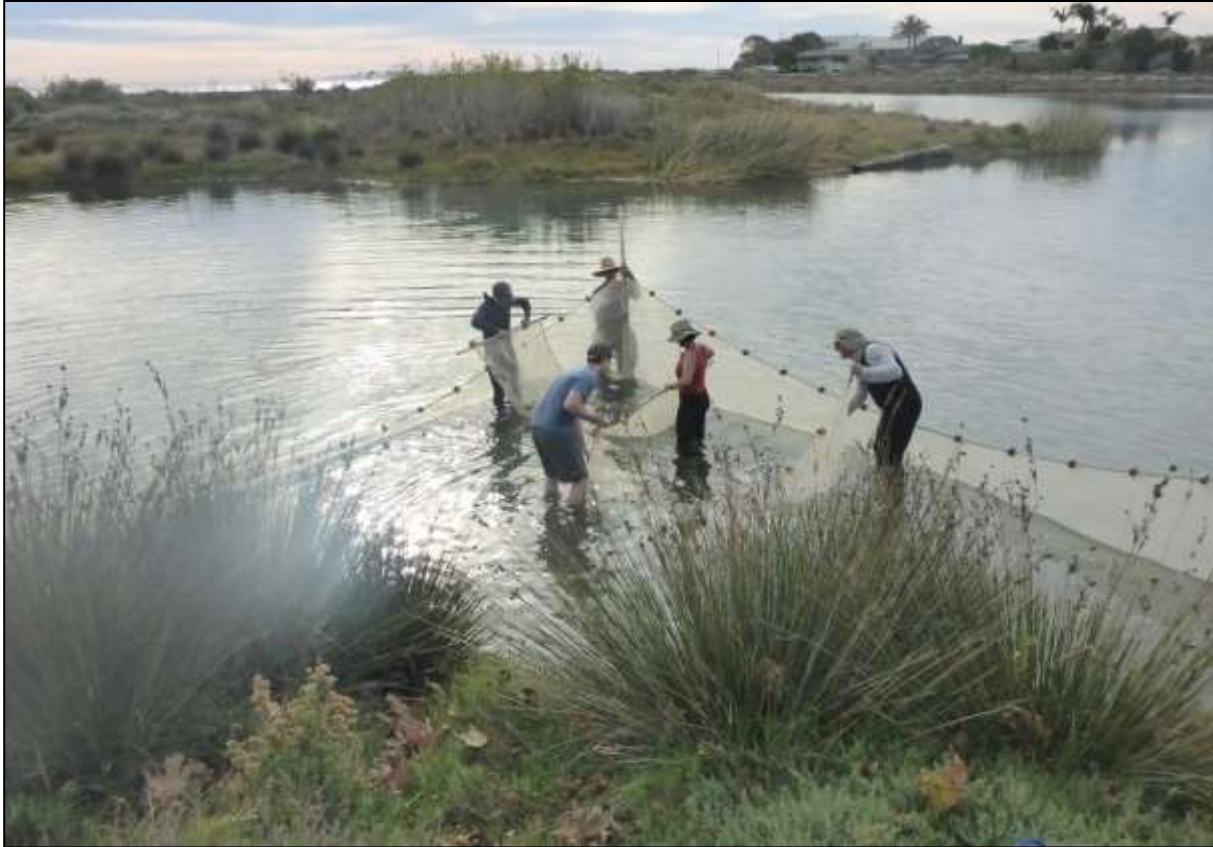
Figure 30. Representative photograph of fish surveys being conducted at Site 1 on 30 January 2018 (credit: RCDSMM).

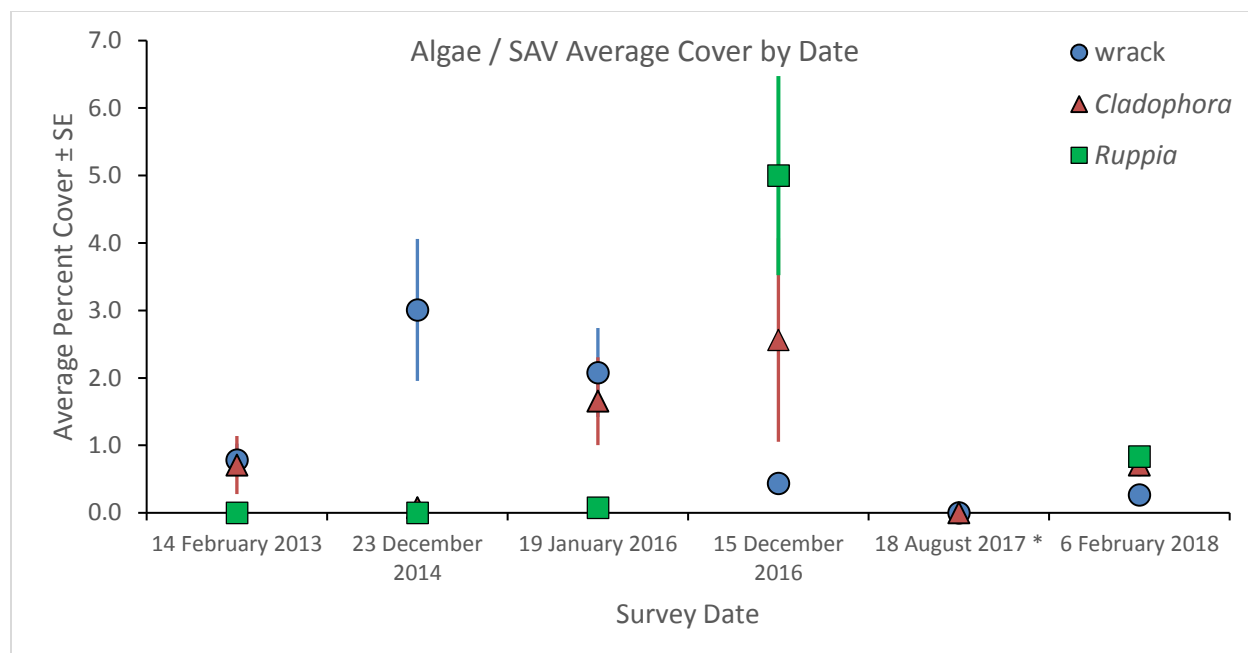
Figure 34. Graph indicating average algae and SAV cover (\pm SE) by survey date and category of algae/SAV. Asterisk indicates *Ruppia* data excluded as an outlier from the graph; see *Ruppia* totals in Table 19.

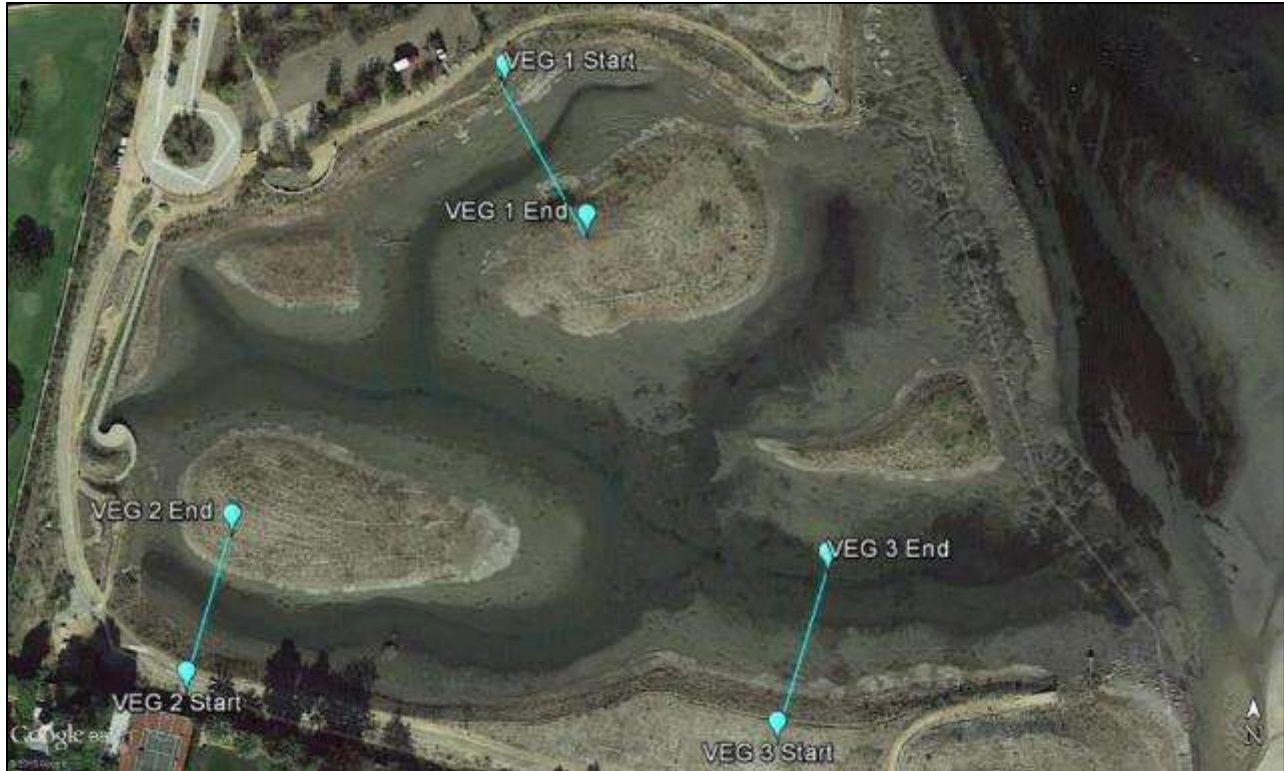
Figure 35. Map of vegetation transect locations and start/end points.

Data for absolute percent cover of native/nonnative vegetation species were collected along three, 50-meter transects (Figure 35) using the line-intercept method on 15 March 2013, 7 May 2014, 18 December 2014, 5 May 2015, 22 December 2015, 20 May 2016, 21 December 2016, 27 June 2017 (Year 5), and 17 April 2018 (Year 5). These data were combined to provide a comprehensive set of post-restoration vegetation surveys to evaluate native and non-native relative vegetation cover over time. At least one more vegetation cover assessment will be conducted.

Each transect location was recorded with a submeter global positioning system (GPS) unit and photographed at each end. Absolute cover data were calculated based on the total distance for each species within each transect. Species data were collected to an accuracy of 0.01 m along each 50-meter transect. Species were categorized into native or non-native and added together. Cover data were relative, as non-vegetated mudflat and channel habitats were removed from the total transect length. Data were displayed as a bar graph showing percent cover for each transect.

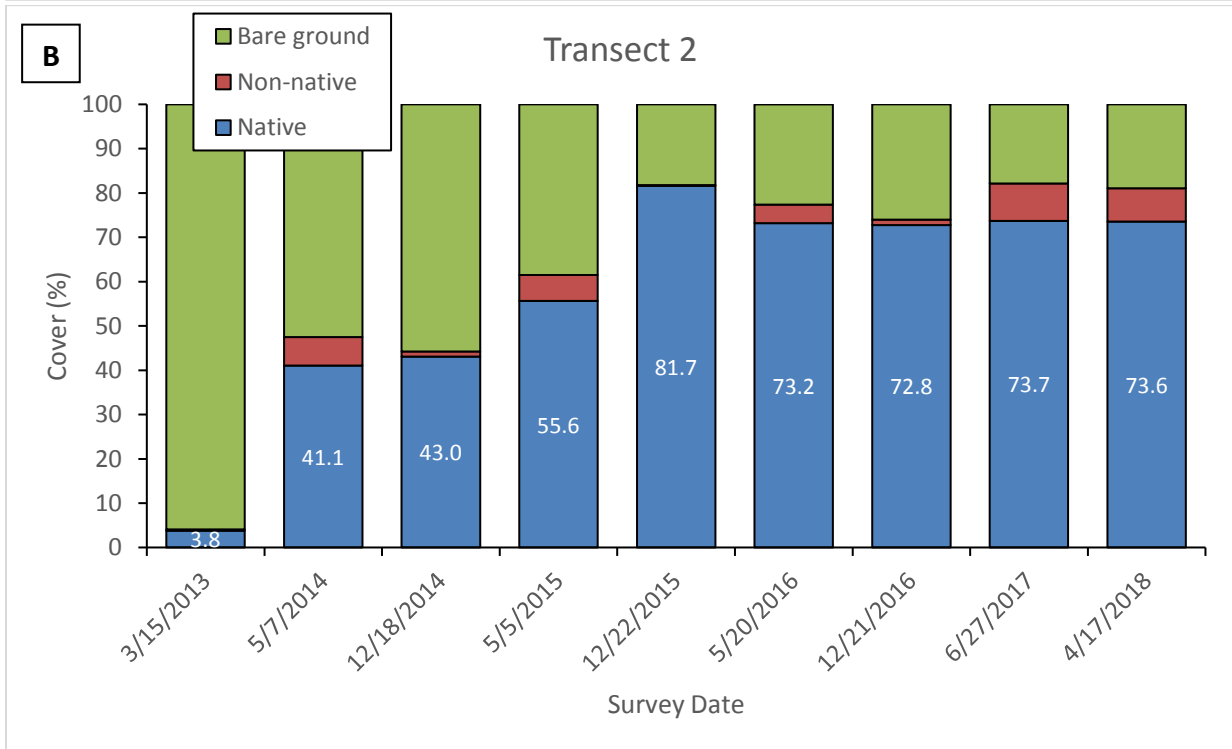
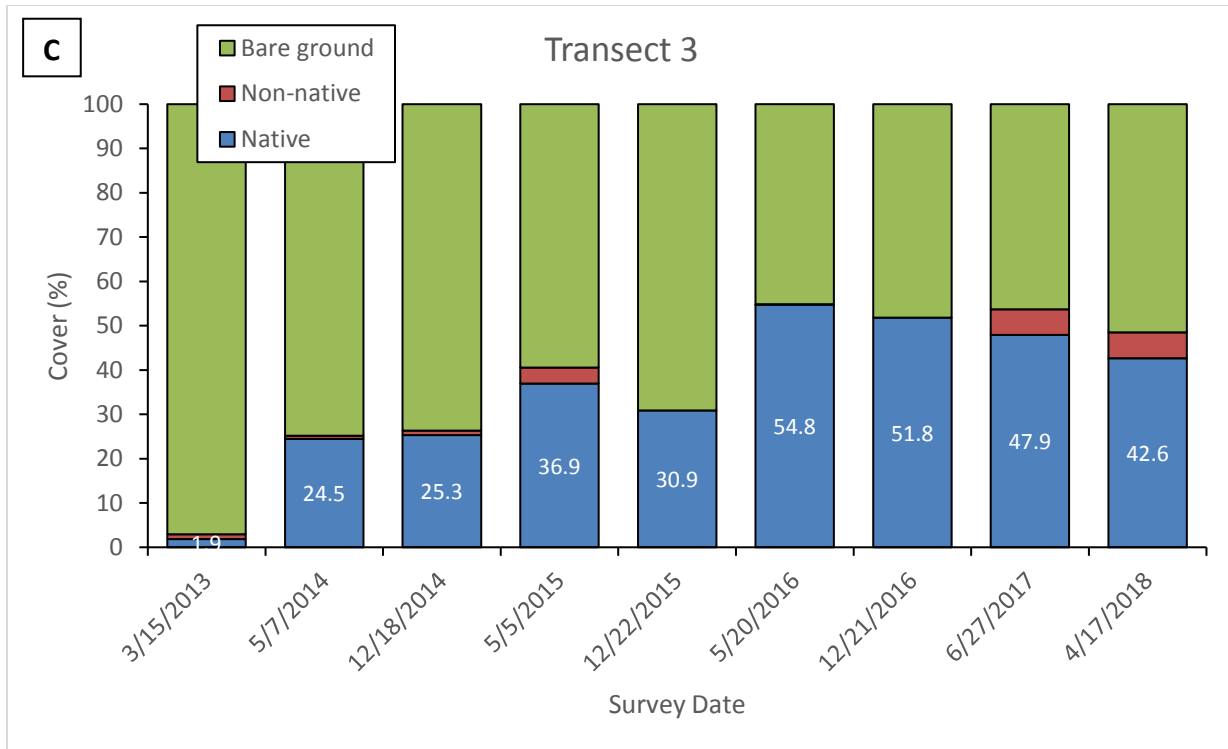
Figure 36. Graphs displaying absolute cover of vegetation across each Transect: (A) 1, (B) 2, and (C) 3.

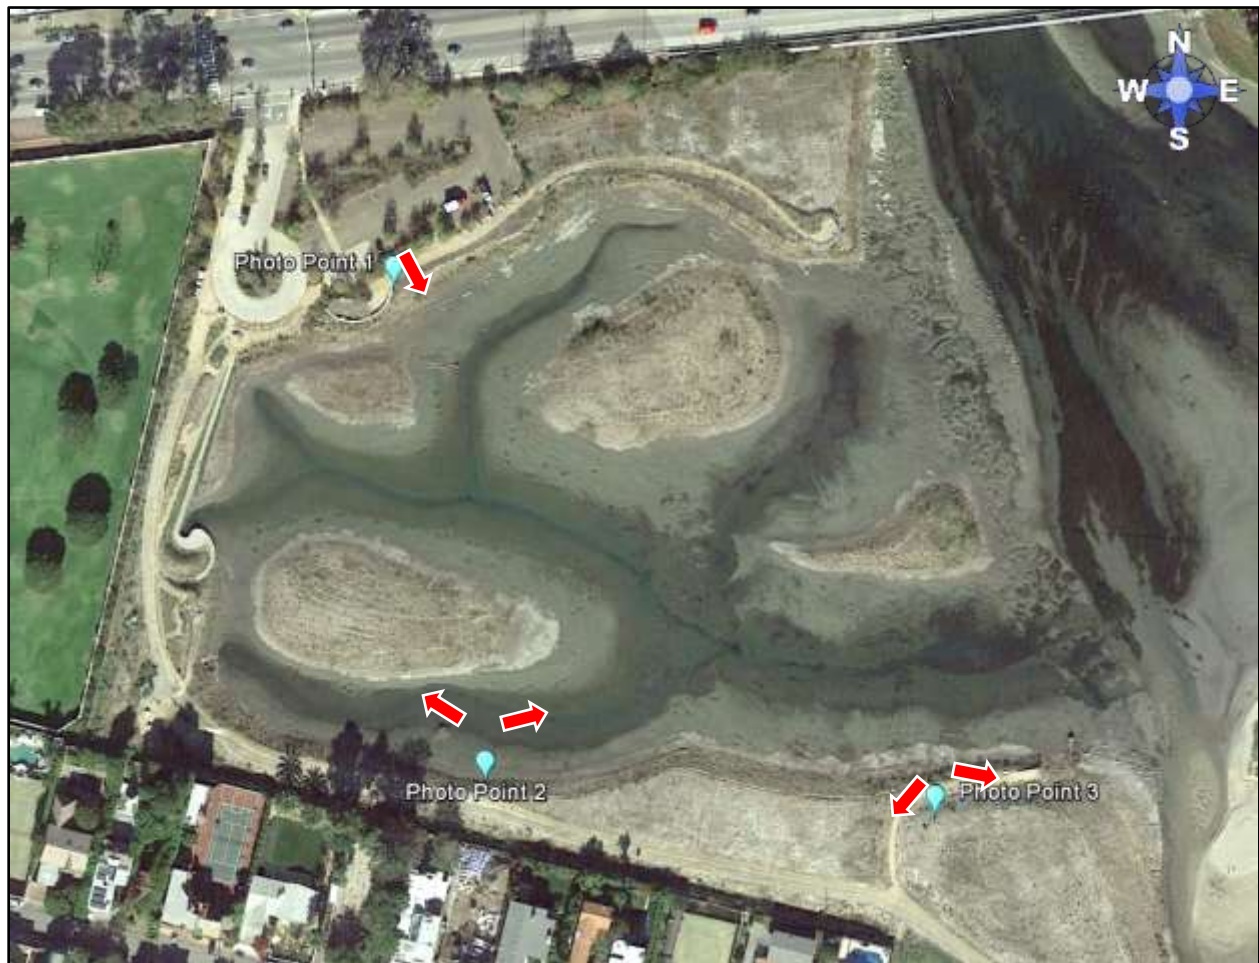
Figure 37. Map of photo-point locations and bearings for the surveys.

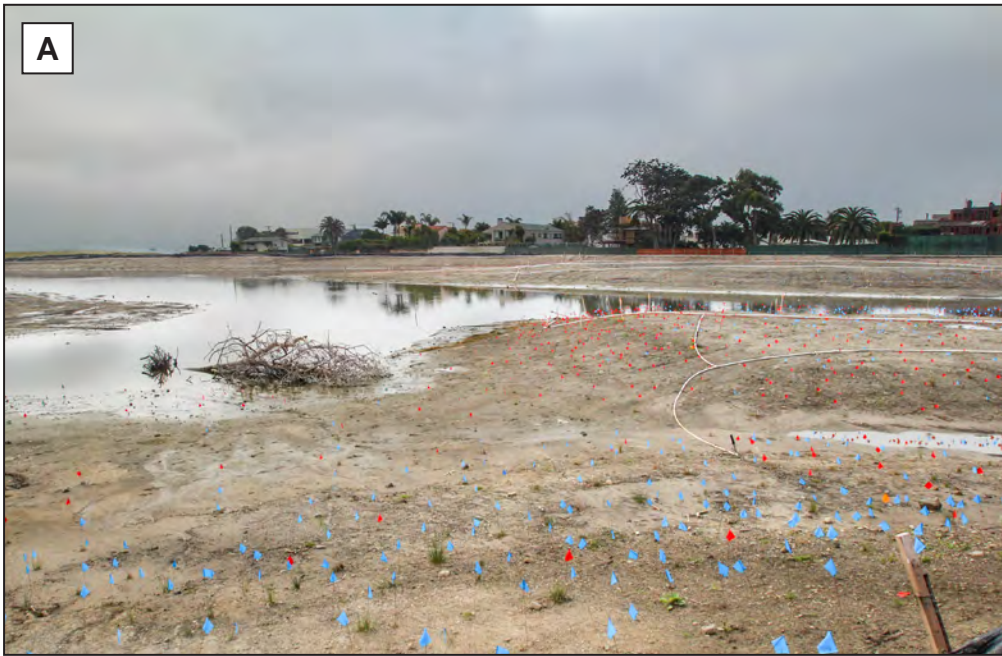
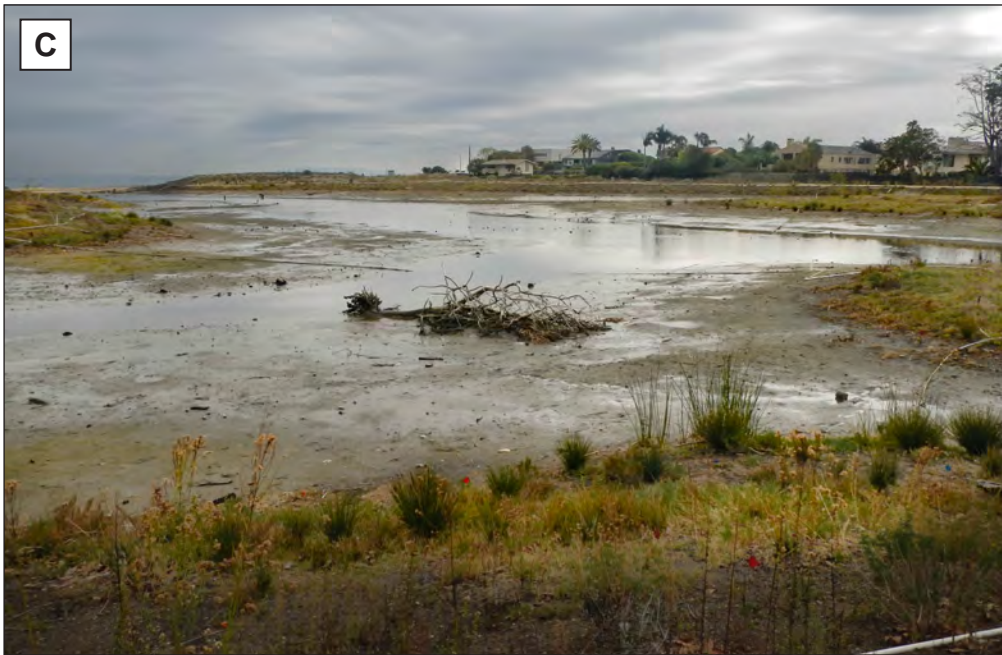
Figure 38. Photograph of Photo Point 1, bearing 155° on (A) 15 March 2013; (B) 7 May 2014; (C) 18 December 2014; (D) 5 May 2015.

Consistent with the evaluation for plant cover transect monitoring and CRAM scores, the post-restoration georeferenced photos show a consistent increase in vegetation over time, with a large increase after the initial post-restoration Photo Point survey. Unlike the prolific growth seen in the second and third photo point surveys in 2014, photographs from Years 3-5 showed more subtle variations.

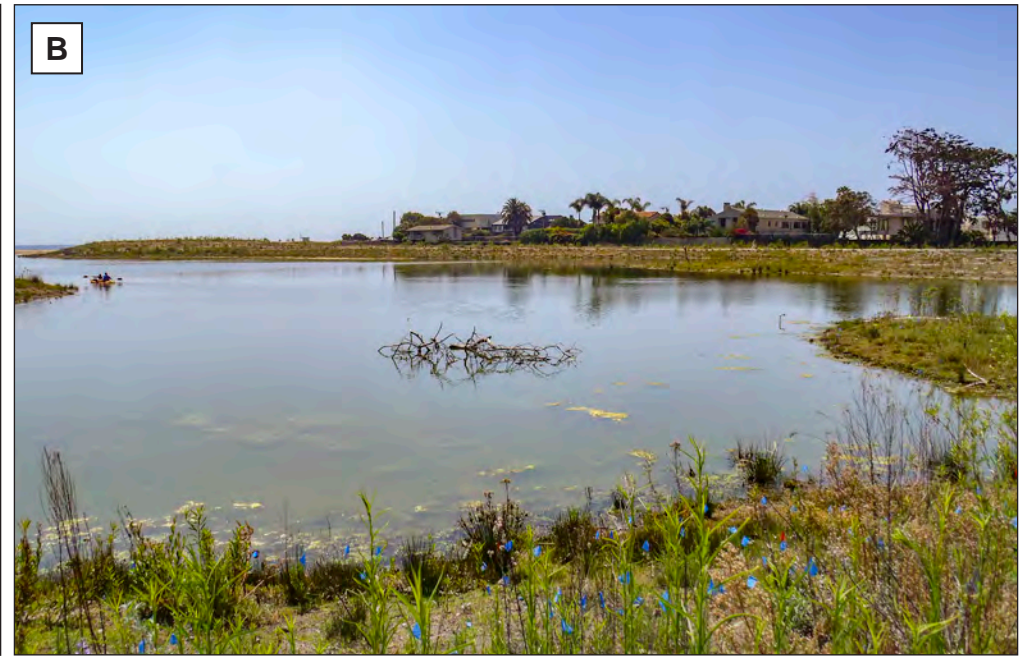
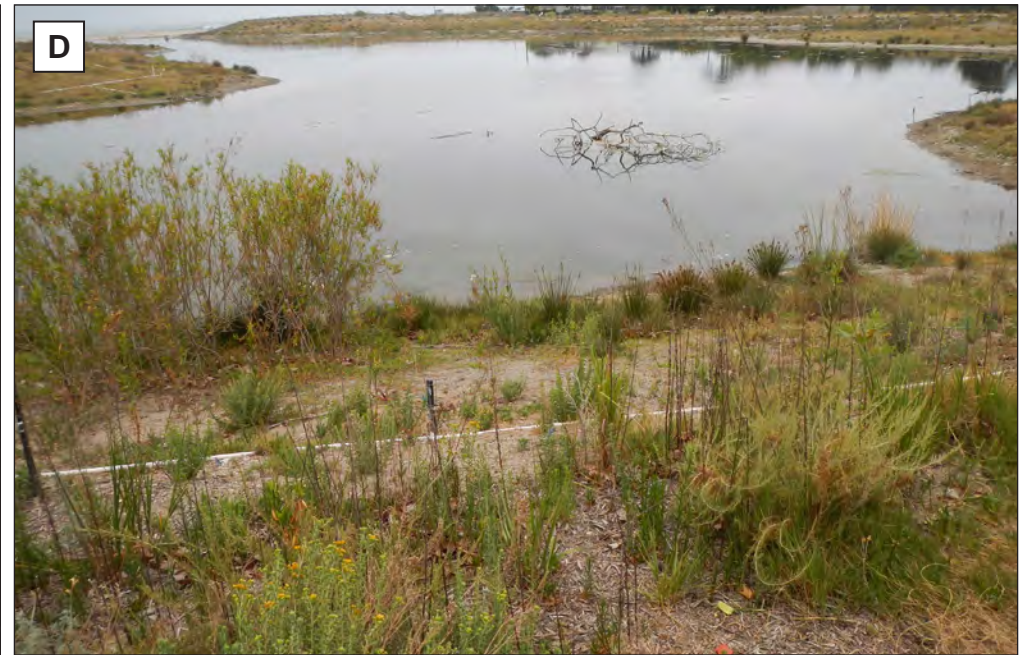
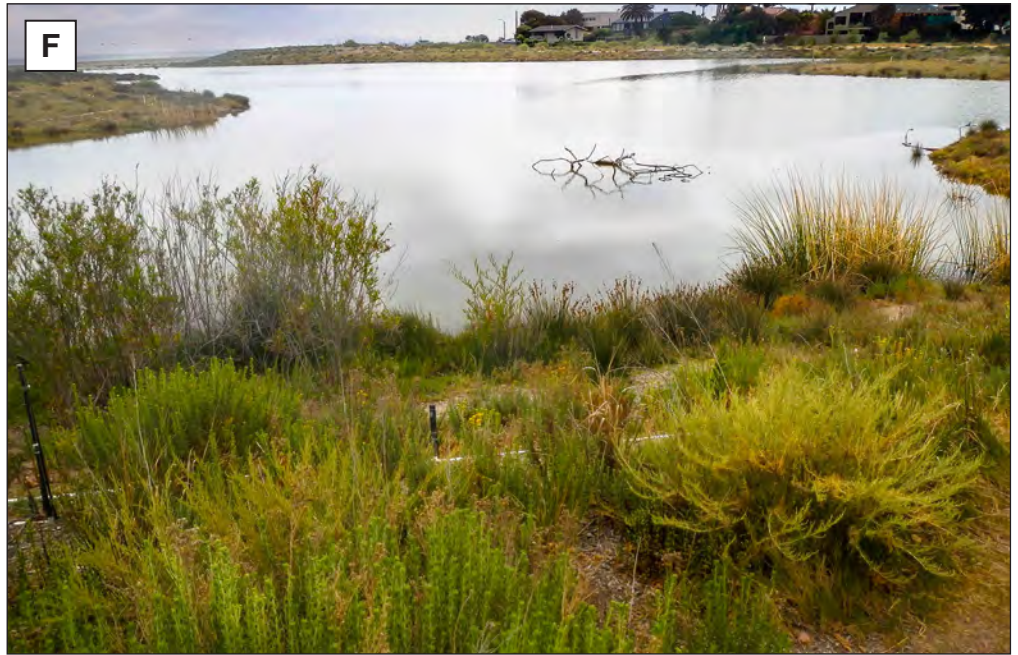
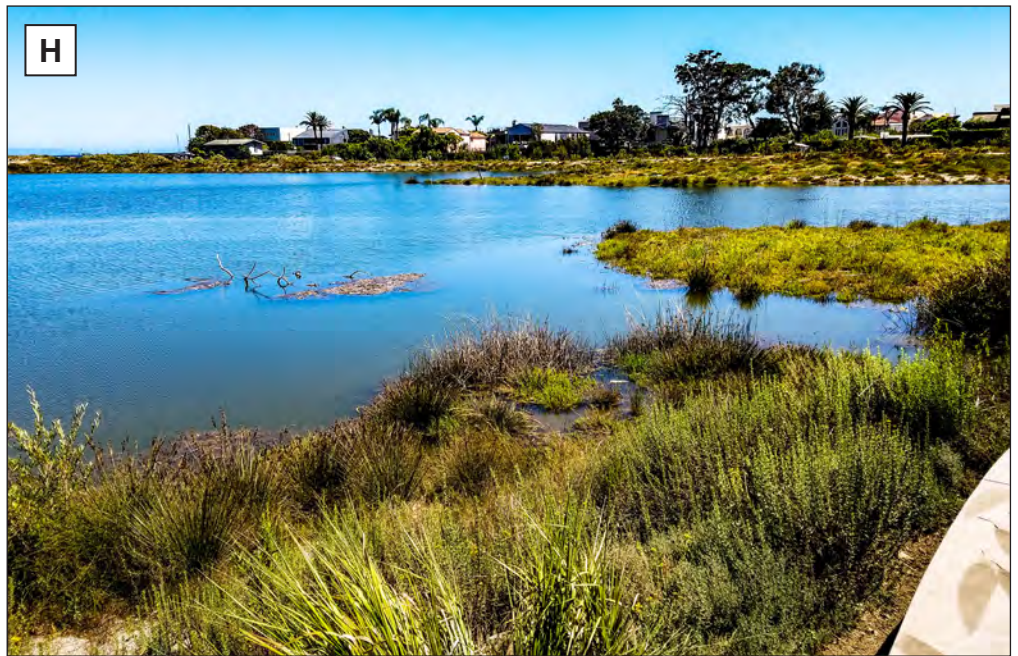
Figure 38 (continued). Photograph of Photo Point 1, bearing 155° on (E) 22 December 2015; (F) 16 May 2016; (G) 27 December 2016; (H) 27 June 2017.
