Malibu Lagoon Restoration and Enhancement Project

Comprehensive Monitoring Report (Year 5)

July 2018

Prepared by: The Bay Foundation (TBF)

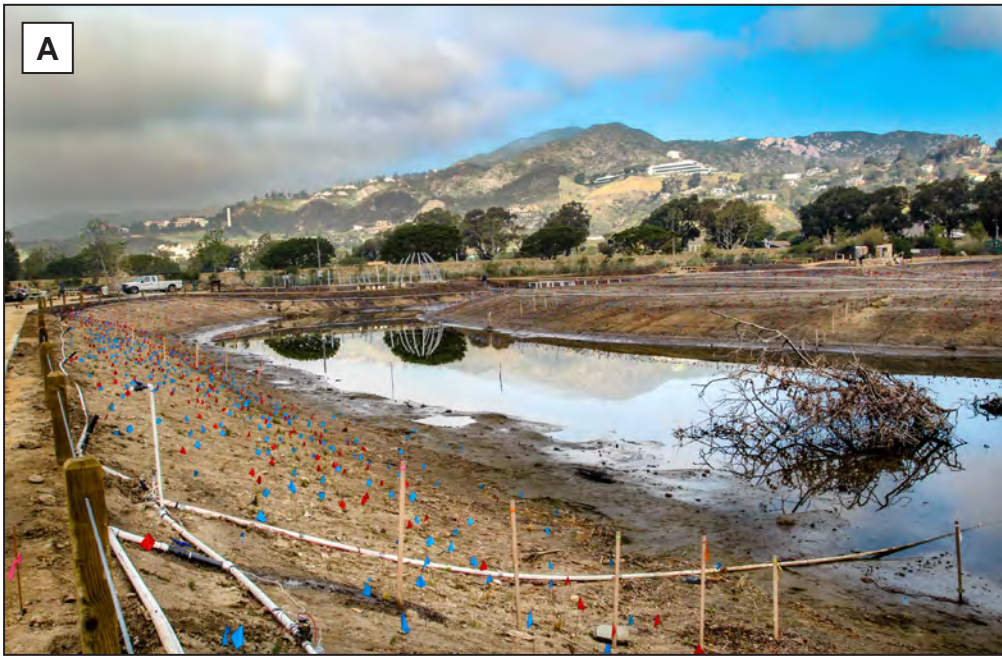
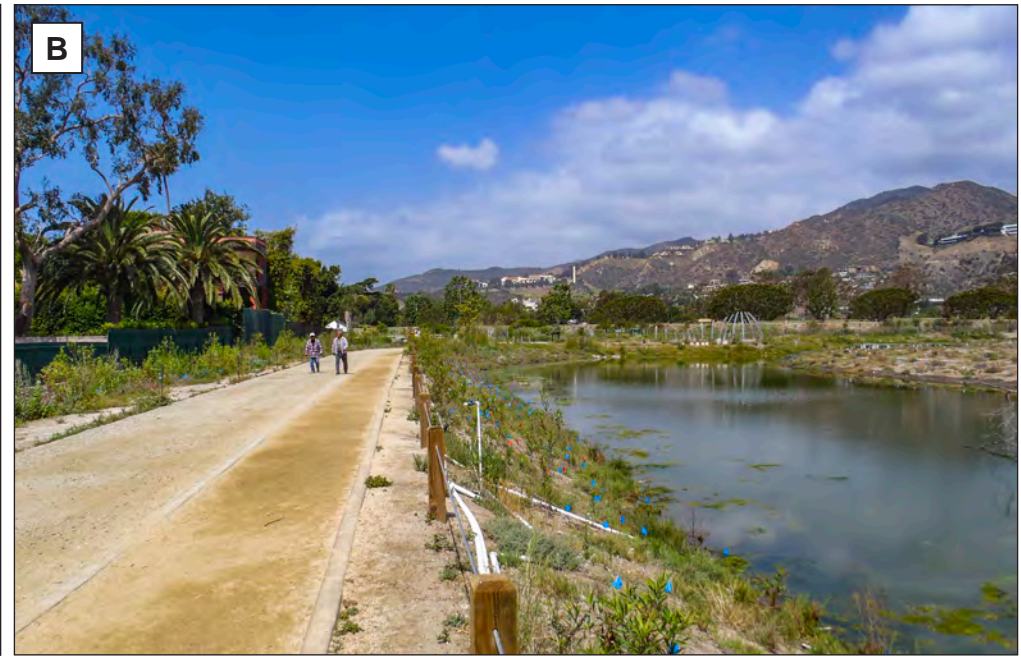
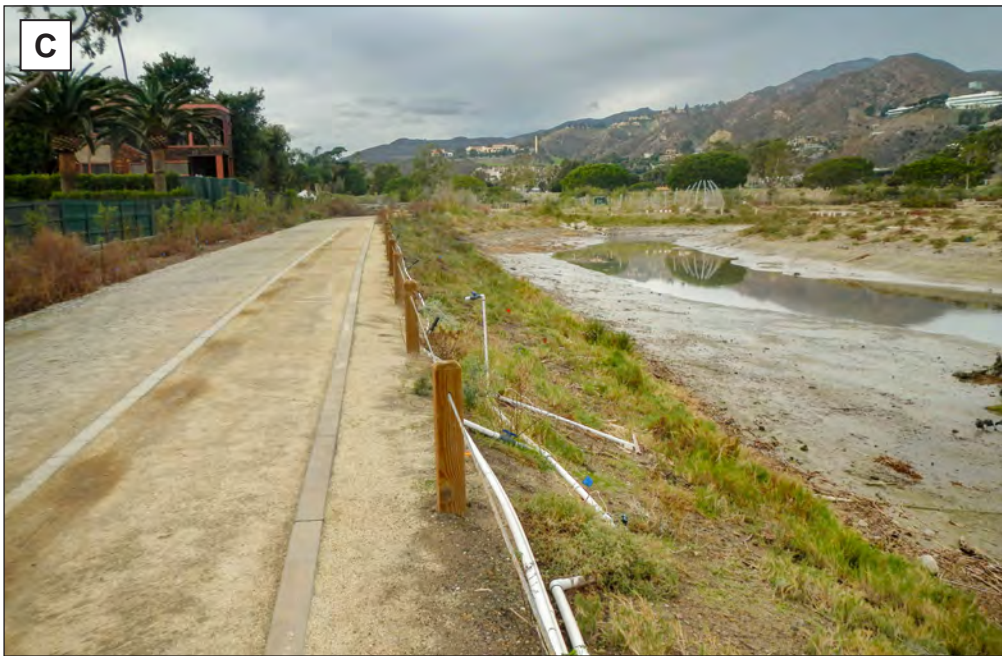
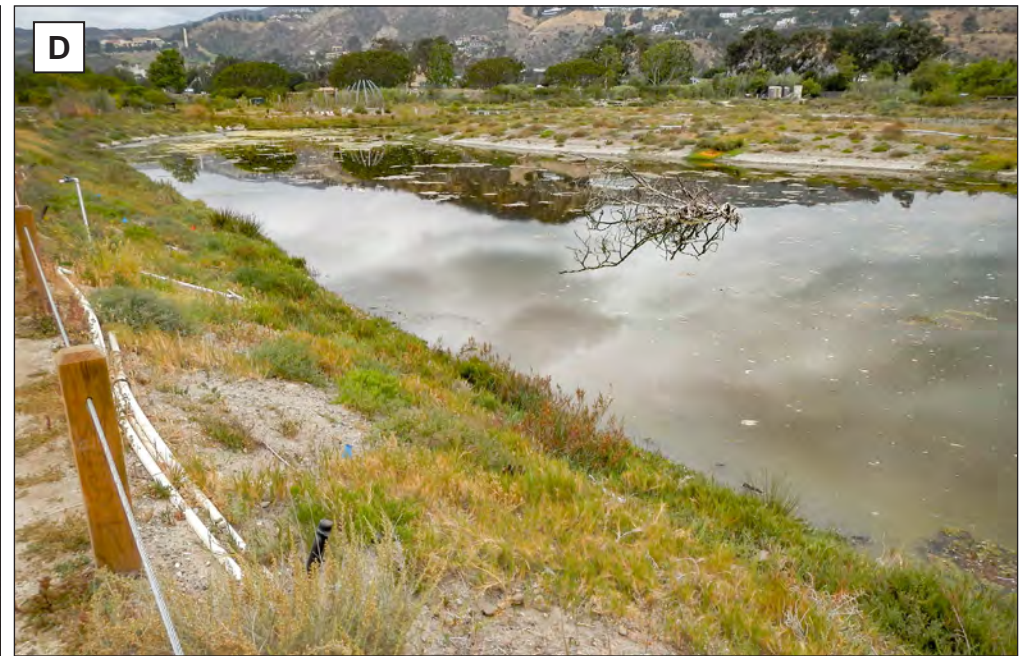
Figure 39. Photograph of Photo Point 1, bearing 300° on (A) 15 March 2013; (B) 7 May 2014; (C) 18 December 2014; (D) 5 May 2015.

Consistent with the evaluation for plant cover transect monitoring and CRAM scores, the post-restoration georeferenced photos show a consistent increase in vegetation over time, with a large increase after the initial post-restoration Photo Point survey. Unlike the prolific growth seen in the second and third photo point surveys in 2014, photographs from Years 3-5 showed more subtle variations.

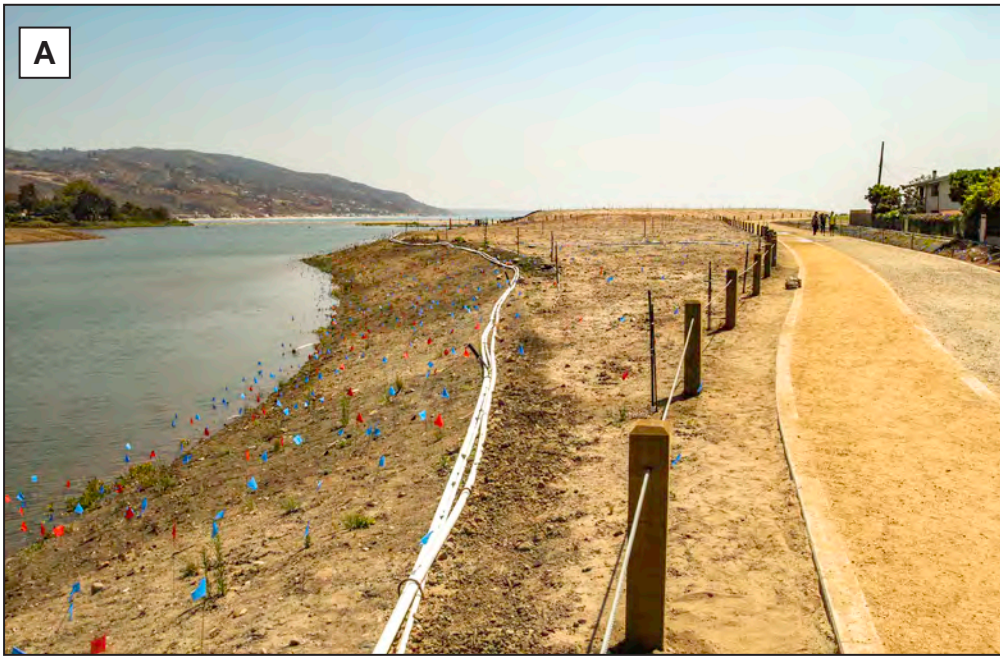
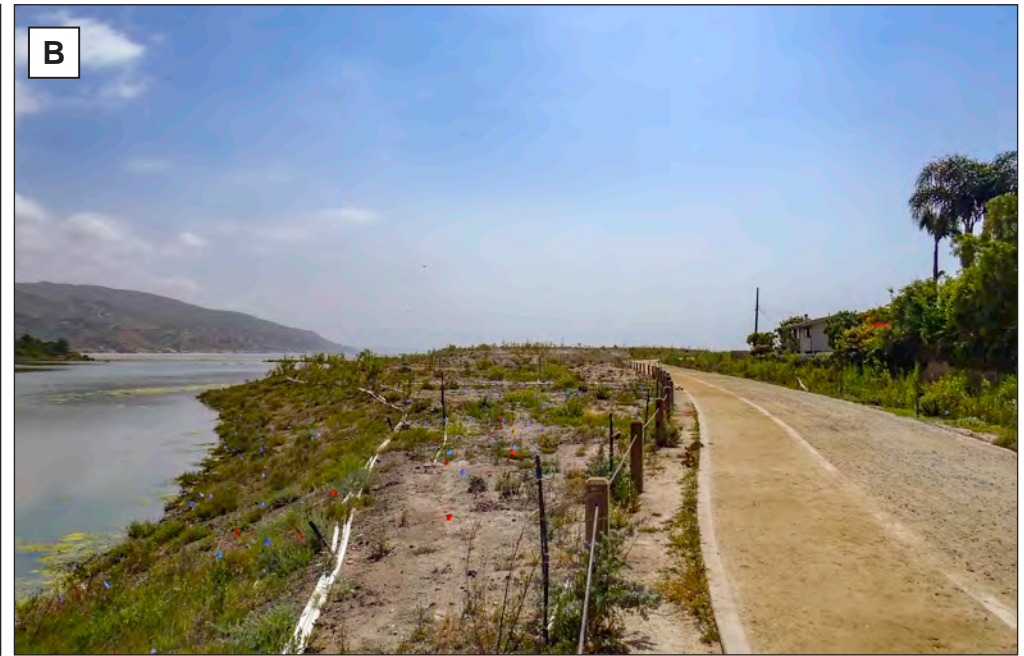
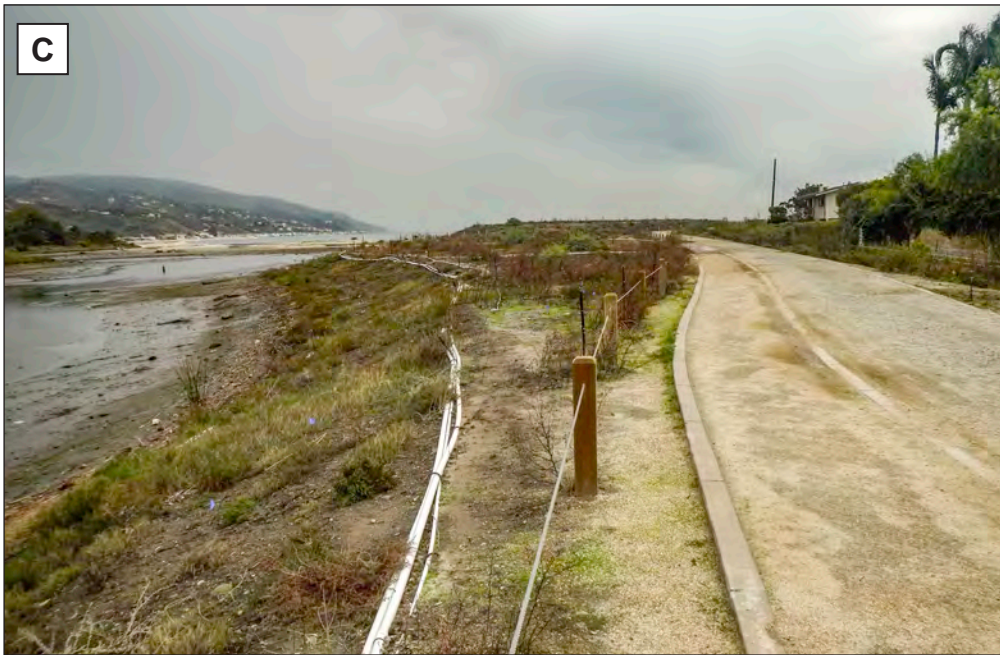
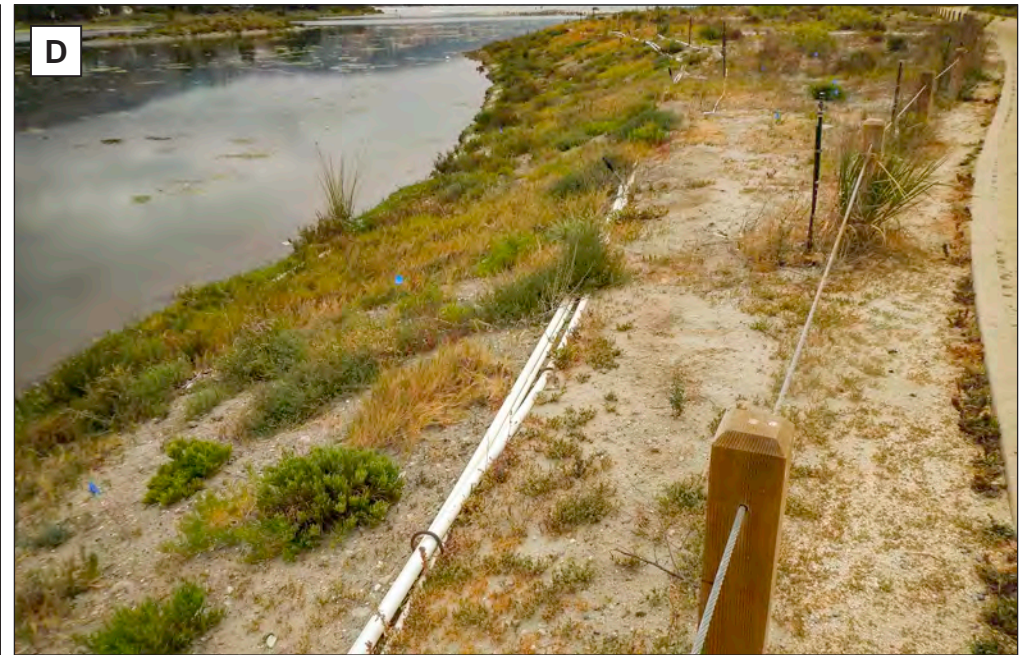
Figure 40. Photograph of Photo Point 1, bearing 75° on (A) 15 March 2013; (B) 7 May 2014; (C) 18 December 2014; (D) 5 May 2015.

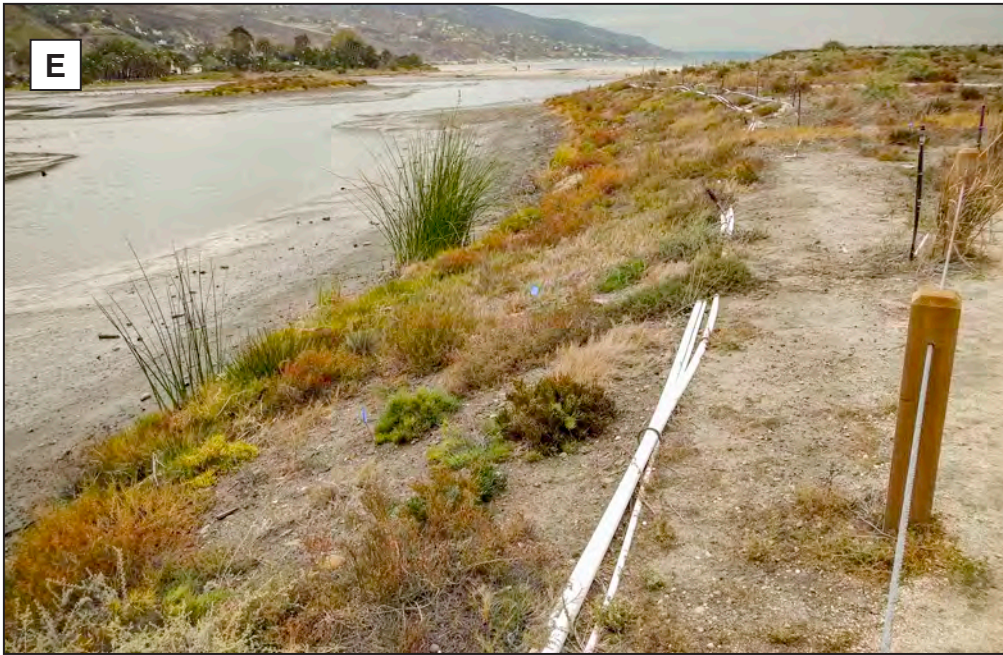
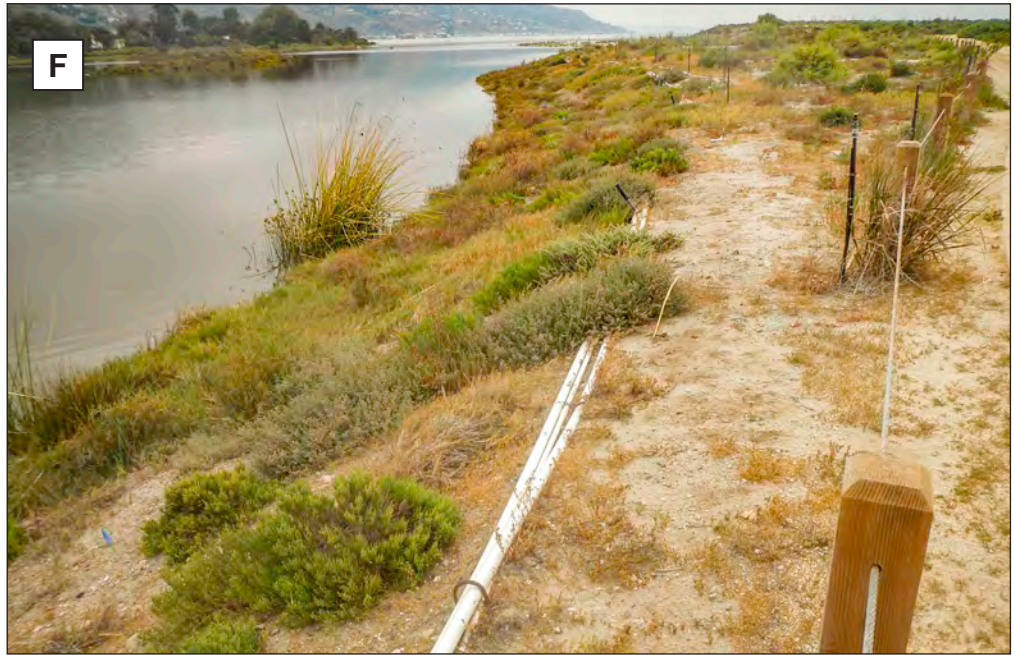
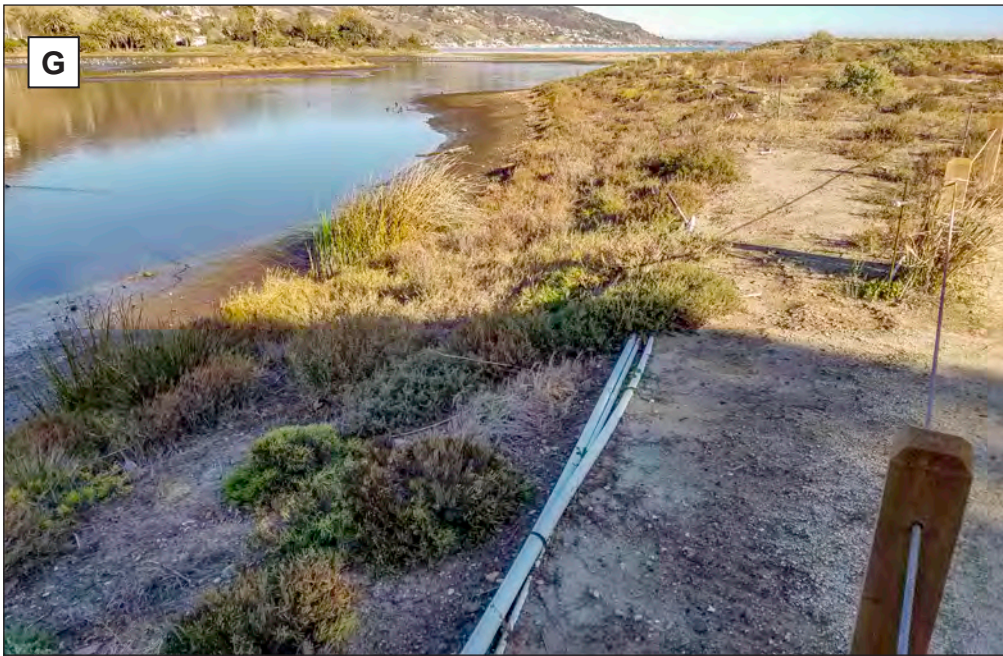
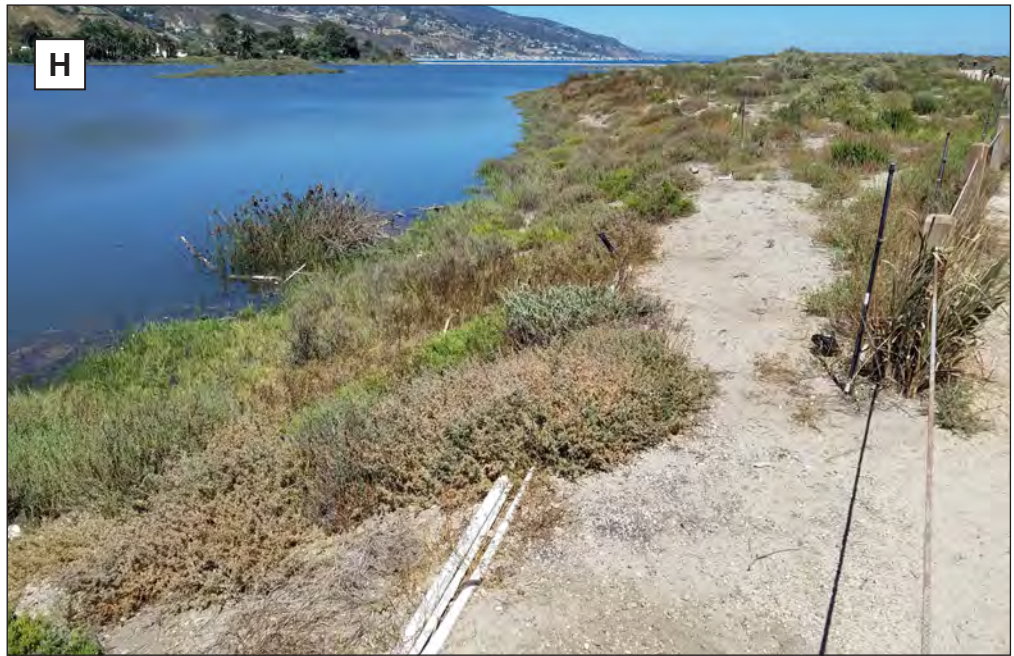
Figure 40 (continued). Photograph of Photo Point 1, bearing 75° on (E) 22 December 2015; (F) 16 May 2016; (G) 27 December 2016; (H) 27 June 2017.

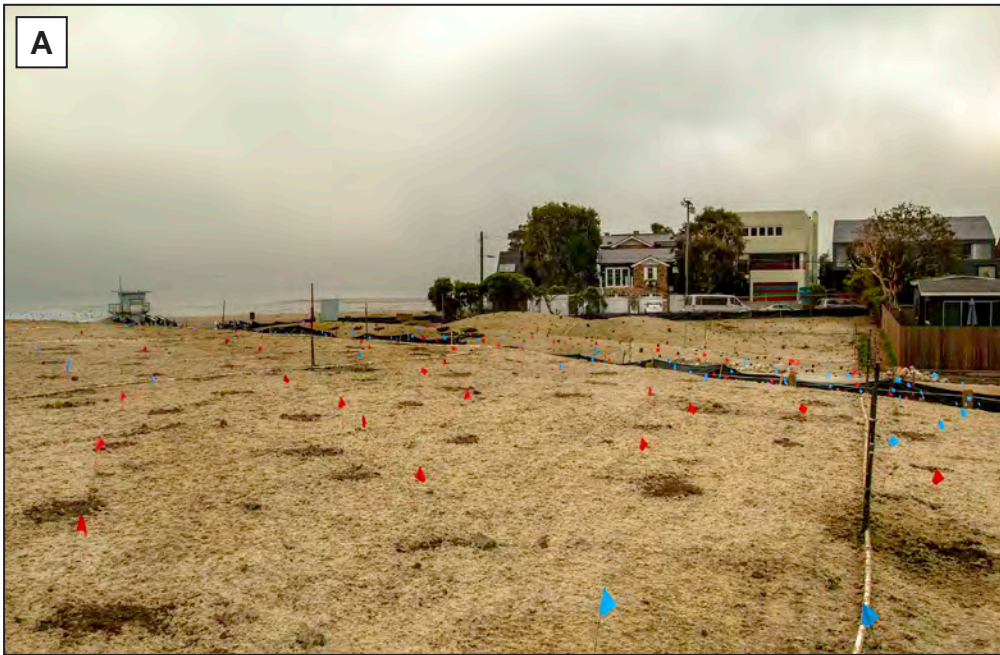
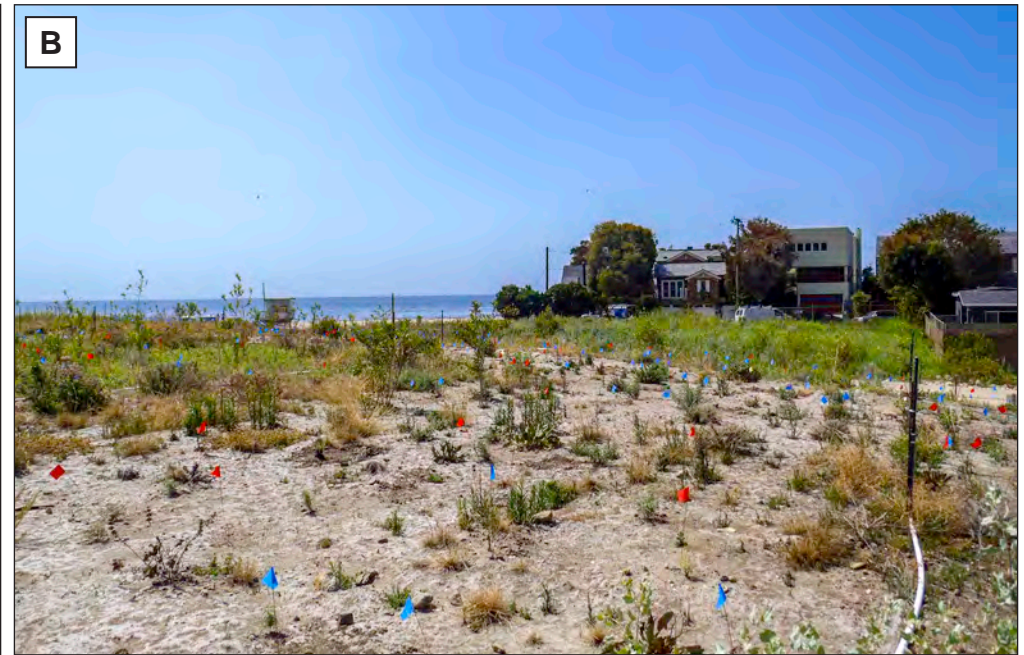
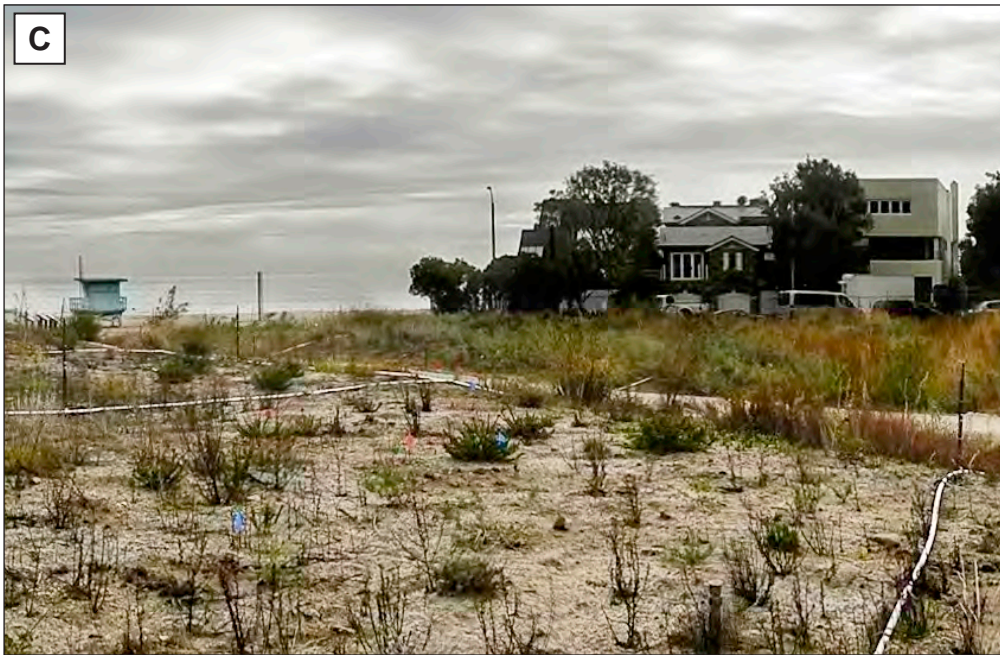
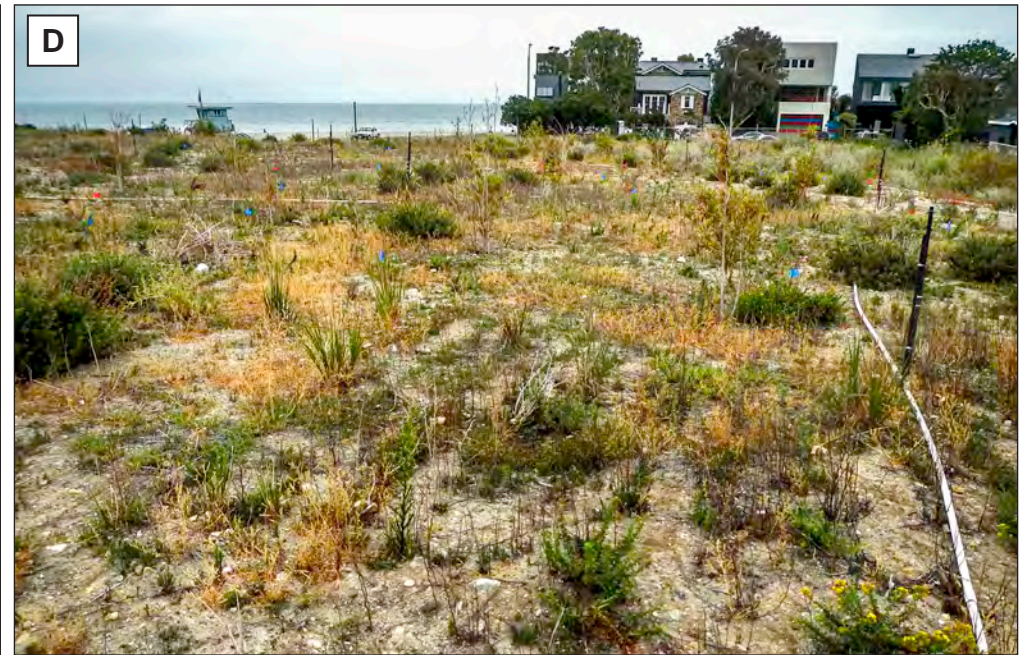
Figure 41. Photograph of Photo Point 1, bearing 100° on (A) 15 March 2013; (B) 7 May 2014; (C) 18 December 2014; (D) 5 May 2015.

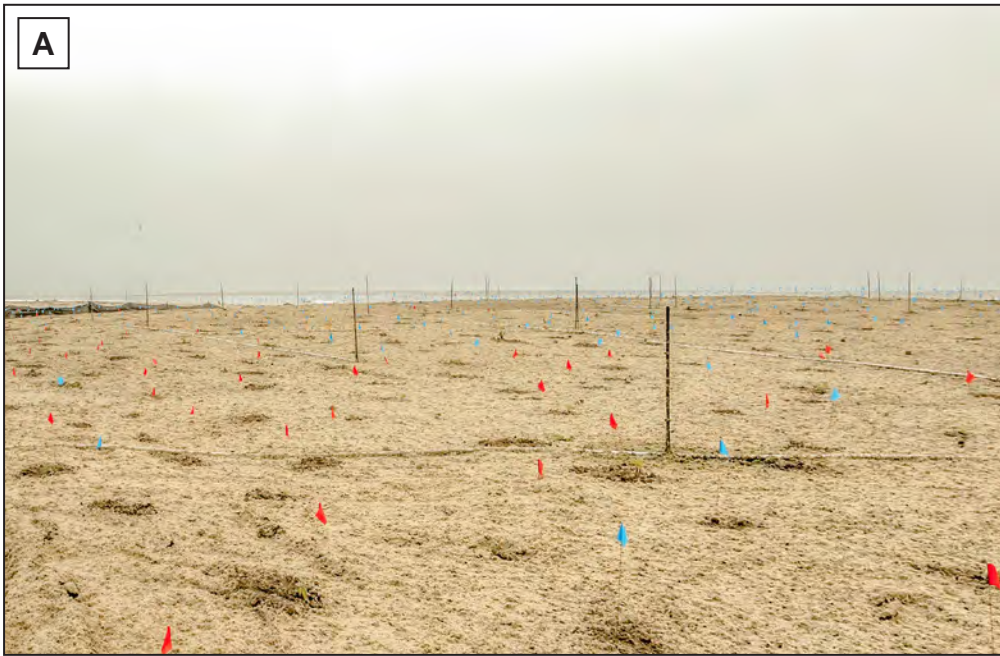
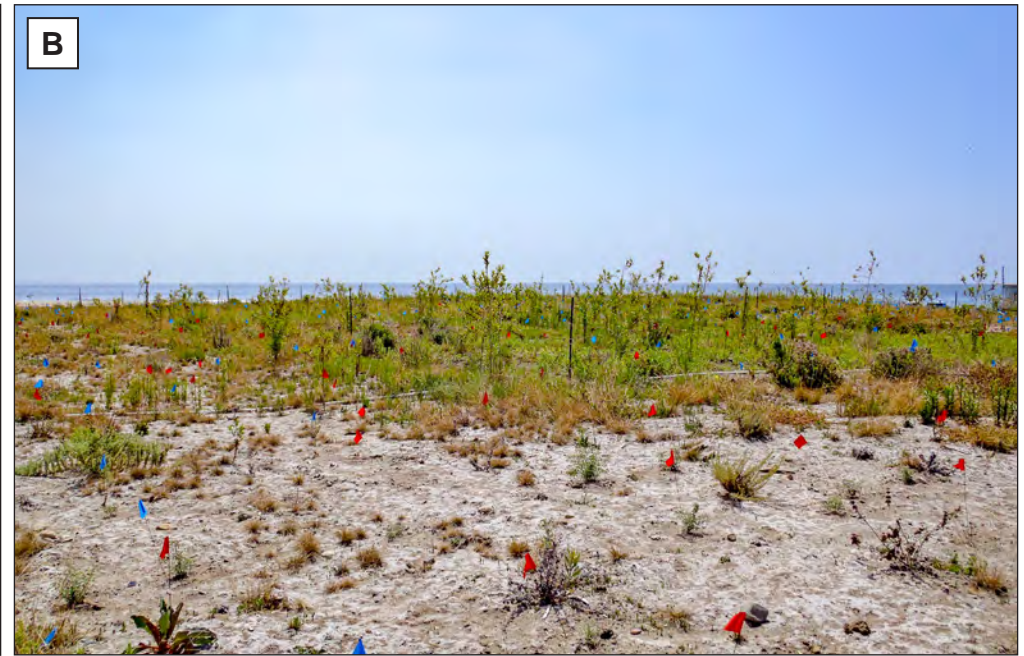
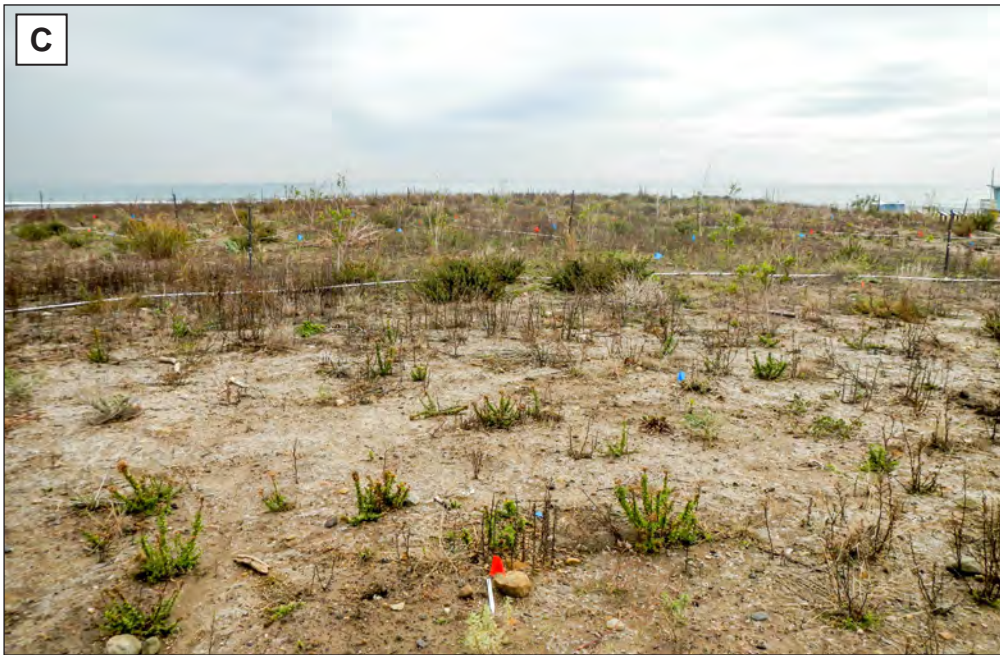
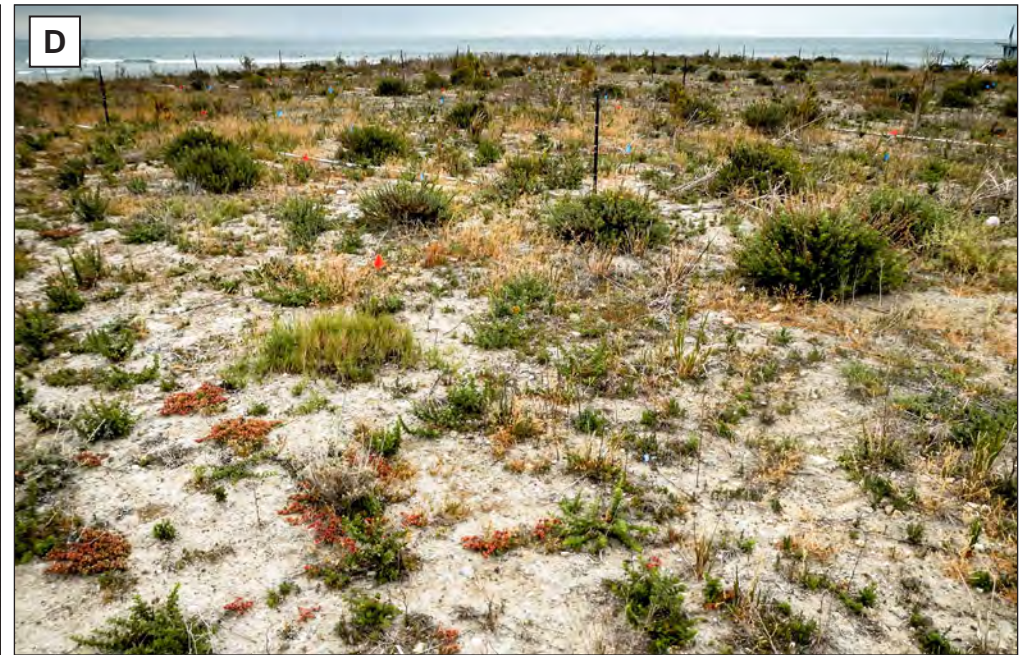
Figure 41 (continued). Photograph of Photo Point 1, bearing 10° on (E) 22 December 2015; (F) 16 May 2016; (G) 27 December 2016; (H) 27 June 2017.

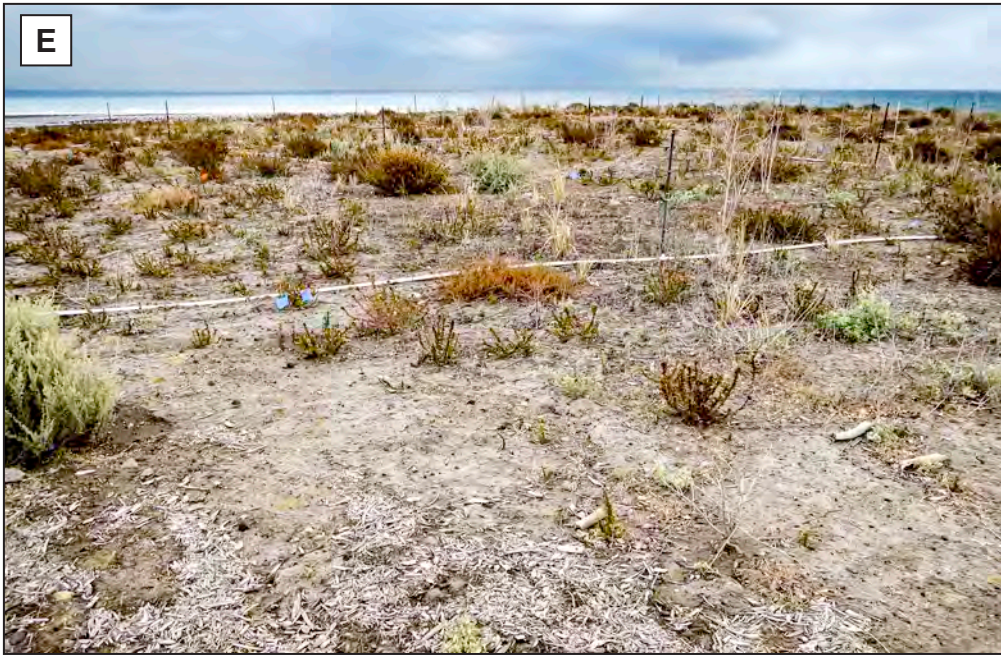
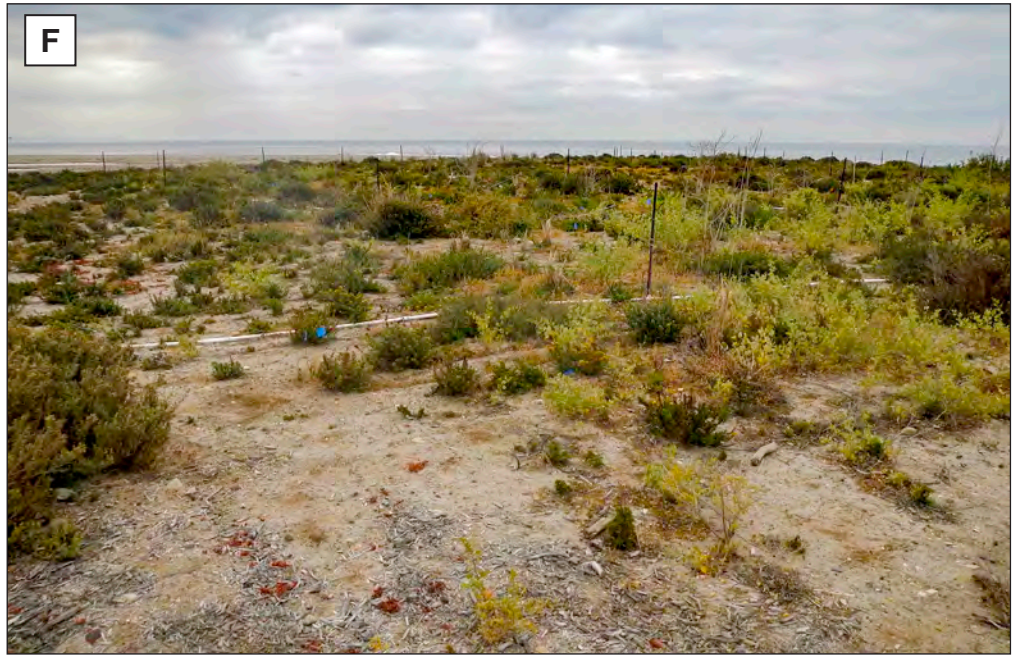
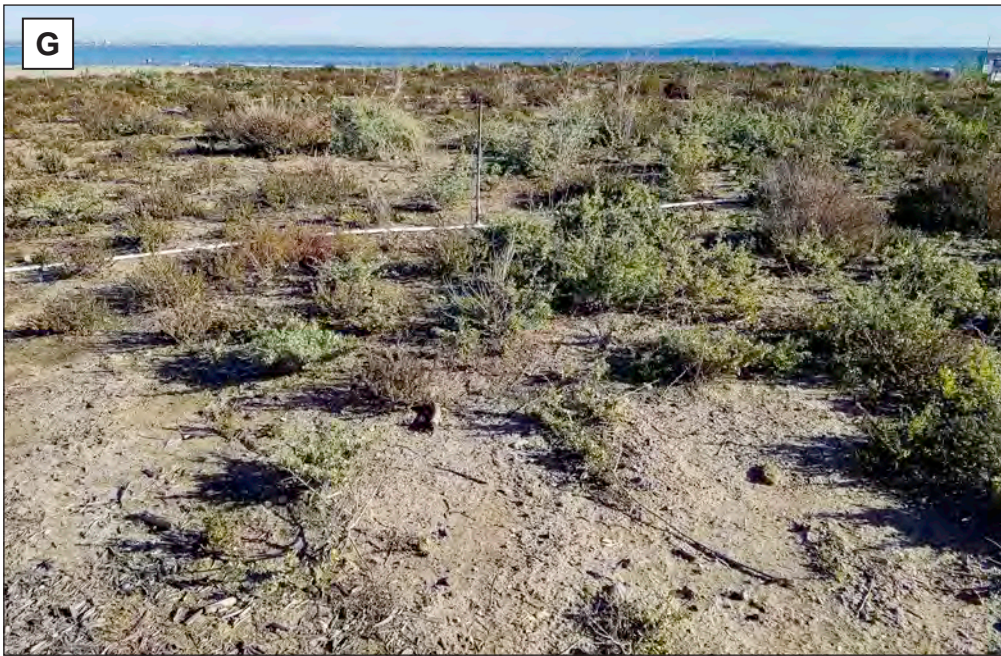
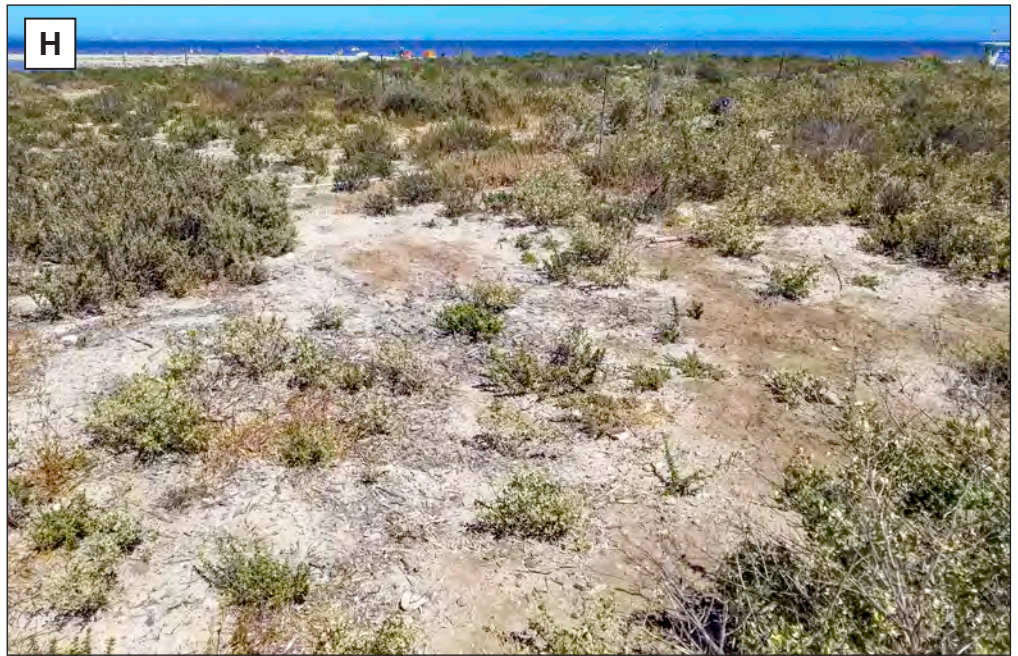
Figure 42. Photograph of Photo Point 1, bearing 100° on (A) 15 March 2013; (B) 7 May 2014; (C) 18 December 2014; (D) 5 May 2015.

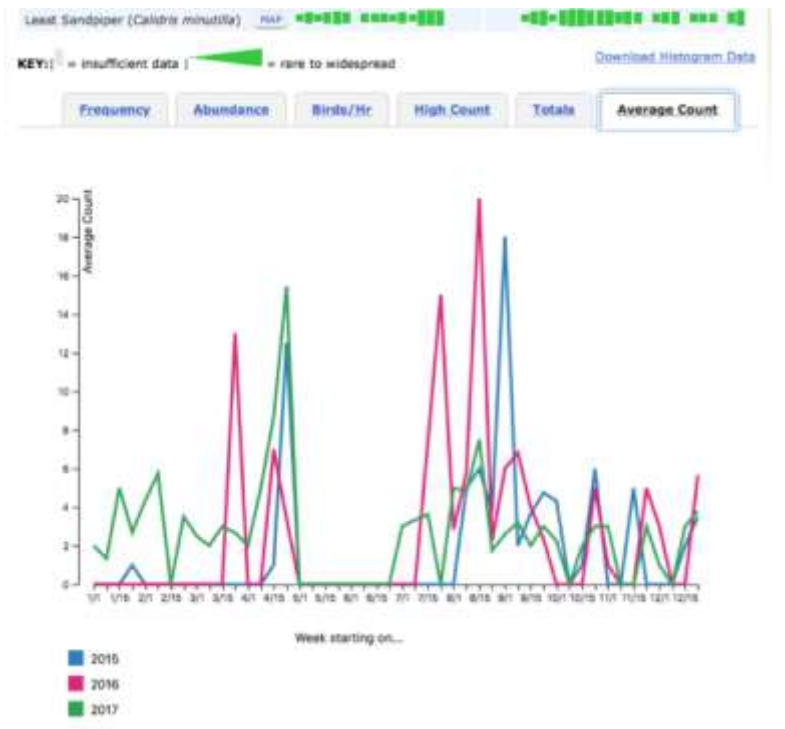
Figure A2. Counts of Least Sandpiper (top) and Marbled Godwit (bottom) at Malibu Lagoon, Jan. 2015 – Dec. 2017 (eBird data).

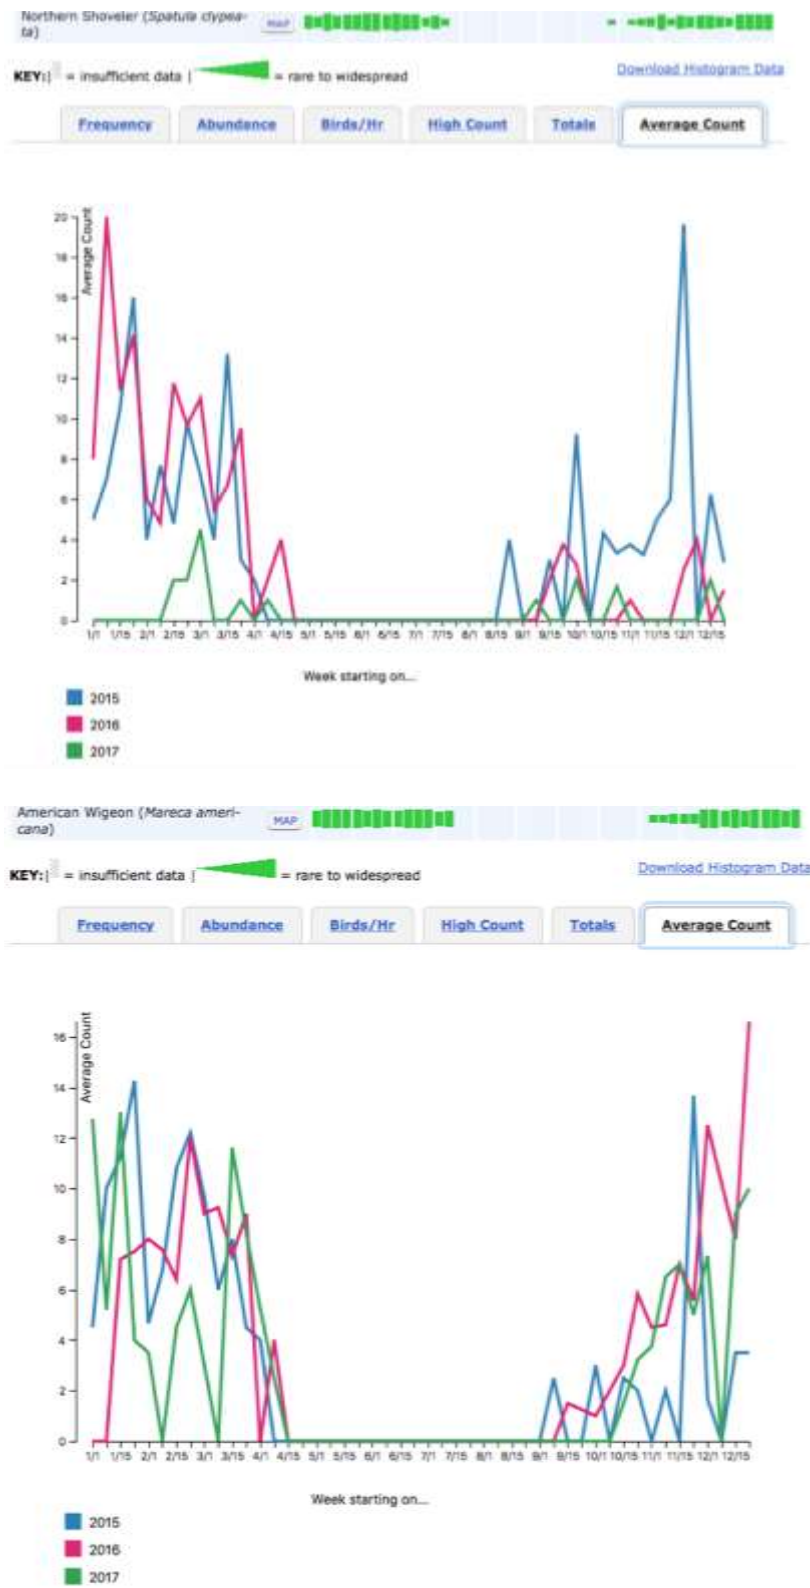
Figure A4. Counts of Northern Shoveler (top) and American Wigeon (bottom) at Malibu Lagoon, Jan. 2015 – Dec. 2017 (eBird data).
