1 **Malibu Creek Ecosystem Restoration Study**
2
3 **Los Angeles and Ventura Counties, California**

4
5 **Appendix C**

6
7 **Civil Design & Structural**
8

9
10 U.S. Army Corps of Engineers
11 Los Angeles District
12

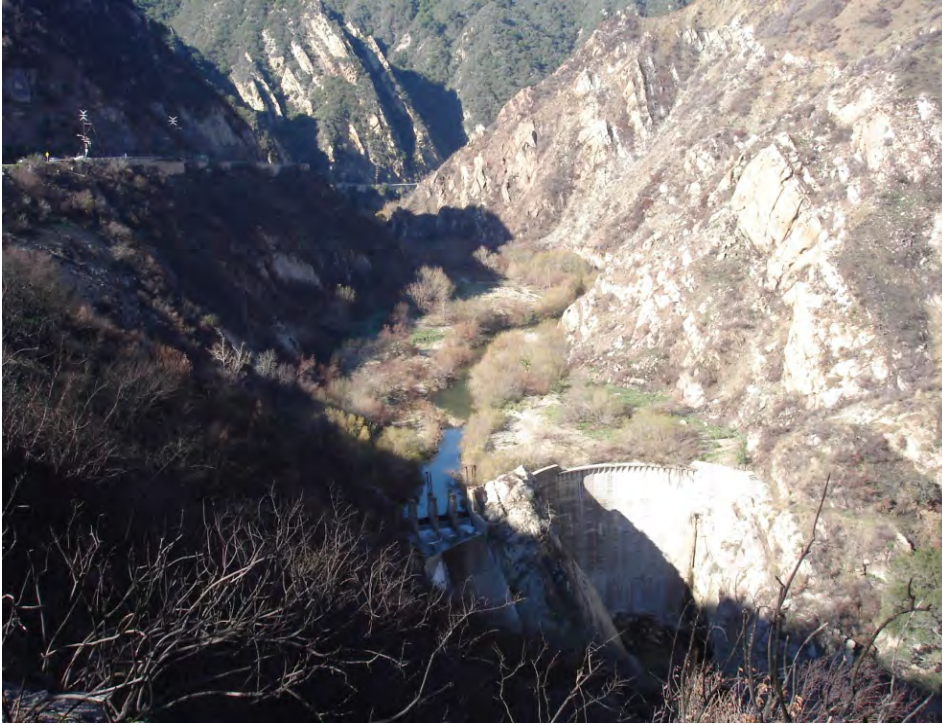
Figure 2.5-2 Rindge Dam

11
12 Built between April 1924 to January 1925, Rindge Dam is a 100-ft-high thin-arch concrete
13 dam with a detached spillway cut into bedrock. The dam became State of California
14 jurisdictional for safety following passage of legislation in August 1929. It was certified for
15 safety operation on October 17, 1935. On May 2, 1967, the dam was declared
16 nonjurisdictional when it was found to store less than 15 acre-feet of water which is the
17 threshold storage the State defines for a dam. **Figure 2.5-1** – Rindge Dam shows the dam
18 viewed from above and looking upstream from Malibu Canyon Road.

19
20 The length of the dam at the crest is 175 ft and 95 ft at its base. The thickness of concrete
21 at the base of the dam is 11.5 ft and tapers to a width of 2 ft at the top. The dam foundation
22 extended 15 ft to below the original streambed to bedrock. Based on as-built drawings, the
23 dam was reinforced with 30-foot long steel railroad rails weighing sixty lbs/yd. The rails were
24 placed vertically near the abutments at the crest and at the base at the center of the arch on
25 the upstream face.

1 Table 3.1-1 and **Figure 2.5-2** show the test locations and rebound values on the dam and
2 abutment bedrock.
3
4 Utilizing the conversion curves attached to the Tecnotest Schmidt hammer, the average
5 rebound values have been converted into approximate compressive strengths, as shown in
6 **Table 3.1-2**. Although there is a range of compressive strength values, the strengths do
7 generally indicate that the concrete is in good condition. This assessment is in agreement
8 with the visual inspection of the dam, which found that the concrete was free of significant
9 spalling or other surficial distress.
10

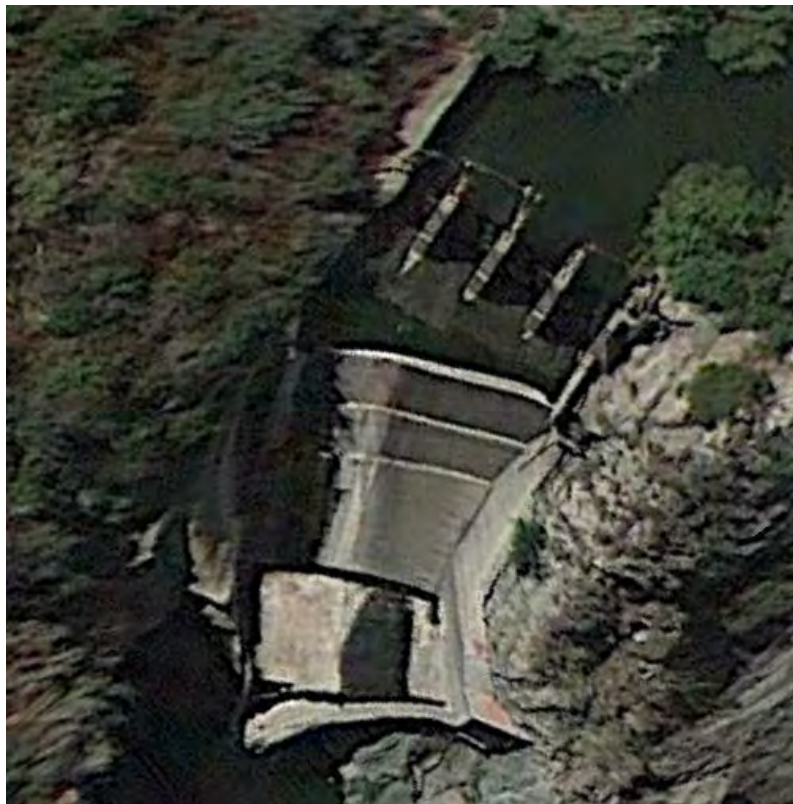
Figure 2.5-1 Rindge Dam Spillway

26
27 The spillway has five concrete buttresses with four 8 ft wide by 11 ft high flow ways. The
28 dam foundation extended 15 ft to below the original streambed to bedrock. A plan view of
29 the spillway, taken from Google Earth, can be seen in **Figure 2.5-1**. The spillway would be
30 removed with the dam.

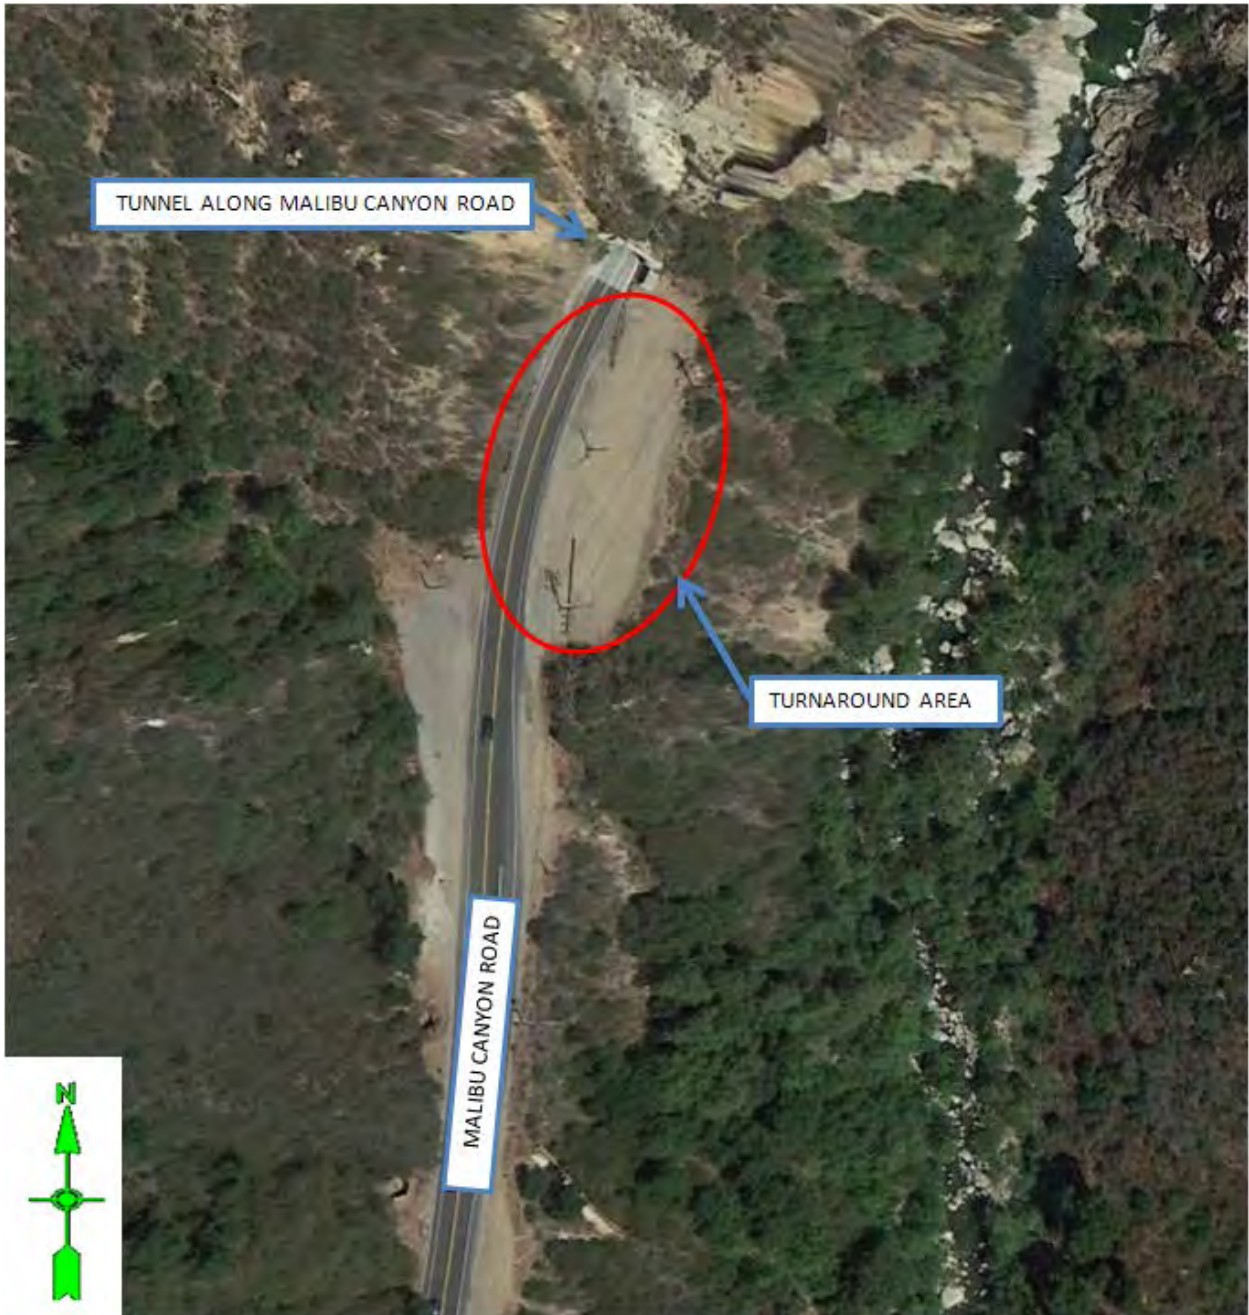
Area 1 is located about 0.30 mi north of the Northbound Ramp intersection with Malibu Canyon Road. This area was eliminated because both lanes of traffic would be blocked while the truck makes the turn from the northbound lane to the southbound lane. This would heavily impact traffic during construction hours, as outlined in the analysis of the **Figure 4.1-1** access ramp. There is also a safety concern due to the limited visibility of southbound traffic passing through the nearby tunnel.

Figure 4.2-4 Turnaround Area 1

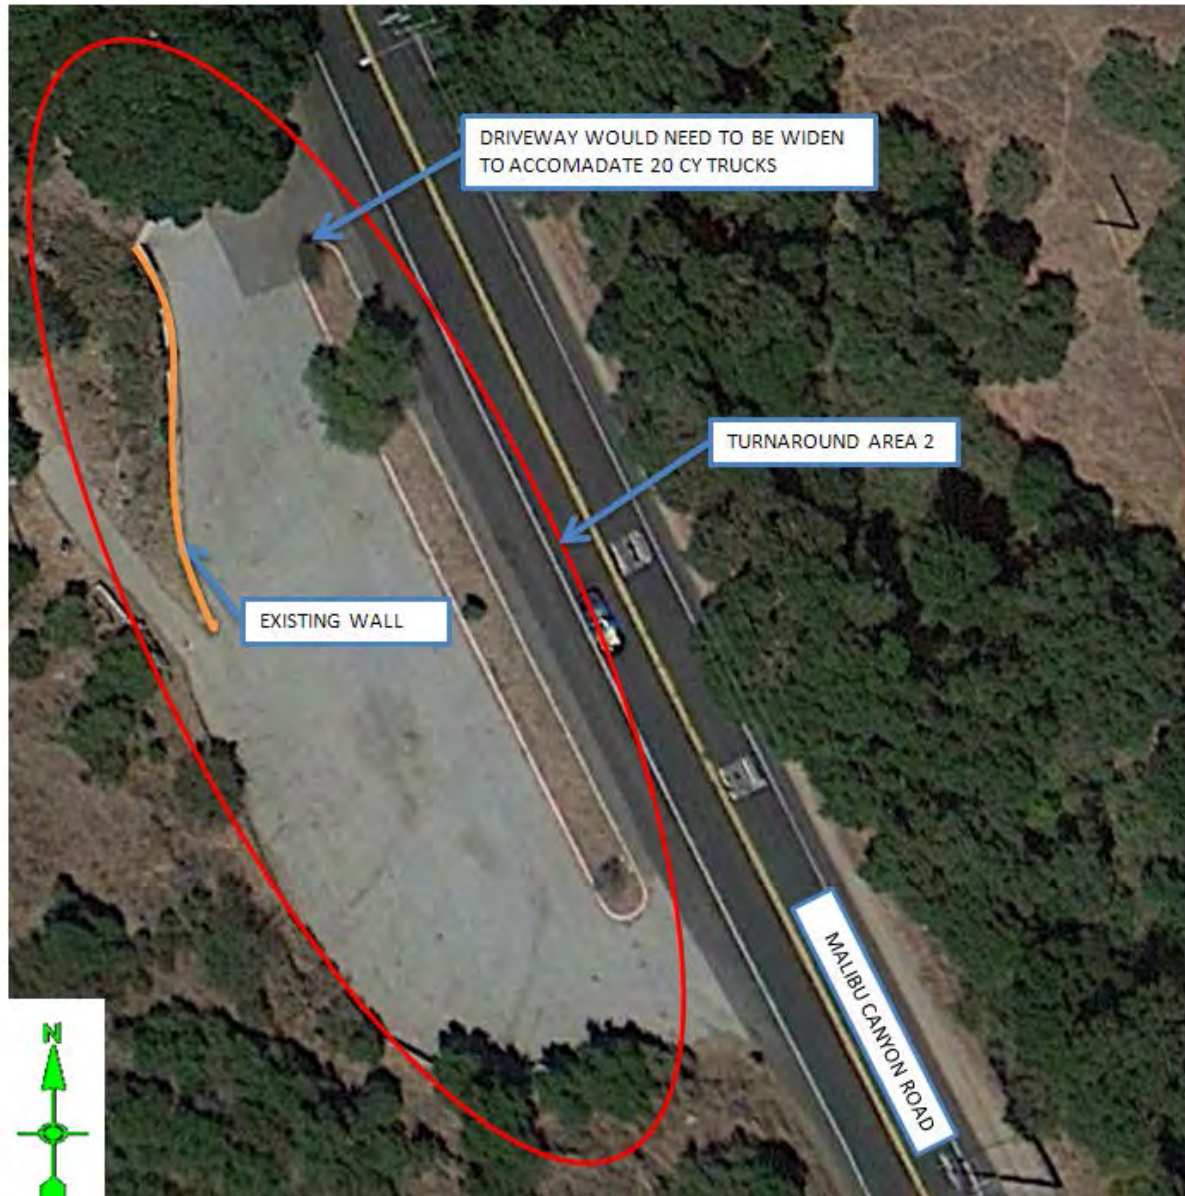
Figure 4.2-5 Turnaround Area 2

Turnaround Area 2 - Existing pavement feature north of the tunnel

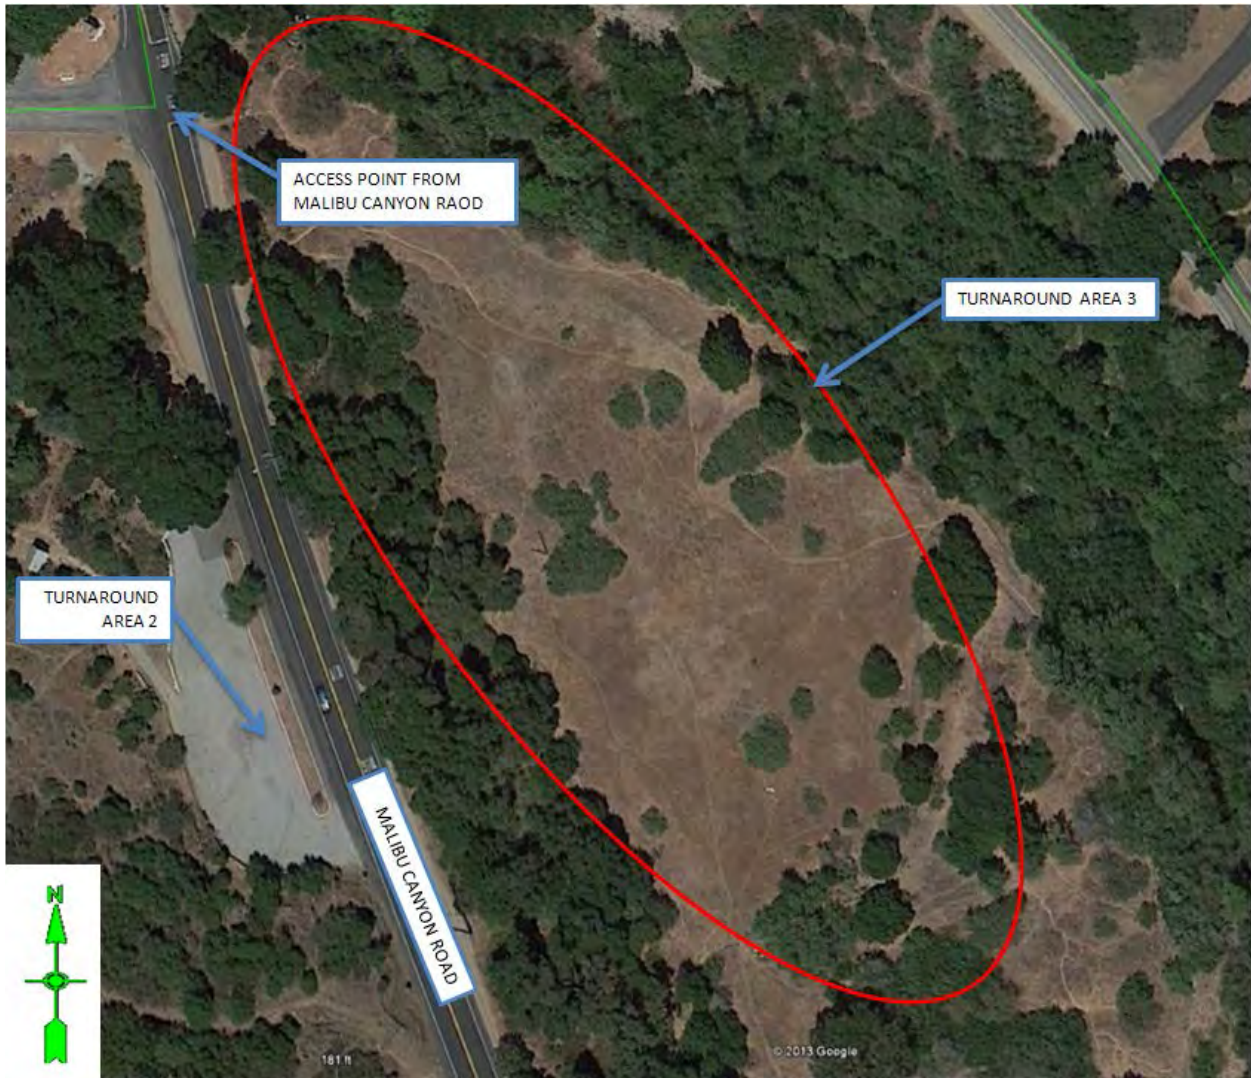
The entrance to Area 3 is located 275 ft north of the entrance to Area 2, and approximately 1.05 mi north of the Northbound Ramp intersection with Malibu Canyon Road. There is an existing intersection at the northern end of the site that can be modified to allow trucks to turn into the site and exit the site. There is plenty of room for multiple trucks to turn around at the same time and allow staging to get back onto Malibu Canyon Road. According to Google Maps this area is part of the Santa Monica Mountains National Recreation Area but the exact owner of the land is unknown at this time. This area was eliminated because it adds 2.1 mi to the haul route for material going south.

Figure 4.2-6 Turnaround Area 3

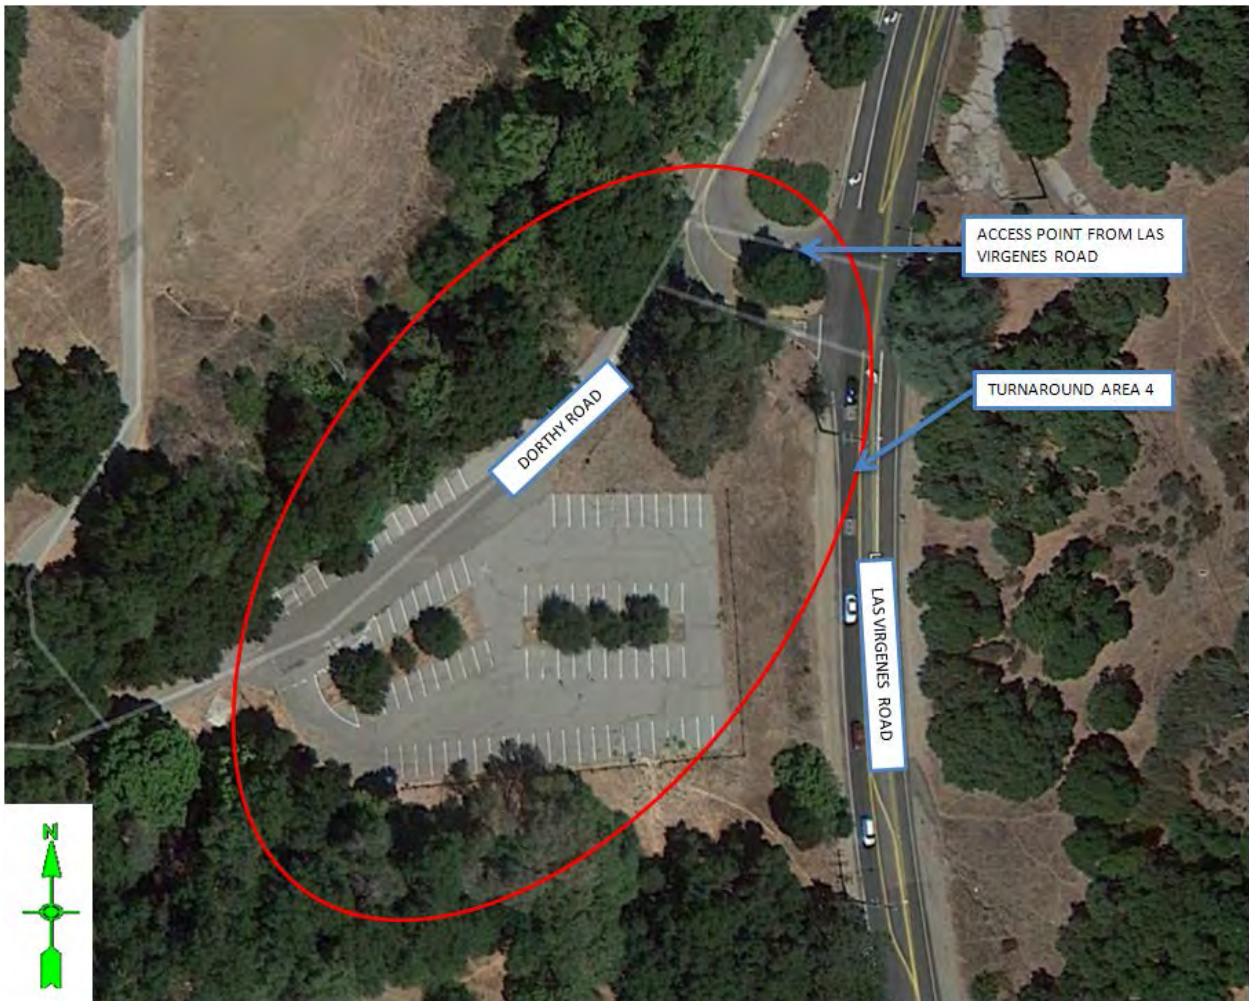
Area 4 is a parking lot located approximately 1.3 mi north of the Northbound Ramp intersection with Malibu Canyon Road tunnel. The first left turn onto Dorothy Road would need some modification to allow 20 cy capacity trucks through, but there is plenty of room in the parking lot for multiple trucks to pass through at the same time. There is already a traffic signal and a dedicated left turn lane along Las Virgenes Road to facilitate truck traffic and the parking lot area could also be used as a staging area or equipment storage site. This parking lot would have to be closed down during sediment removal operations. Traffic that would normally travel along Dorothy Road would have to be redirected so it does not interfere with truck traffic. The owner of this parking lot is unknown at this time. This site was eliminated because it added 2.6 mi the haul route for material going south.

Figure 4.2-7 Turnaround Area 4

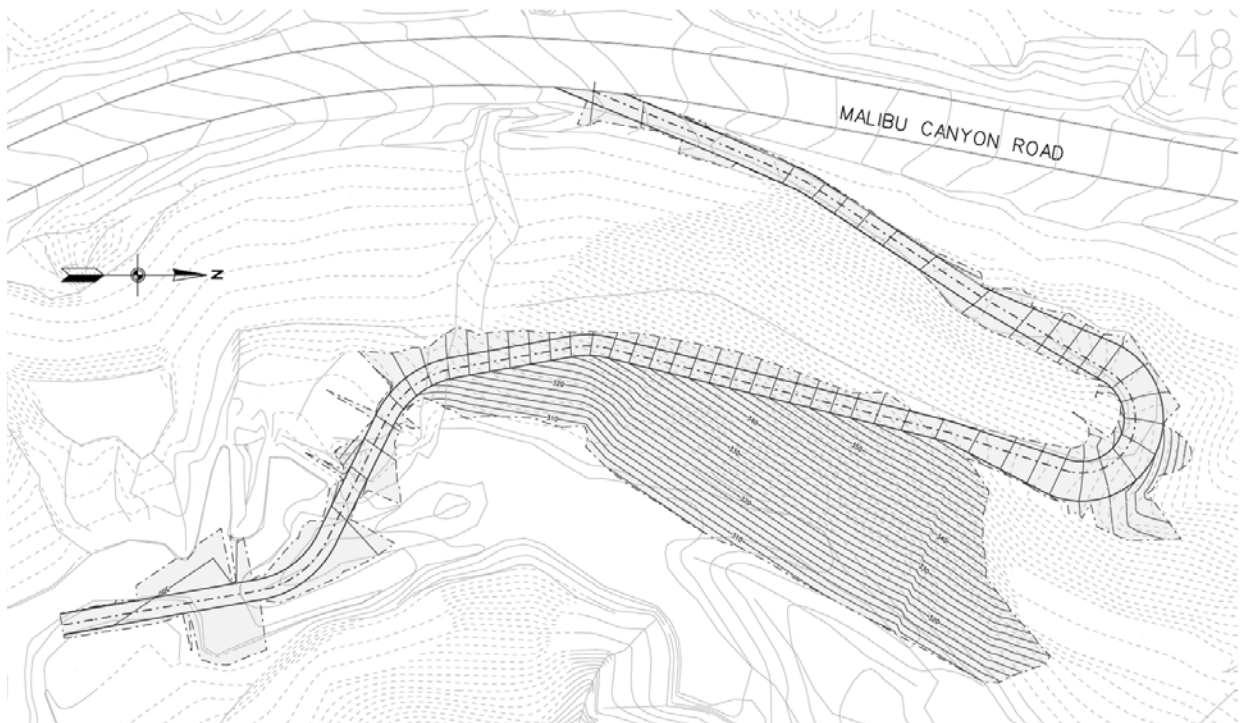
There is an existing ramp that at one time provided access to the creek invert, however the bottom half of the ramp has, over time, been washed away. The reconstructed ramp would only be 12 ft wide and have a maximum grade of 18%. Even though an 18% grade was determined to be too steep for the access ramp presented in **Figure 4.1-1**, it is an acceptable grade for the invert access ramp because the ramp was designed to allow construction equipment to get into the creek to begin clearing, dewatering, diverting the creek and excavation. The ramp would not accommodate full 20 cy capacity trucks. The ramp design is shown in **Figure 4.2-8**. This ramp would require 15,700 cy of imported material.

Figure 4.2-8 Reconstructed Invert Access Ramp

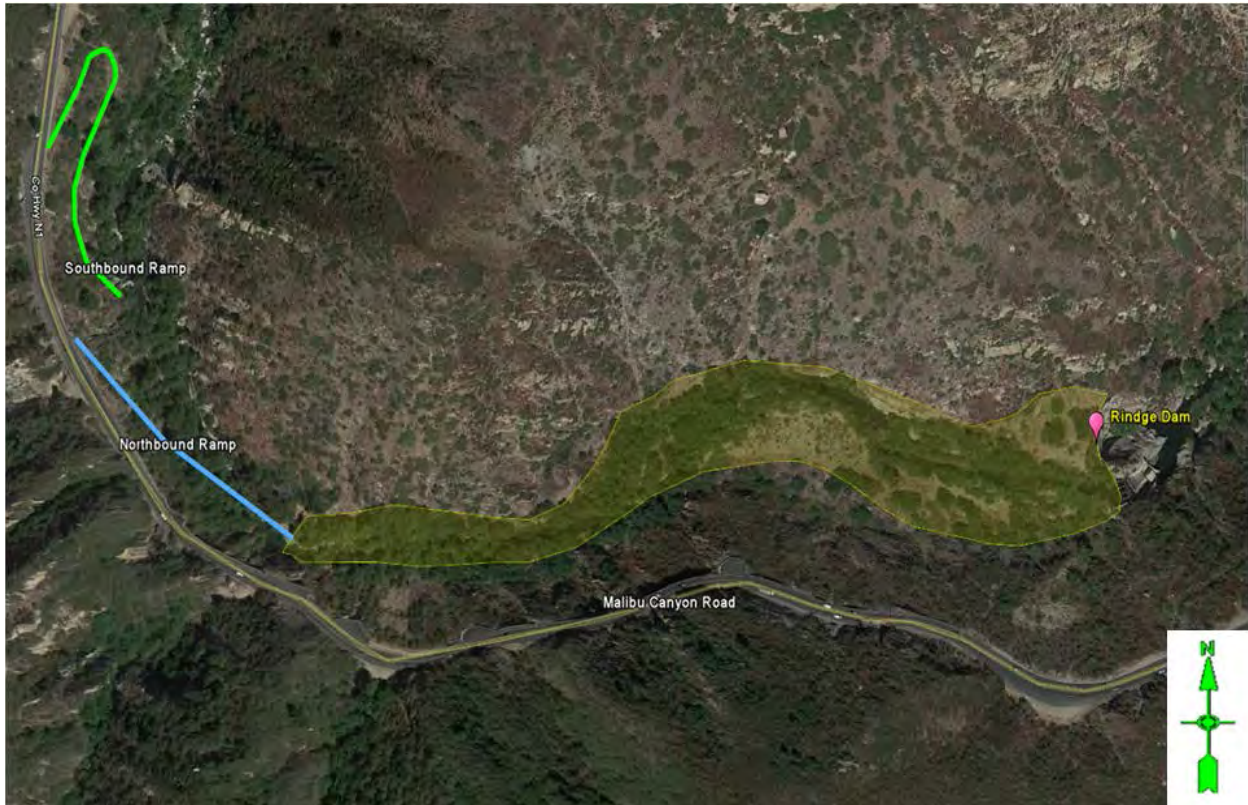
29
30
31 The sediment area to be removed is confined to the narrow canyon along the creek bed
32 from the dam to about 2,400 ft upstream of the dam. The top of the sediment is roughly 250
33 ft wide near the dam and maintains this width consistently to about 1,400 ft upstream of the
34 dam, at which point it narrows to about 100 ft for the remainder 1,000 ft upstream. The
35 approximate impounded sediment area is shown in yellow in **Figure 5.1-1**. **Figure 5.1-1** also
36 depicts the Northbound Ramp in blue and the Southbound Ramp in green.
37

Figure 5.1-1 Sediment Impound Area

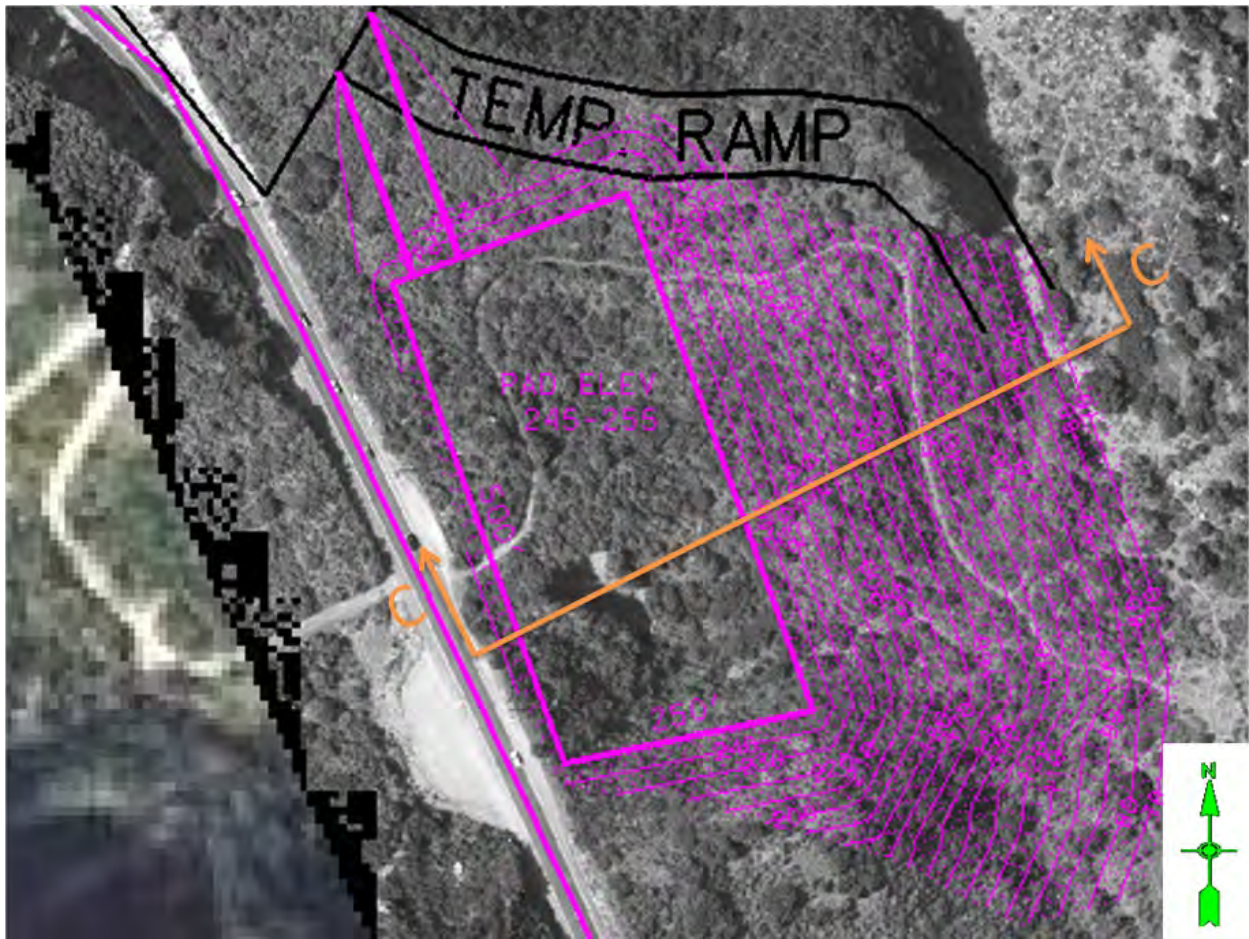
13 station located next to DSC would have to be protected in place. DSC would probably need to
 14 be revegetated to strengthen the slopes because these slopes would be 2H:1V.
 15
 16

Figure 6.2-5 Disposal Site C - Plan View

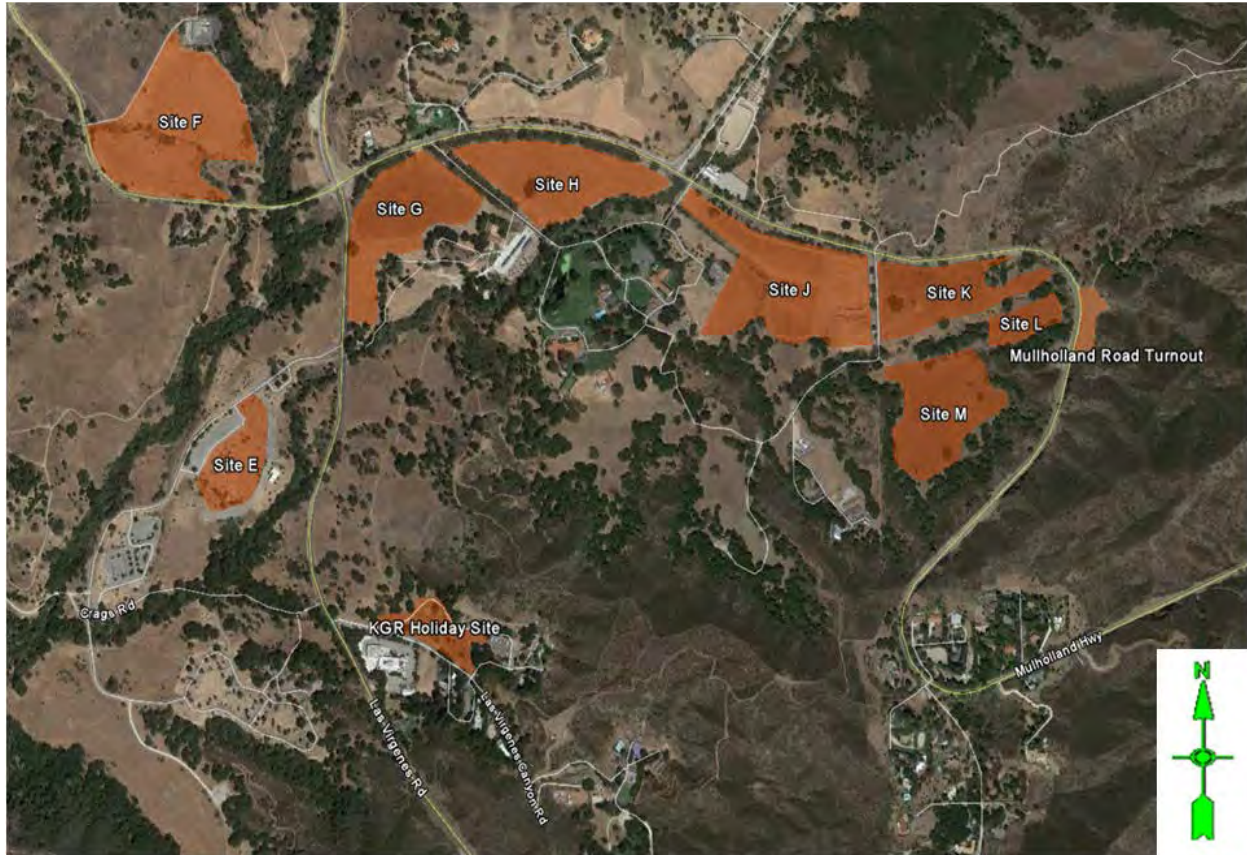
Ten different sites were investigated as potential temporary stockpile sites. **Figure 6.3-1** shows the ten sites that were located approximately 3 mi north of Rindge Dam.

Figure 6.3-1 Alternate Temporary Stockpile Sites North of Rindge Dam

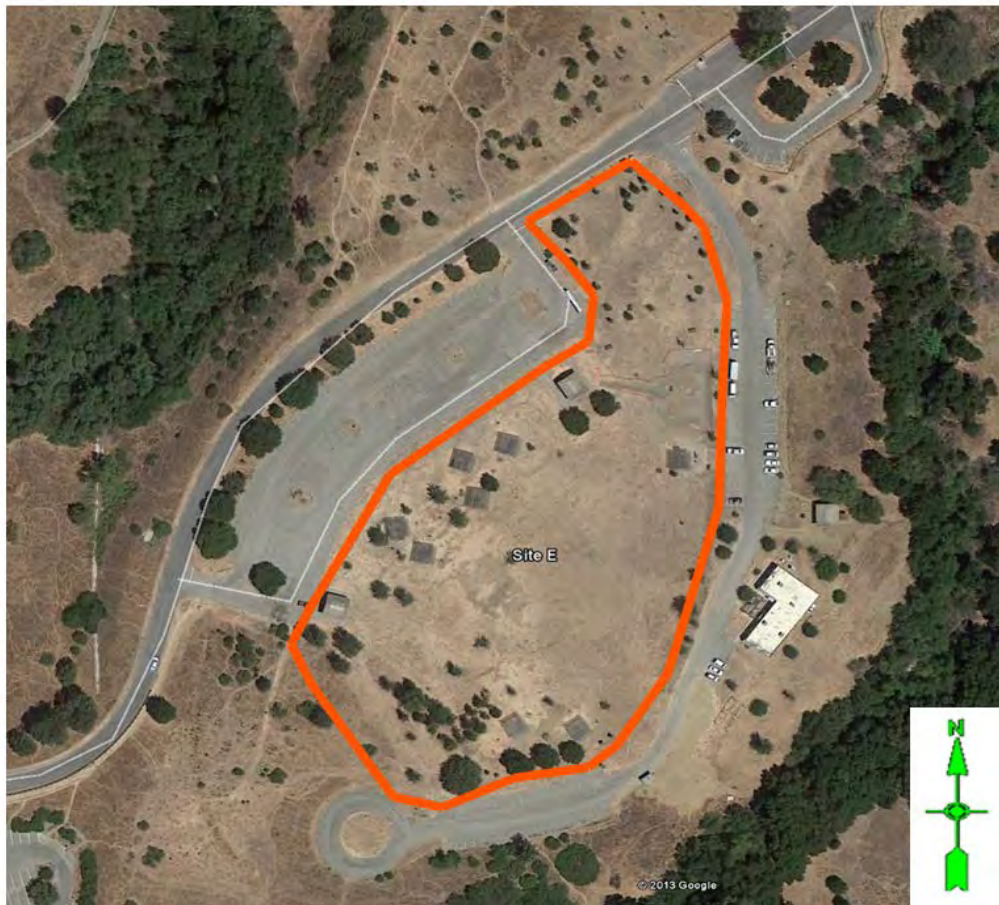
- 14 • Temporary Stockpile Site E (**Figure 6.3-2**) was only 5 ac and was determined to be too small
15 to use as a stockpile site.
- 16
17 • Temporary Stockpile Site F (**Error! Reference source not found.**) was owned by State
18 Parks and they felt any stockpile would interfere with their efforts to use the site for future
19 mitigation efforts.

Figure 6.3-2 Temporary Stockpile Site E

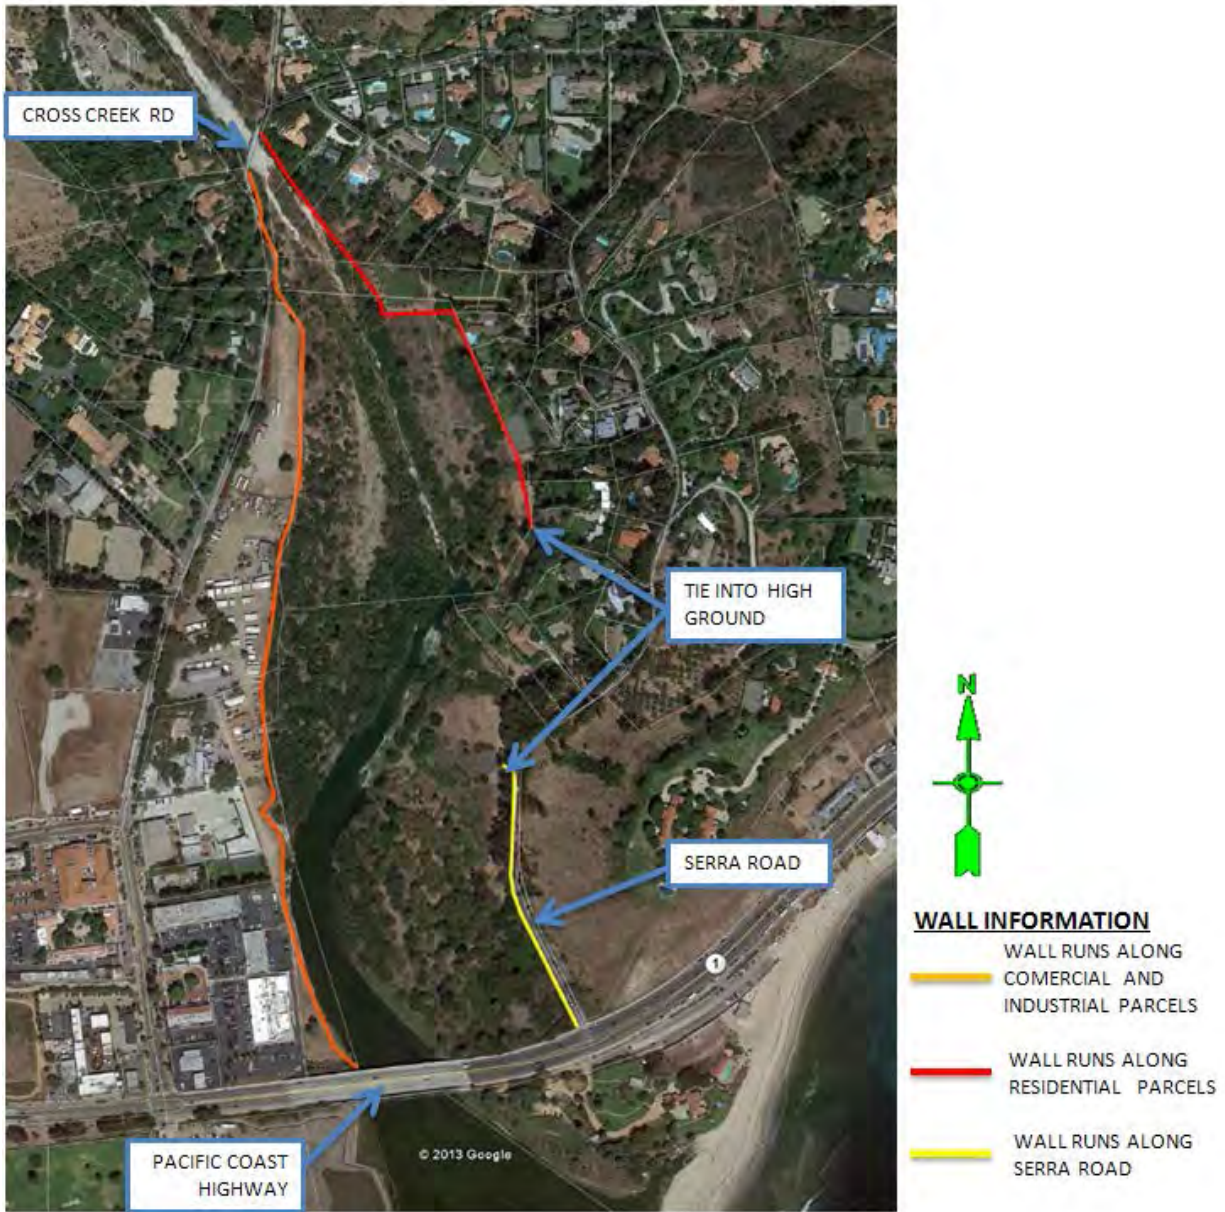
Alternatives 4a and 4b would require a 5 ft flood wall while Alternative 3a and 3b would require a 10 ft flood wall along each bank. A preliminary design concept for the flood wall was assumed for inclusion in the study to provide a cost estimate based on parametric design of similar applications of sheet pile flood walls from Project Delivery Team discussions. It should be noted that no geotechnical investigation or assessment have been performed concerning the site for the proposed flood walls. If flood walls become a feature in the final alternative, appropriate geotechnical investigations and structural design would be necessary. See additional discussion in Appendix D, Section 5.7. For cost estimating purposes, the flood walls was assumed to be an I-Wall design with a, 8" thick reinforced concrete flood wall built above ground and sheet pile extended below the existing creek invert. The concrete flood wall would not require a footing because it would attach directly to the sheet pile concrete cap.

Figure 8.1-1 Downstream Flood Mitigation Alignment

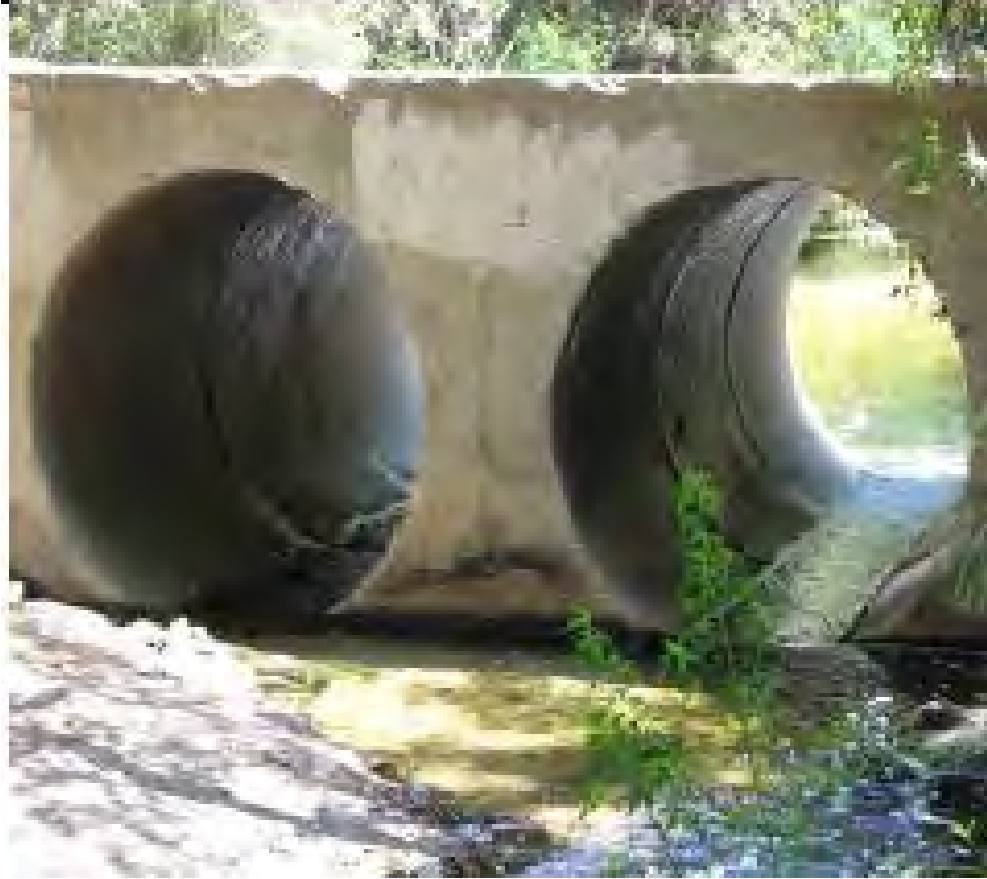
LV1, Craggs Road Culvert is a 6 ft diameter concrete, double barrel culvert located on Malibu State Parks land along Las Virgenes Creek. It currently serves as a crossing for maintenance vehicles for Malibu State Park and fire trucks.

1
2 **Figure 3.1-2 LV1, Craggs Road Culvert (Picture taken while looking upstream toward the outlet of**
3 **the culvert)**

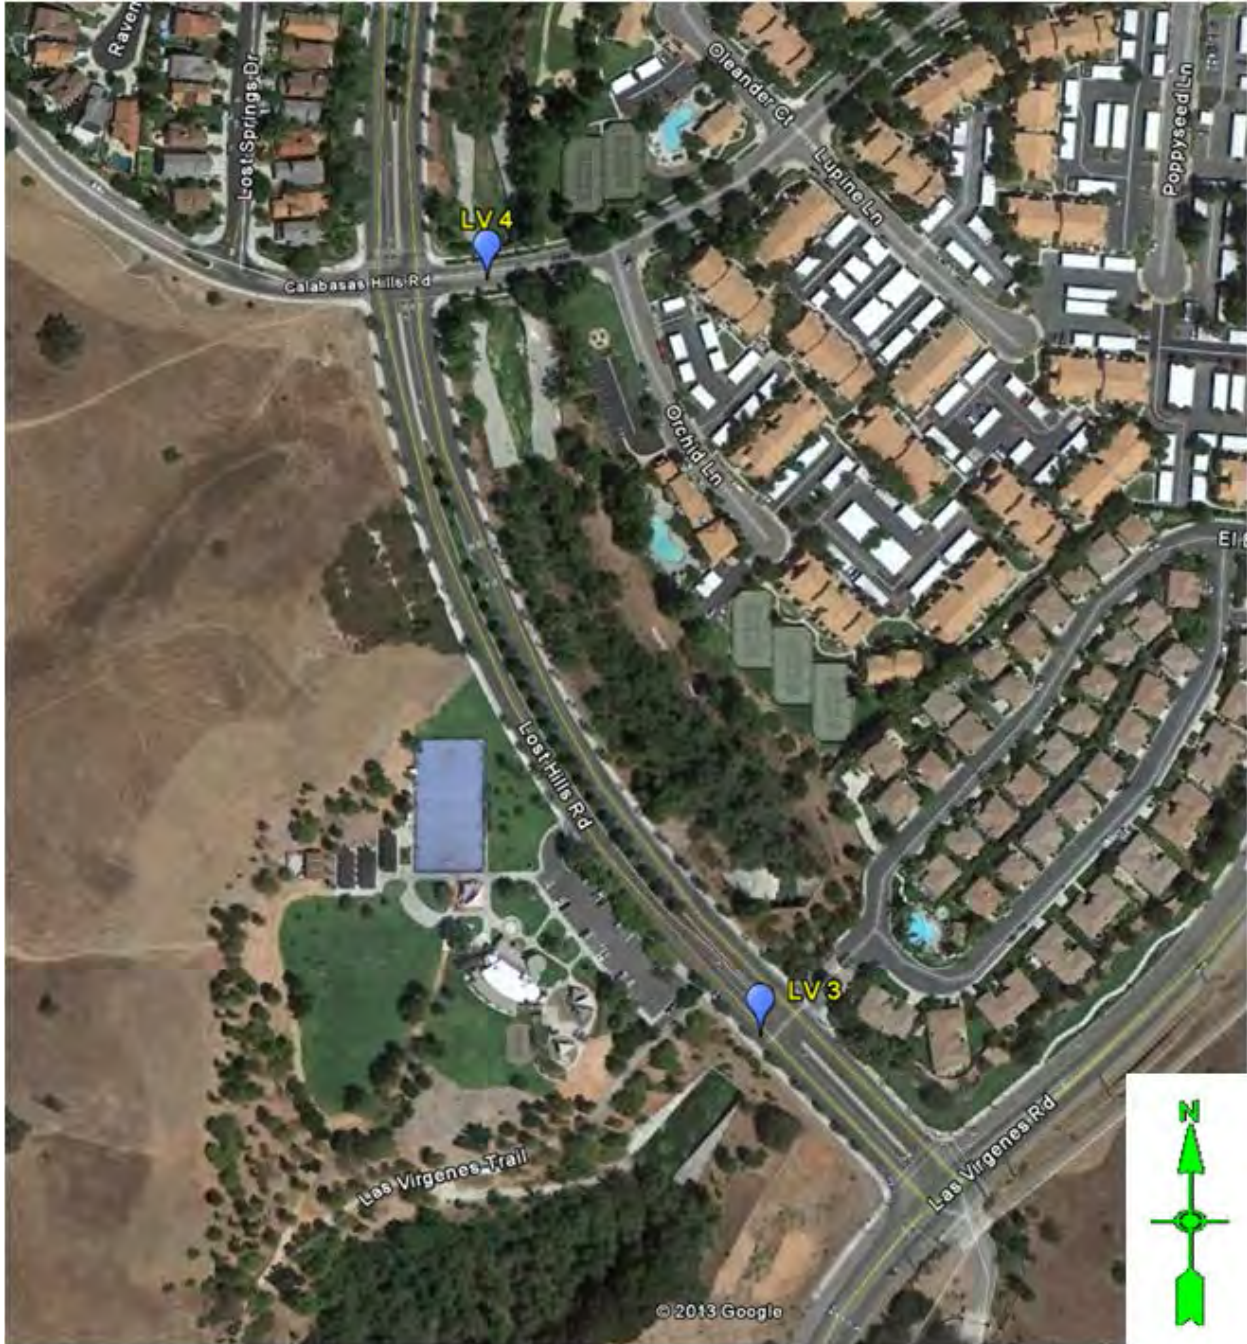
3
 4 **Figure 3.3-1 LV3 and LV4 Lost Hills Road Culvert and Meadow Creek Lance Crossing (Aerial View)**

8 LV3, Los Hills Road Culvert is a 61 ft wide, 241 ft long, concrete box culvert with four 14 ft x 14 ft
 9 openings. The culvert follows a curve in the creek. Los Hills Road is a four lane road that passes
 10 over the culvert and through a densely developed residential area. There are concrete aprons
 11 that extend 100 ft upstream of the inlet and 100 ft downstream of the outlet of the culvert. LV 4,

1 Meadow Creek Lane Crossing, is 930 ft upstream of LV3 and consists of a 61 ft wide, 82 ft long
2 concrete box culvert with four 14 ft x 14 ft openings. There are concrete aprons that extend 170
3 ft upstream of the inlet and 170 ft downstream of the outlet of the structure. Meadow Creek Lane
4 is a two lane road that passes over the culvert and it serves as one of two points of entry into a
5 densely developed residential neighborhood. Both structures are located on Las Virgenes Creek.
6

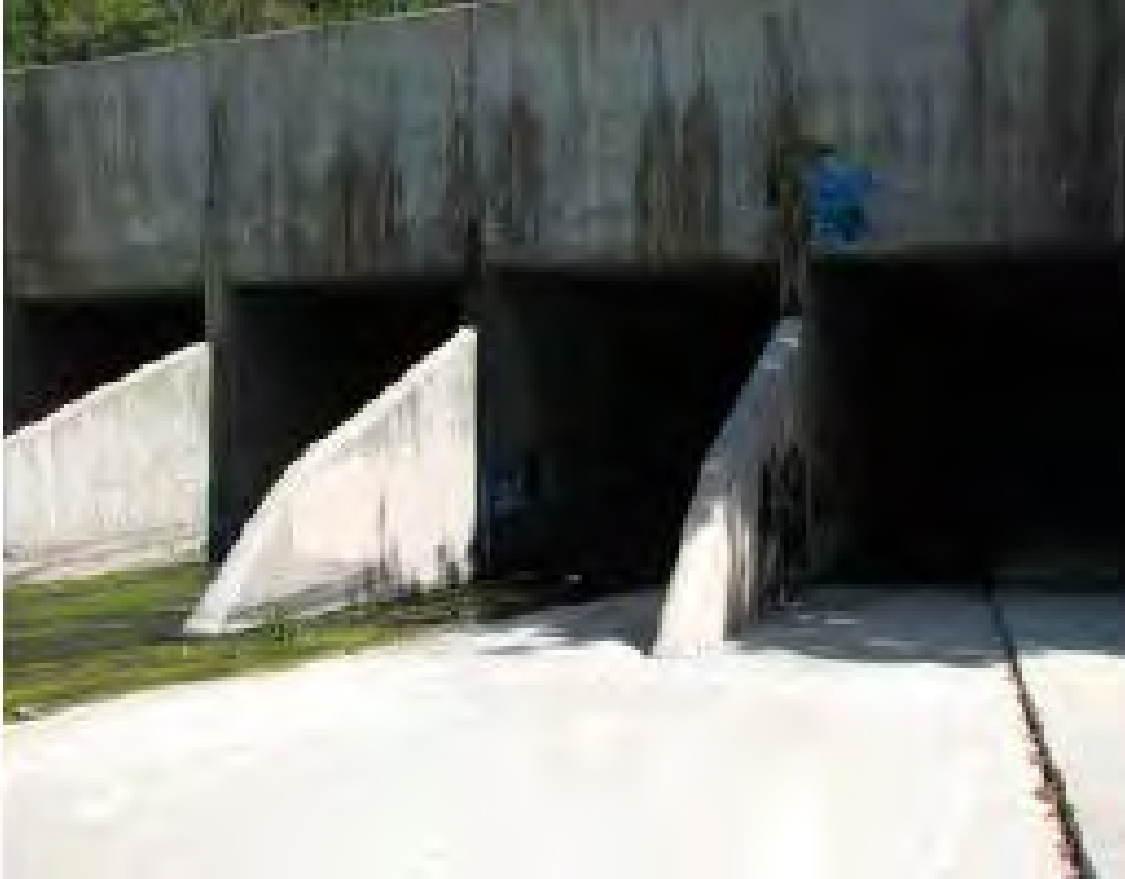
Figure 3.3-3 LV3, Lost Hills Road Culvert Inlet (Picture taken looking downstream)

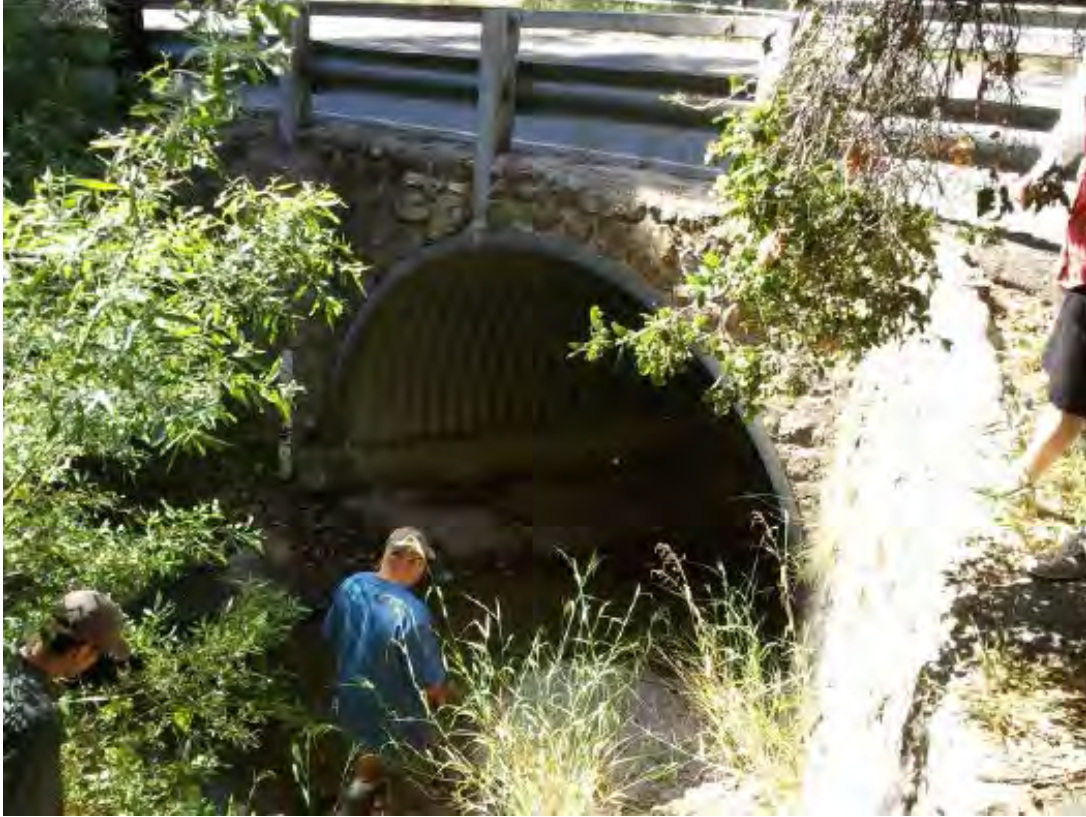
6
 7
 8 CC1, Piuma Culvert is a 12 ft long, 46 ft wide corrugated metal pipe (CMP) arch culvert with a
 9 concrete invert. The downstream end of the concrete invert ends abruptly and there is a two foot
 10 drop from the top of the concrete invert to the creek bed. Piuma road is a two lane rural road that
 11 passes over the structure and provides access to homes throughout the hills. CC1 is located
 12 along a curve in Piuma Road. There is a 90 degree bend in Cold Creek approximately 50 feet
 13 downstream of the culvert where bed rock is exposed.
 14

Figure 3.4-2 CC1, Piuma Culvert (Picture taken looking upstream)

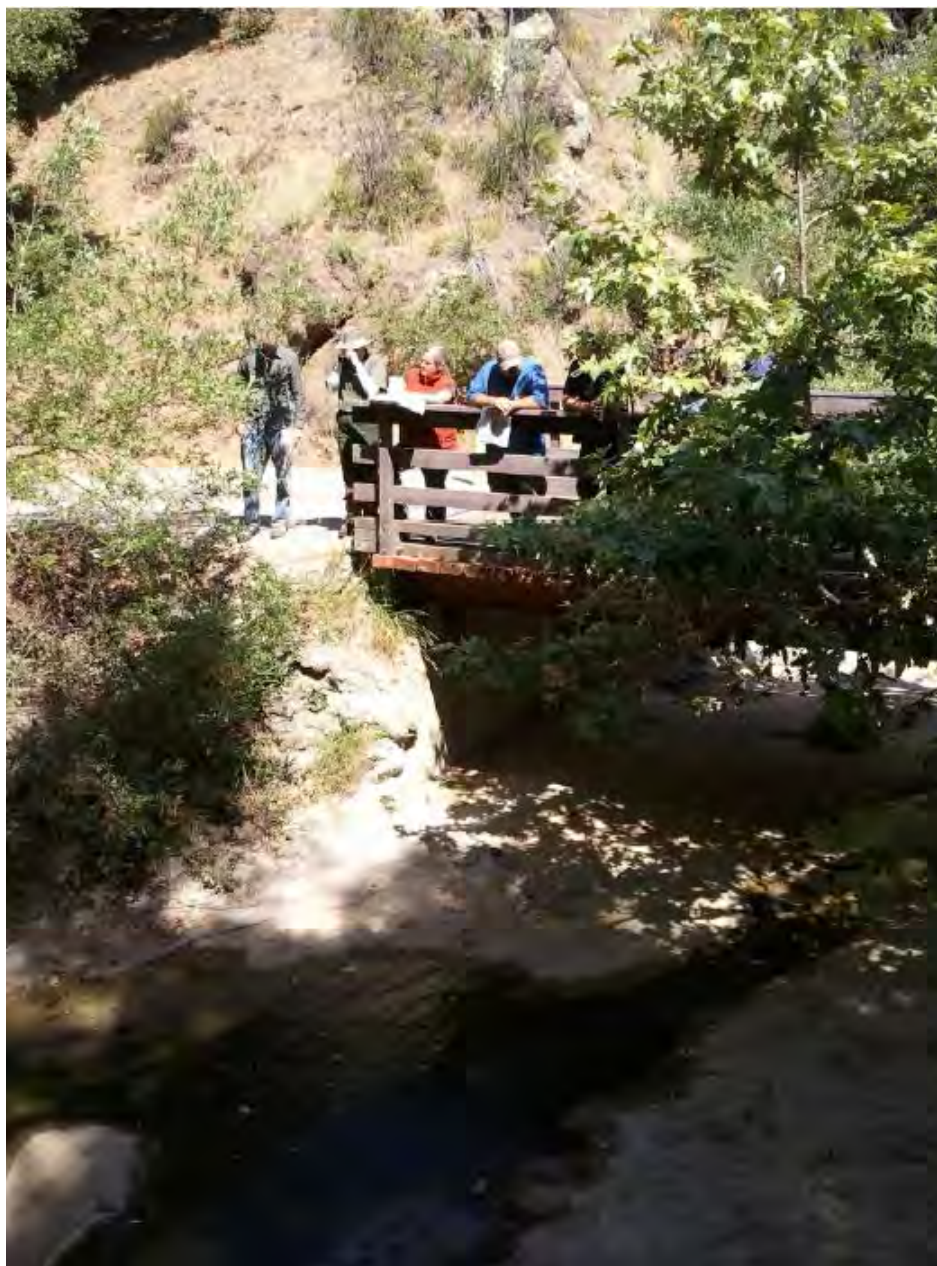
2
3 CC2, Malibu Meadows Road Crossing, is a 28 ft wide, 40 ft long steel beam bridge with a wood
4 deck. A concrete slab that is at least 18 inches thick passes under the bridge and ends abruptly
5 just downstream of the structure. There is a two foot to three foot drop from the top of the concrete
6 slab to the creek invert. The bridge is part of Malibu Meadows Road which is a narrow two lane
7 road that serves homes throughout the hills.
8

9
10 **Figure 3.5-2 CC2, Malibu Meadows Road Crossing, Upstream End**
