1 **Malibu Creek Ecosystem Restoration Study**
2
3 **Los Angeles and Ventura Counties, California**

4
5 **Appendix C**

6
7 **Civil Design & Structural**
8

9
10 U.S. Army Corps of Engineers
11 Los Angeles District
12

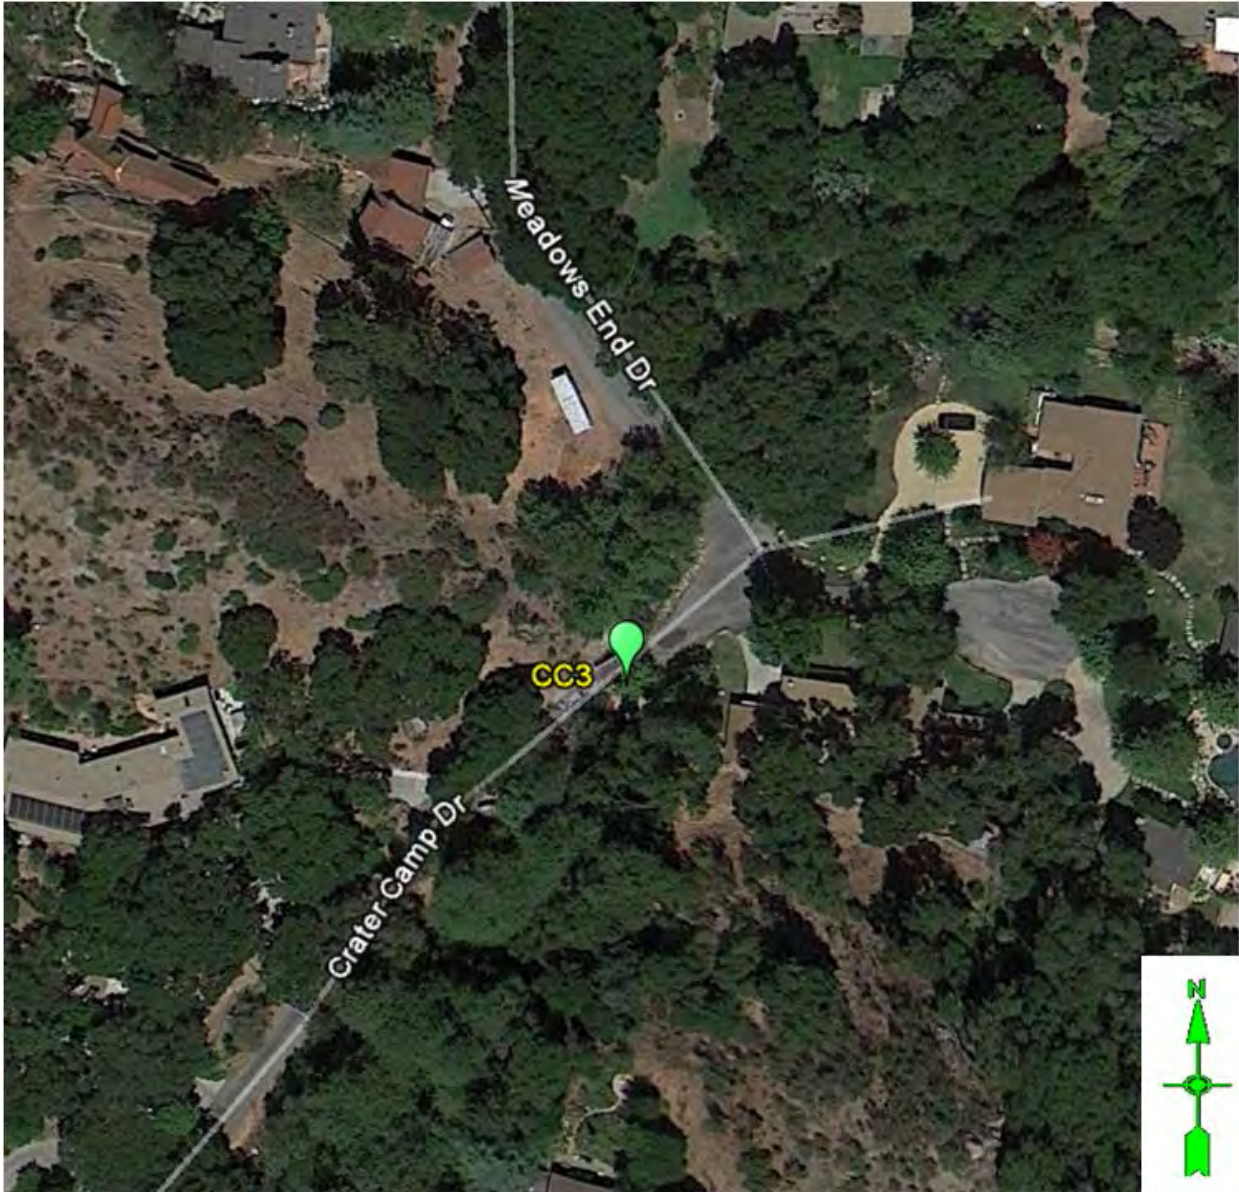
3
4 **Figure 3.6-1 CC3, Crater Camp Road Crossing (Aerial Image)**

8 CC3, Crater Camp Road Crossing, is 11 ft wide, 46 ft long steel beam bridge with a wood deck.
9 A concrete slab that is at least 18 inches thick passes under the bridge and ends abruptly just
10 downstream of the structure. There is a three foot drop from the top of the concrete slab to the
11 creek invert. The bridge is part of Crater Camp Road which is a narrow road that serves homes
12 throughout the hills.
13
14

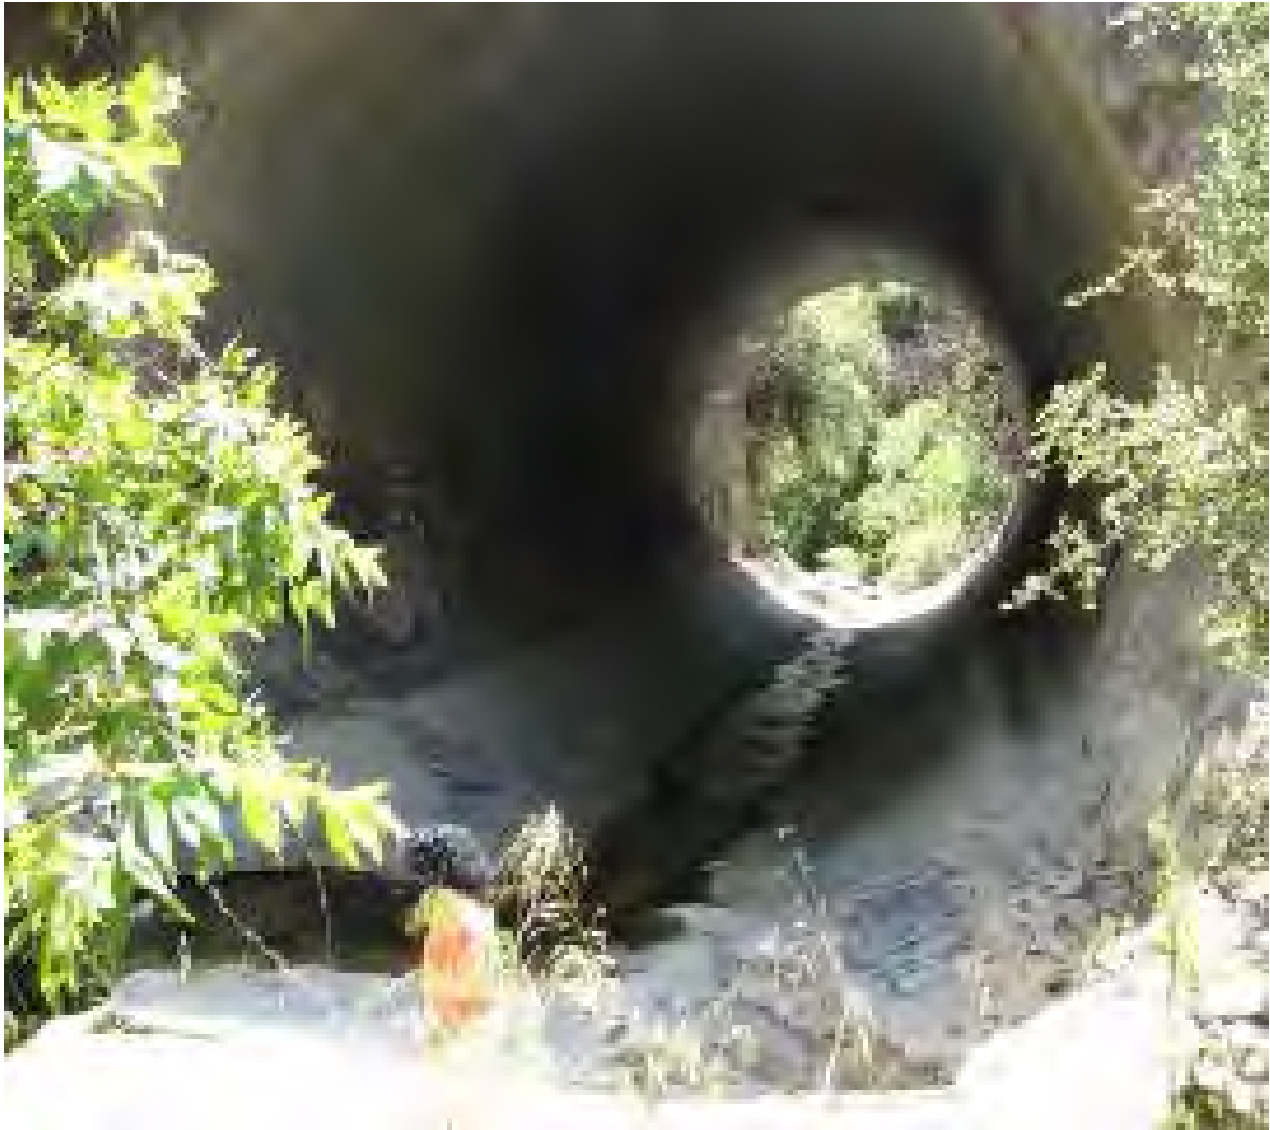
2
3 CC5, Cold Canyon Road Culvert is a 25 ft diameter concrete culvert along Cold Creek. Cold
4 Canyon Road is a two lane rural road that serves homes in the mountains.
5

6
7 **Figure 3.8-2 CC5, Cold Canyon Road Culvert (Picture taken looking upstream)**

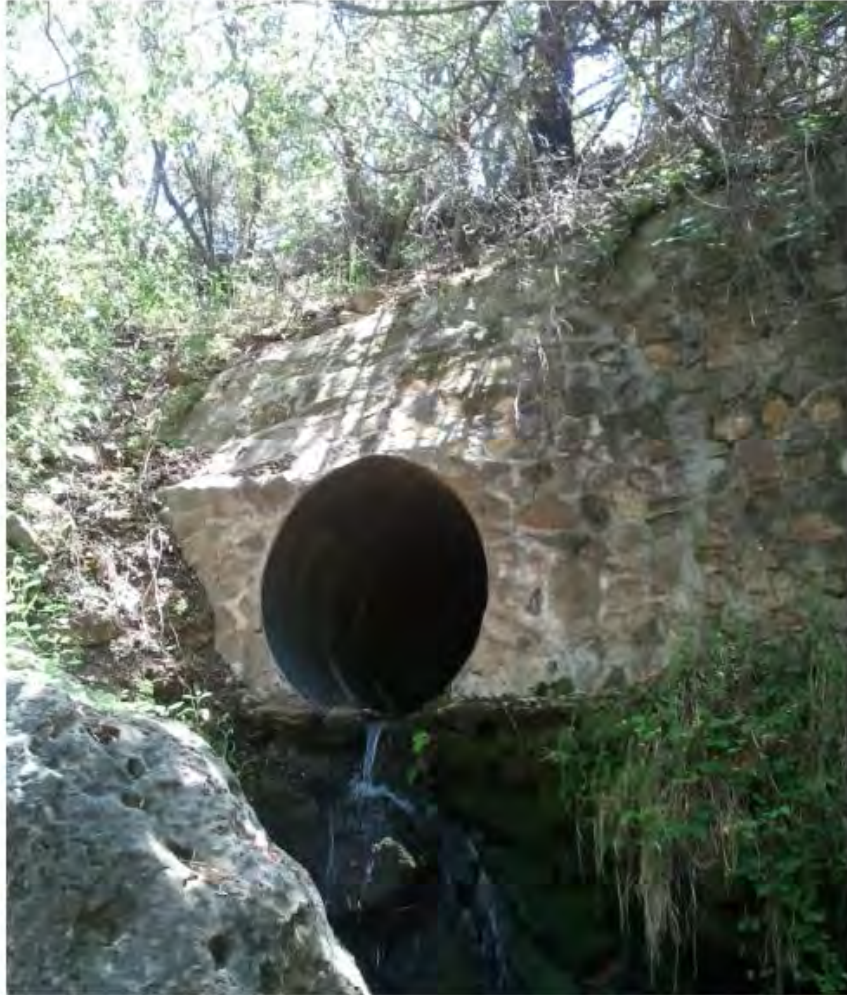
7 CC8, Stunt Road Crossing is a six foot diameter CMP culvert that runs along the creek for 104 ft.
 8 The structure is covered with at least 20 ft of soil and has a stone headwall at the outlet that also
 9 acts as a retaining wall for the embankment of Stunt Road. Stunt Road is a two lane rural road
 10 that serves traffic passing through the mountains. The culvert is located along a curve in Stunt
 11 Road on Cold Creek.
 12

1
2 **Figure 3.9-2 CC8, Stunt Road Crossing Picture (Picture taken looking upstream)**
